## Technical product information

| <b>Topic</b> | Fuel pressure regulator - DTC P242200 with symptom code 14536 evident within address 0001 |
| <b>Brand</b> | Bentley |
| <b>Transaction No.</b> | 2065926/2 |

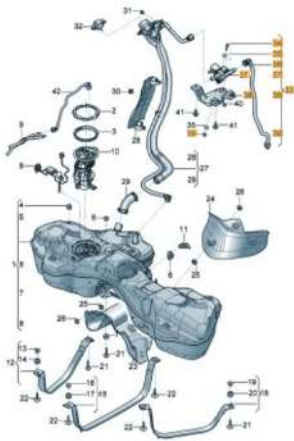
4M0 201 549A - Pressure regulator assembly and associated parts as shown below

- 1) Referring to Rep.Gr20 - Replace the Pressure regulator assembly and associated components
- 2) Conduct a road test in EV Mode and/or Hybrid drive mode where possible
- 3) On return from road test - Check to confirm the issue is resolved and DTC P242200 is not evident within address 0001
