## Technical product information

| <b>Topic</b> | Knocking noise from the front and/or rear - DTC C1298F1 evident within D4 and/or D5 |
| <b>Brand</b> | Bentley |
| <b>Transaction No.</b> | 2065085/2 |

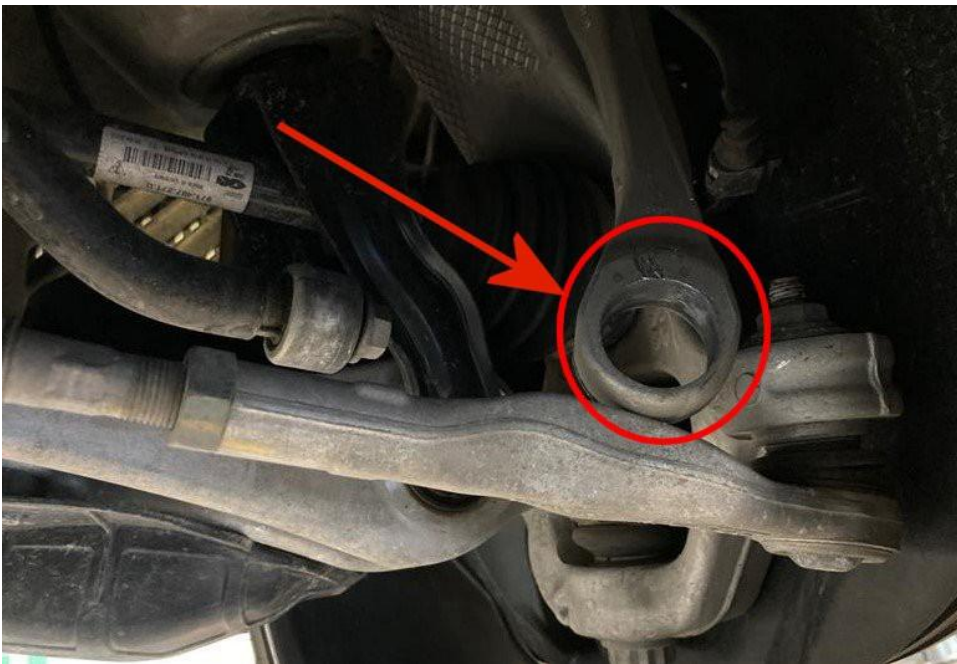
Figure 1

NOTE: The photo shown within this TPI is of the front anti roll bar drop link, please note the issue can also be evident on the rear

1) Check the front and/or rear anti roll bar drop link has not detached (Figure 1) in this scenario DTC (C1298F1: Suspension stabilization actuator Regulation not possible) may be evident within address D4 and/or D5

Check for signs of impact on or around the affected components, ensure photographic evidence of the issues found are attached to a new or already open DISS query to support all warranty claims

3) Raise a DISS query ensuring any photos and videos are attached of the issues found NOTE: The operative does not have to wait for a response before replacing parts - Referring to the applicable Rep.Gr - Replace the applicable drop link
