## Technical Service Bulletin (TSB)

### Incorrect Fuel Tank Installed

| REFERENCE: | TSB: 14-010-26<br>GROUP: 14 - Fuel System | Date: | September 18, 2026 | REVISION: | — |
| VEHICLES AFFECTED: | 2026 (WL) Jeep Grand Cherokee / Grand Cherokee L<br>This bulletin applies to vehicles built on or after January 01, 2026 (MDH 0101XX) and on or before March 05, 2026 (MDH 0305XX) equipped with 2.0L Hurricane 4 Turbo W/ESS (Sales Code EC7). | | | MARKET APPLICABILITY:<br><div><input checked="" type="checkbox"/> NA<input type="checkbox"/> MEA<br/><input type="checkbox"/> SA<input type="checkbox"/> IAP<br/><input type="checkbox"/> EE<input type="checkbox"/> CH</div><br>NOTE: This bulletin applies to the North America market. | |

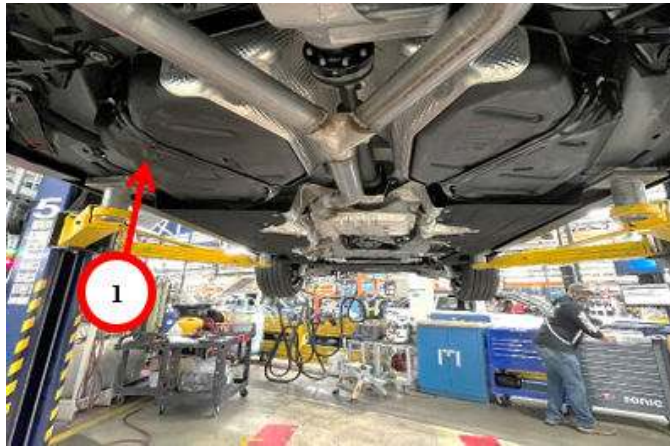
**Fig. 1**  
Left Side Of Fuel Tank

2. Locate the left side of the fuel tank [Fig. 1](#).

1 - Left Side Of Fuel Tank

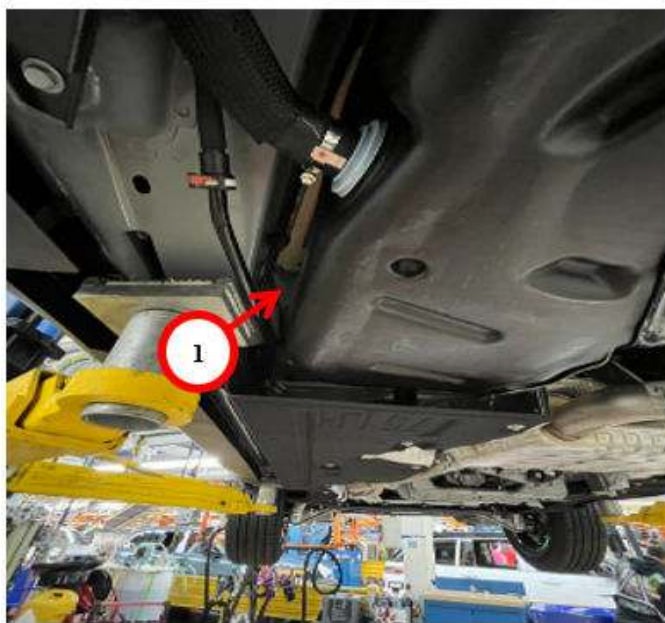
**Fig. 2**  
Mirror Insertion Location For Inspection

3. Use a small inspection mirror to place above the left most end of the fuel tank [Fig. 2](#) [Fig. 3](#).

1 - Inspection Location

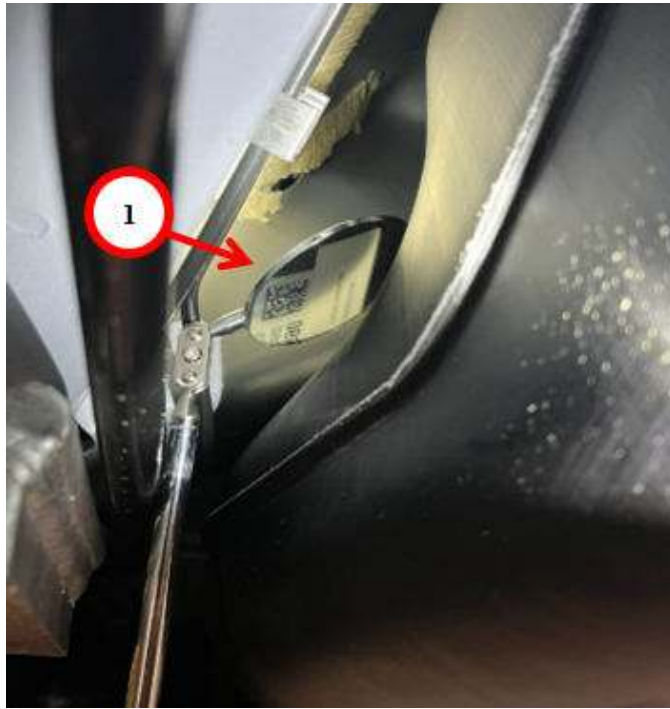
**Fig. 3**  
Mirror Capturing Parts Label On Fuel Tank

1 - Parts Label Location

4. Use adequate lighting and take photo of the mirrored label (two people required) [Fig. 3](#).
5. Check the photo taken for clarity and flip photo to correct the label direction [Fig. 4](#).

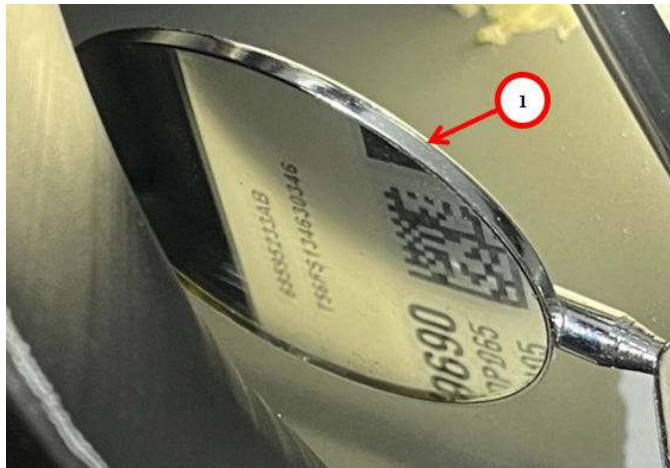
**Fig. 4**  
Camera Image Flipped

1 - Part Label Image Capture

6. Is the fuel tank part number 68595233AA or 68595233AB?
  - YES>>> This bulletin has been completed. Use Inspection LOP (14-50-01-92) to close the active RSU.
  - NO>>> Proceed to [Step 7](#).
7. Replace the fuel pump. Refer to the detailed service procedures available in DealerCONNECT/Service Library under: Service Info> 09 - Engine, 2.0L / Fuel System / Modules / Removal and Installation.
8. Clear DTCs.
