PIC6285B Diagnostic Aid for DTCs P1AEE and P1AEF, Control Module Hybrid/EV Battery System Voltage High Voltage (Over-Voltage)

| Brand: | Model: | Model Years: | VIN: | | Engine: | Transmissions: |
|---|---|---|---|---|---|---|
| Chevrolet | Volt | 2016 - 2019 | All | All | All | All |

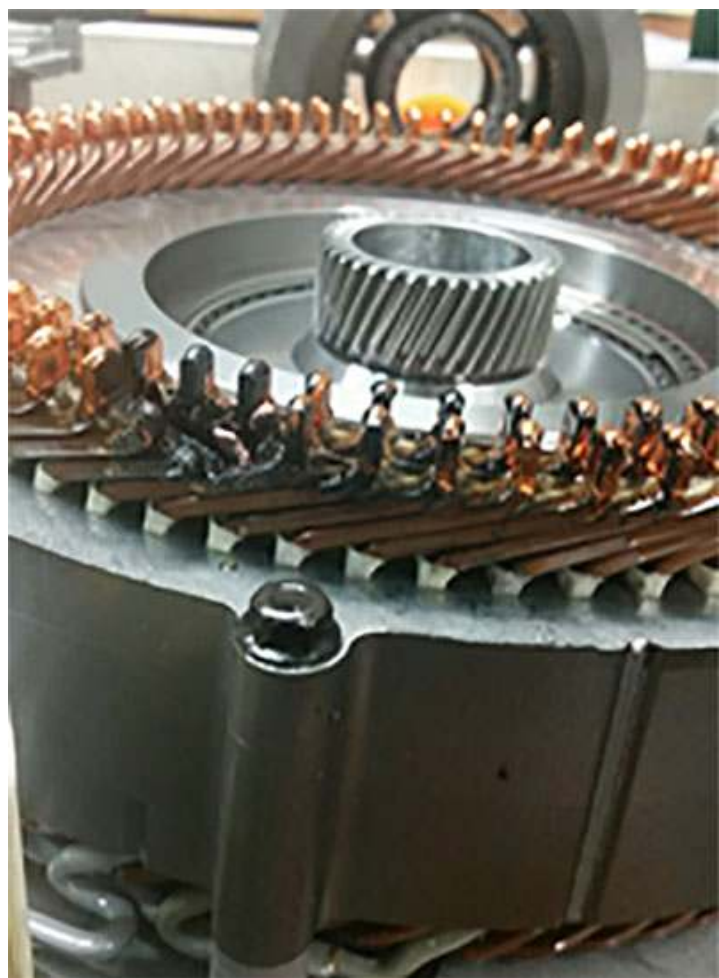
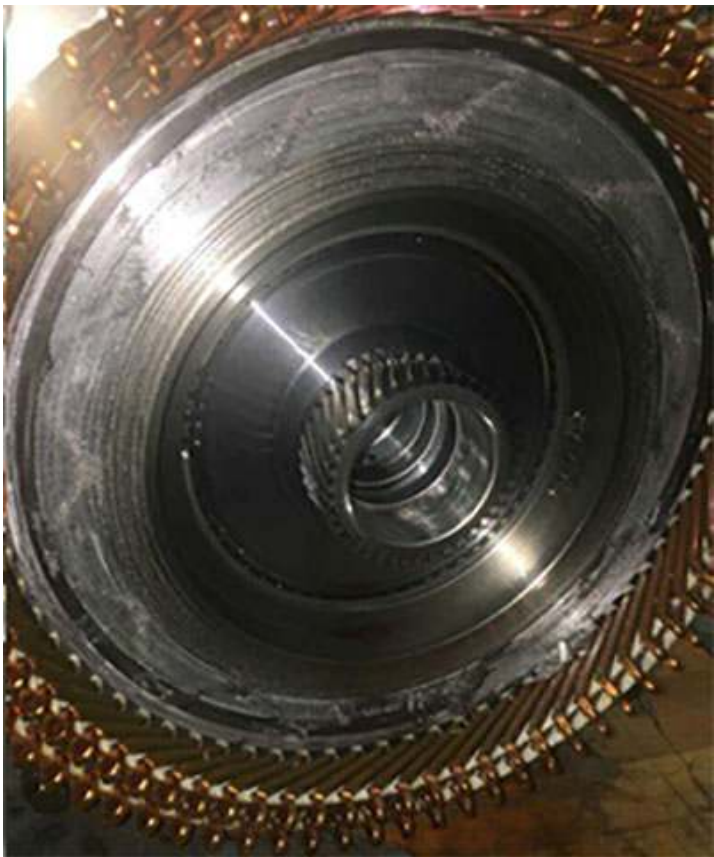
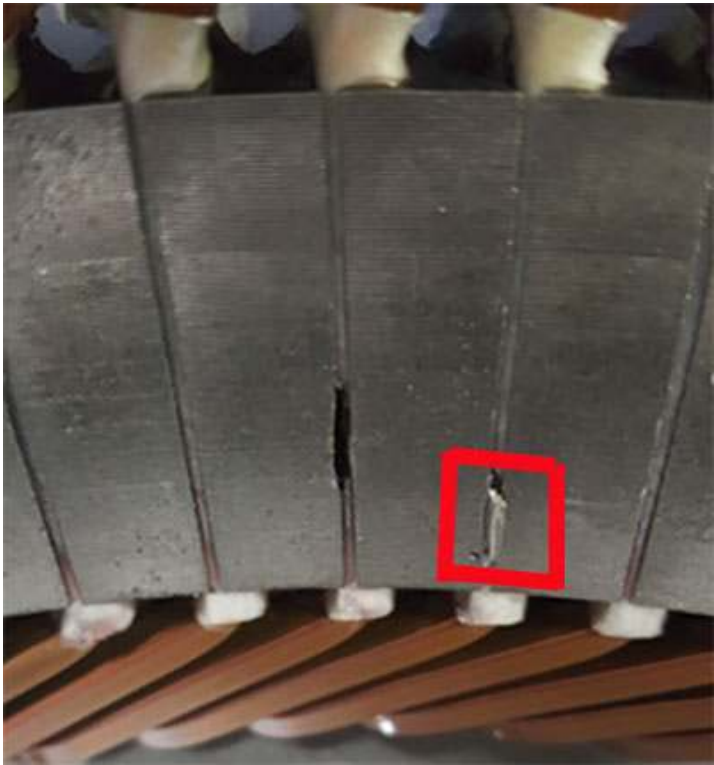
Category 1: P1AEE and P1AEF were caused by a loss of isolation condition in the vehicle

If accompanied by DTCs P1AF0/P1AF2/P1E22 or P0C01/P0C04, then the loss of isolation will be located within the transmission, usually due to debris in the motor stators from a failed internal component.

Examples of debris causing stator problems:

Use the *Loss of Isolation on the High Voltage Main Bus* procedure in SI to help pinpoint which subsystem is causing the loss of isolation.

**Note: Any loss of isolation will not self-heal and needs to be repaired for vehicle safety. Clearing codes without repair is not an acceptable remedy of this category due to the vehicle hazards created by P1AEE and P1AEF.**

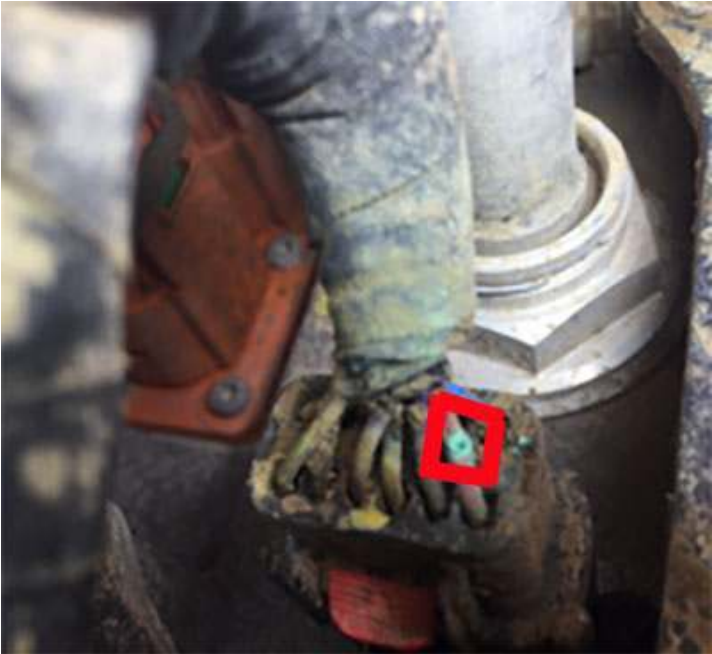
**Any compromise in these circuits may cause the contactors to open unexpectedly.**

Example of connector X357 with stone impingement and corrosion on wiring:

**Inspect circuits 3961 and 3959 for contactor control as well as B+ 5240 and ground circuit 2050 (G302).**

If no trouble is found, replace the K114B HPCM2 module for a possible internal fault with contactor control.

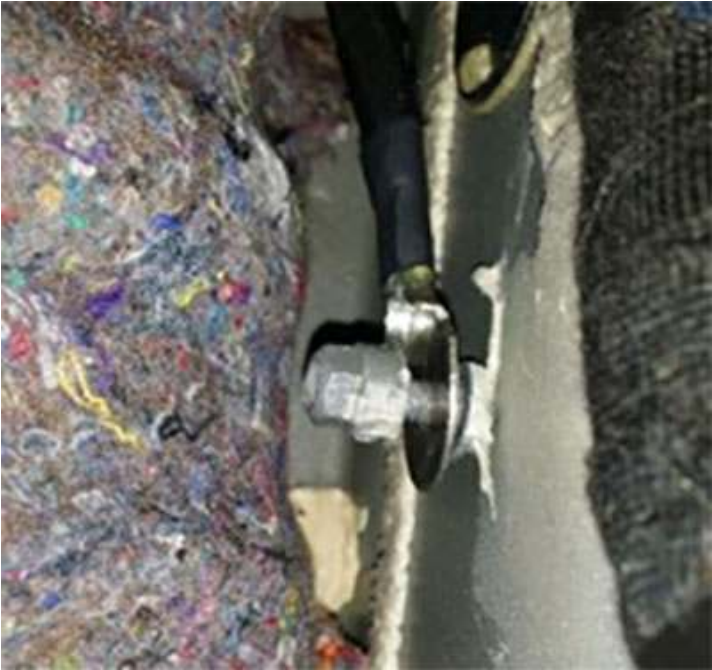
Example of loose ground G302:

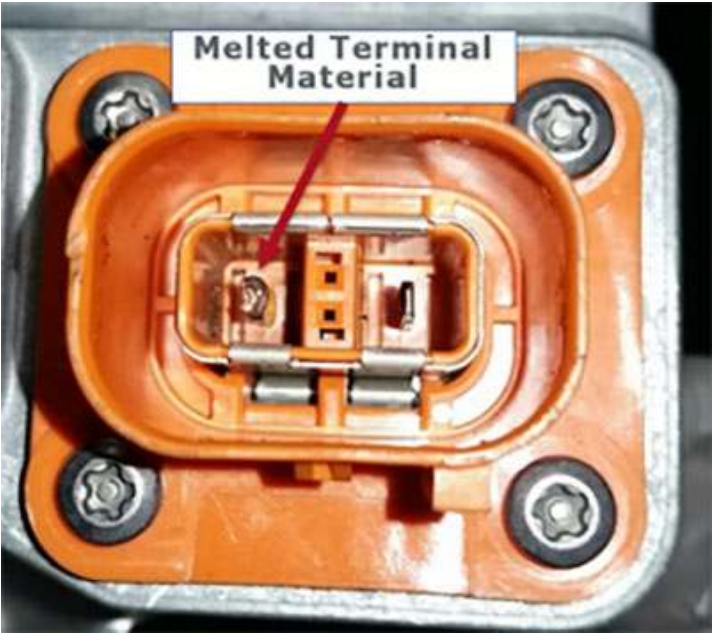
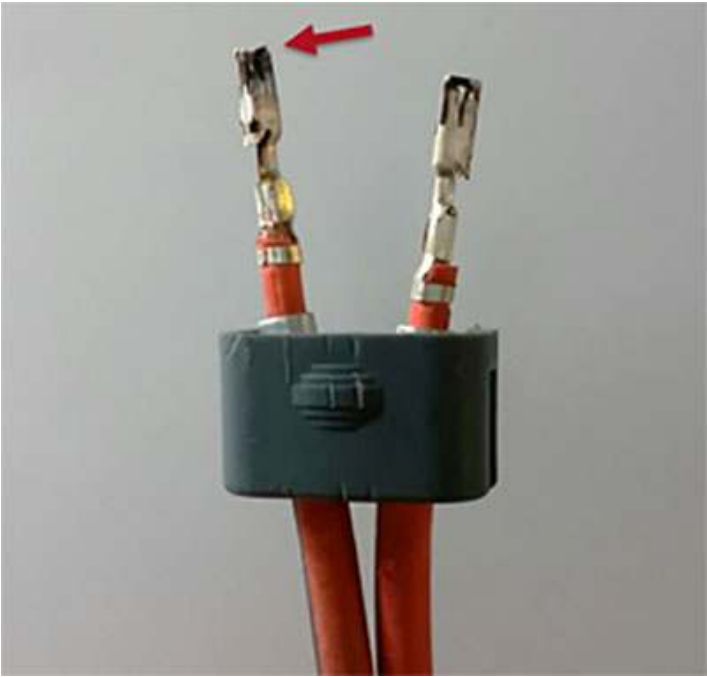
**Category 3: P1AEE and P1AEF caused by a loose or intermittent orange high voltage cable connection**

Example of a loose connector X2 at the K10 Coolant Heater Control Module:

This is expected to be a less common category for P1AEE and P1AEF. If one of the parameters is near but not equal to zero, properly inspect each of the orange high voltage connectors on the vehicle for a loose connection on the high voltage bus.
