## PIP5255A P16D0 P0300 Oil Leak Random Misfire Inspect Oil Galley Plugs In Head

| Brand: | Model: | Model Years: | VIN: | | Engine: | Transmissions: |
|---|---|---|---|---|---|---|
| Chevrolet | Impala | 2014 - 2015 | All | All | 2.5 LKW | All |
| Chevrolet | Malibu | 2014 - 2015 | All | All | 2.5 LKW | All |

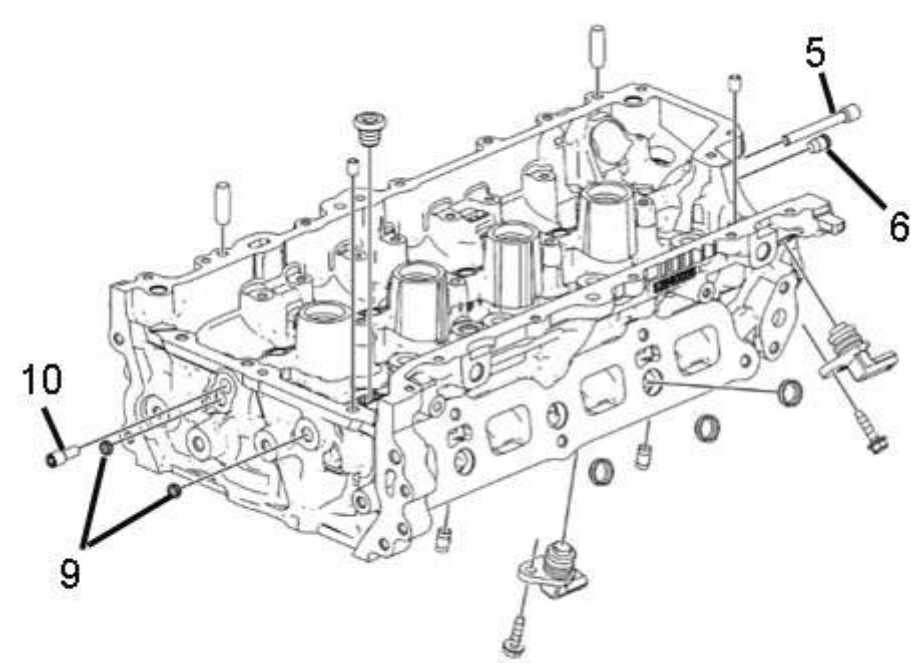
**After cylinder head replacement, the head may have an external oil leak, random misfires on all cylinders when camshaft is on low lift with light throttle and/or sets P16D0 P0300.**

**If code P16D0 and/or P0300 sets, random cylinder misfire on all cylinders only when on camshaft lobe low lift, verify oil galley plug #10 (see illustration below) has been installed. This oil galley plug is located in the head, behind the timing cover and would have an engine oil leak that is internal of the engine.**

**If the head has an external oil leak, verify oil galley plugs #5 and #6 (see illustration below) have been installed.**

**Oil galley plugs #9 (see illustration below) should already come installed in the new head.**
