# Preliminary Information

## PIP5495G Check Engine Light On With P0299 Or P0234

| Cause: | Misdiagnosis Leading to Returned Turbochargers with NTF |

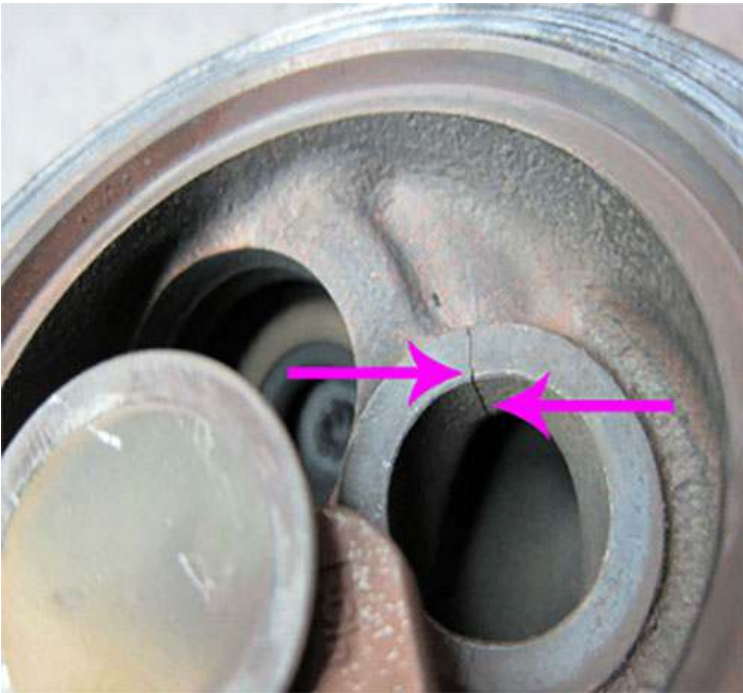
Crack(s) at the wastegate valve port (this is normal and does not affect performance)

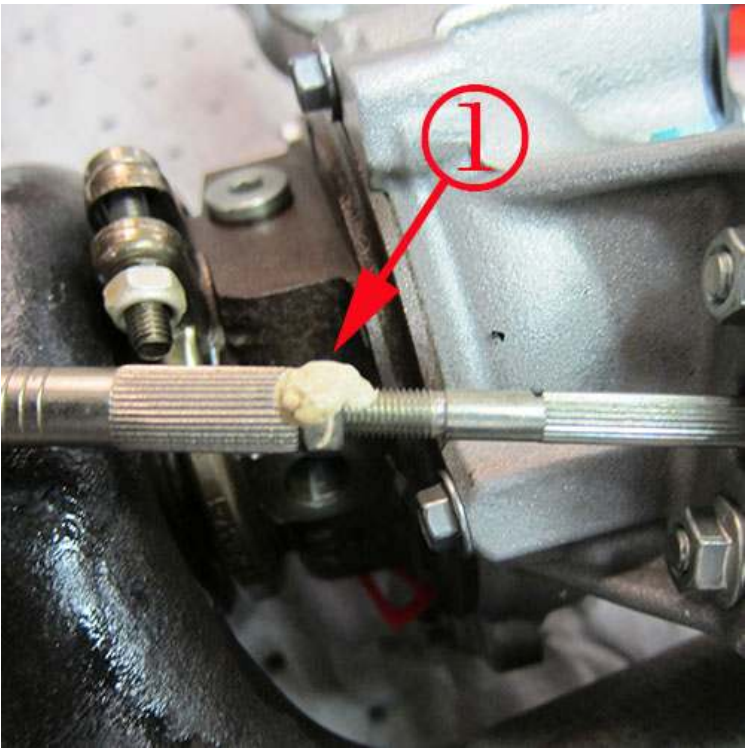
If the tamper paint seal is broken or missing, check the vehicle for any additional sign of modification to the induction, exhaust, or engine calibrations as this may indicate an attempt to adjust the wastegate arm to modify the powertrain operation.

If found, review the powertrain warranty status with your service manager prior to performing repairs

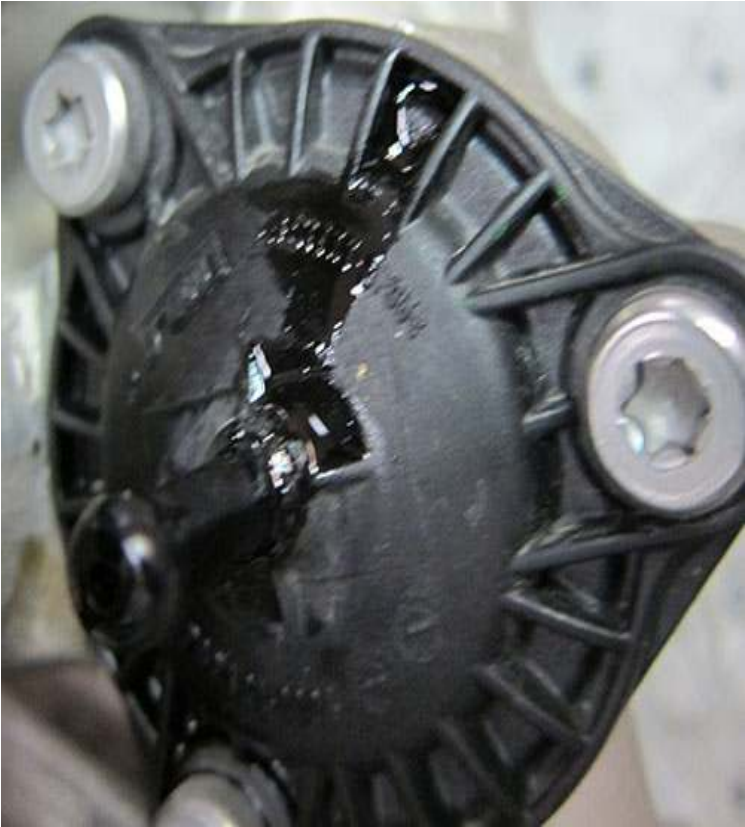
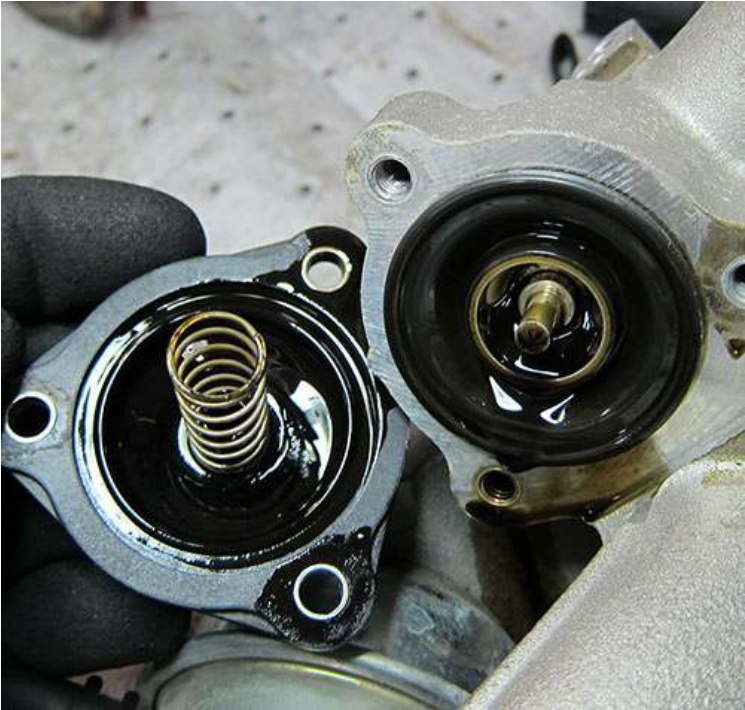
Bypass (recirculation) valve cover port broken or water/oil found inside the valve (clean the components, if necessary replace bypass (recirculation) valve assembly - released for service)

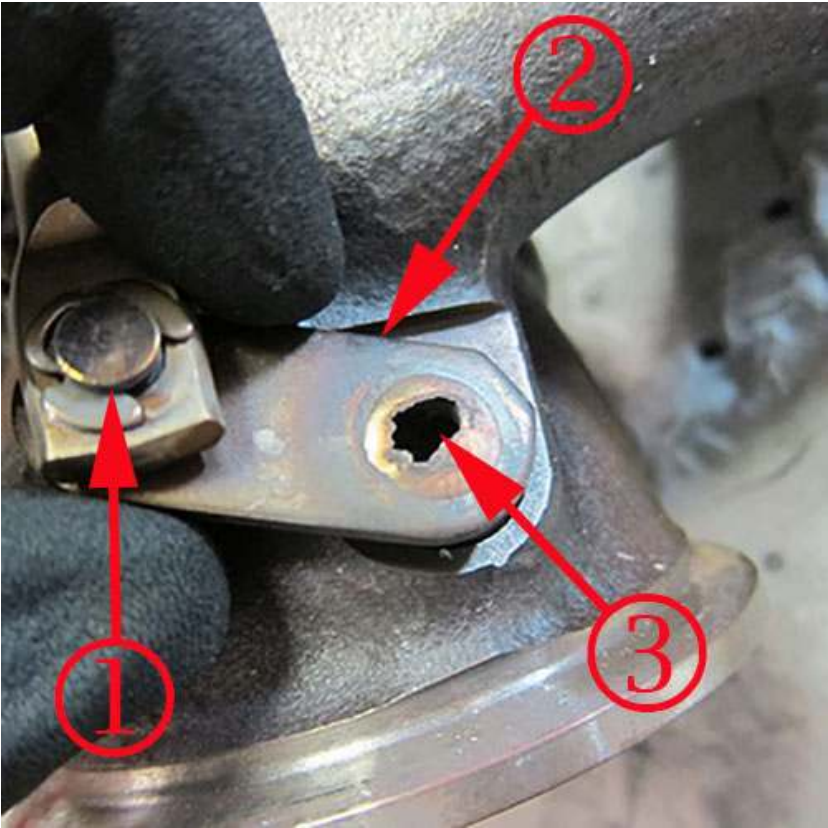
Replace the turbocharger if P0299 is set and at least one of the following is present:  
If the following failures are identified, it is not necessary to perform the Turbocharger Boost Control Test.  
Disconnected wastegate lever arm (crank) (2) from the shaft (3).

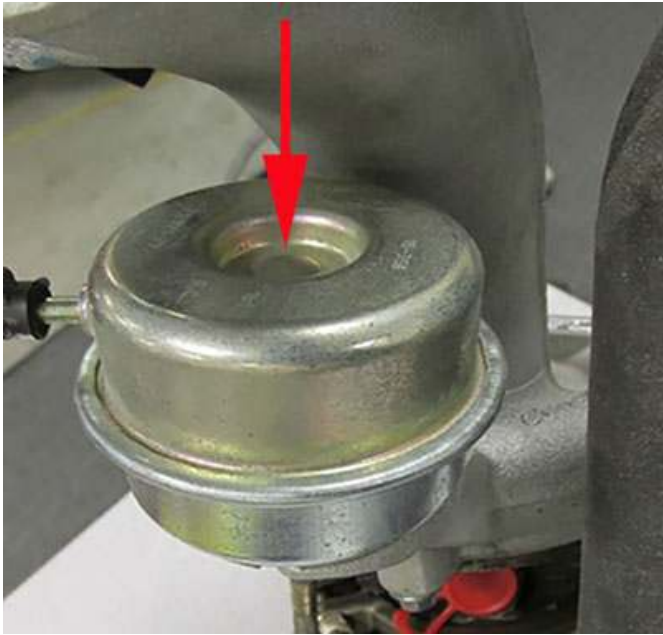
**Note: This issue will only be found on 2011 or 2012 vehicles equipped with original equipment turbochargers.**  
If the lever wiggles with little effort while the actuator rod remains static, the pre-load is insufficient and the turbocharger must be replaced.  
The original equipment wastegate actuator found on 2011 and 2012 model years shown below, has a recessed stop at the head of the actuator.  
The updated design actuator show below has a stop that is not recessed and allows 5mm more travel in the closed direction.  
With this updated design, it is very unlikely that an insufficient preload issue exists.  
Original equipment actuator is found on 2011 and 2012 model years.

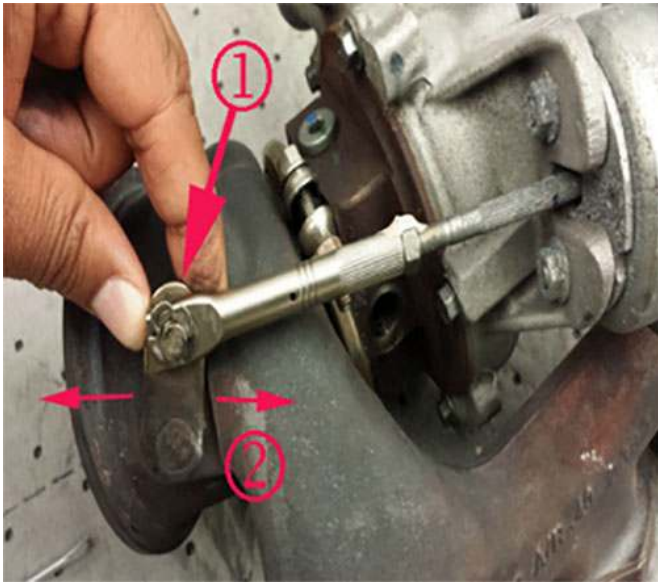
Wastegate Preload Inspection.

Disconnected wastegate lever arm pin (1) from the lever arm (crank) (2).  
Wastegate valve/linkage seized (cannot move).  
Turbine wheel not rotating, turbine wheel shaft broken or missing wheel nut.  
If wheel nut is missing, be sure to locate prior to turbocharger replacement.  
If the Wastegate lever arm (crank (2) is bent, performing the Turbocharger Boost Control Test is required.  
Insufficient wastegate preload.  
Wastegate lever arm (1) moves with little effort in the direction as shown (2) while the actuator rod remains static, see picture below "Wastegate Preload Inspection".

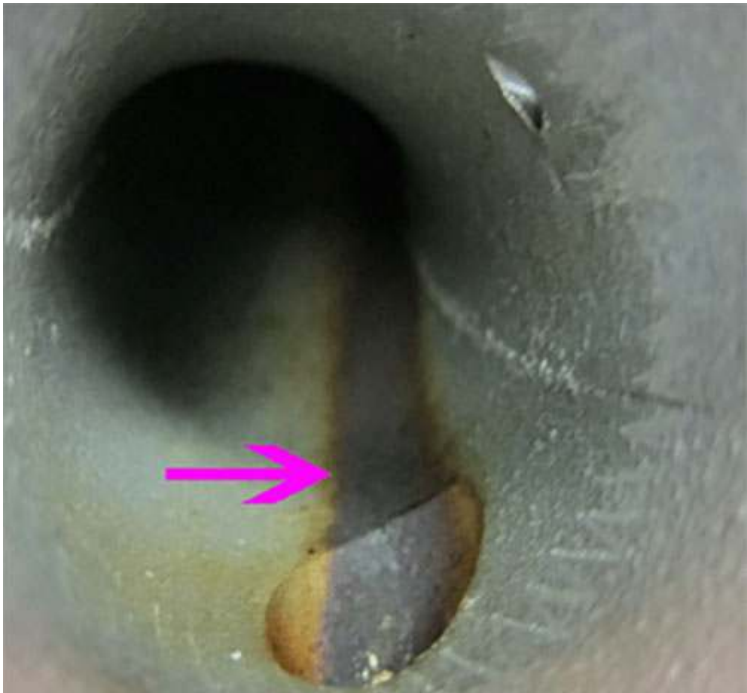
Notice: The view shown below indicates **NORMAL** oil staining in the turbocharger outside air inlet. This dry stain does not represent an oil leak.

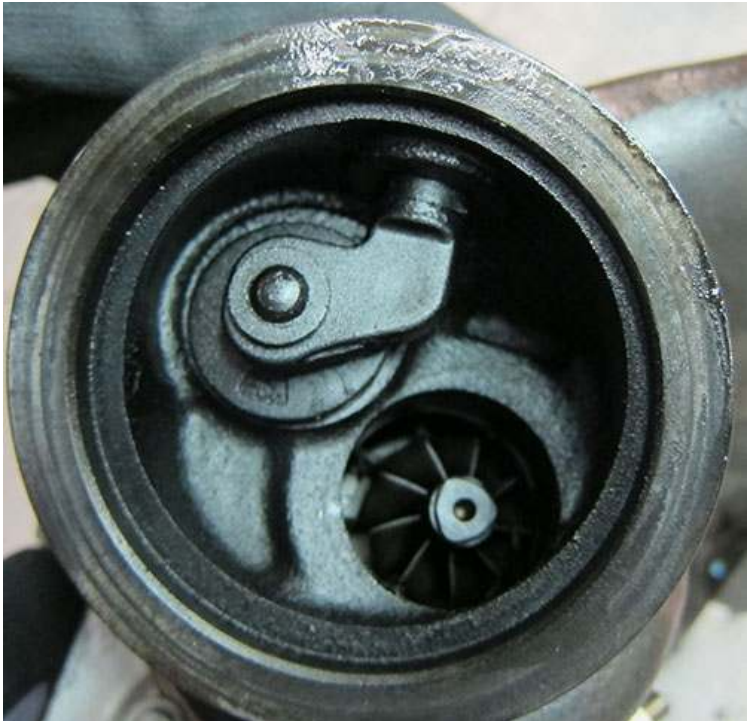
Inspect for the presence of oil in the exhaust system.

If oil is present in the exhaust system, then inspect the turbocharger turbine and compressor wheels to be sure that they are not broken off.

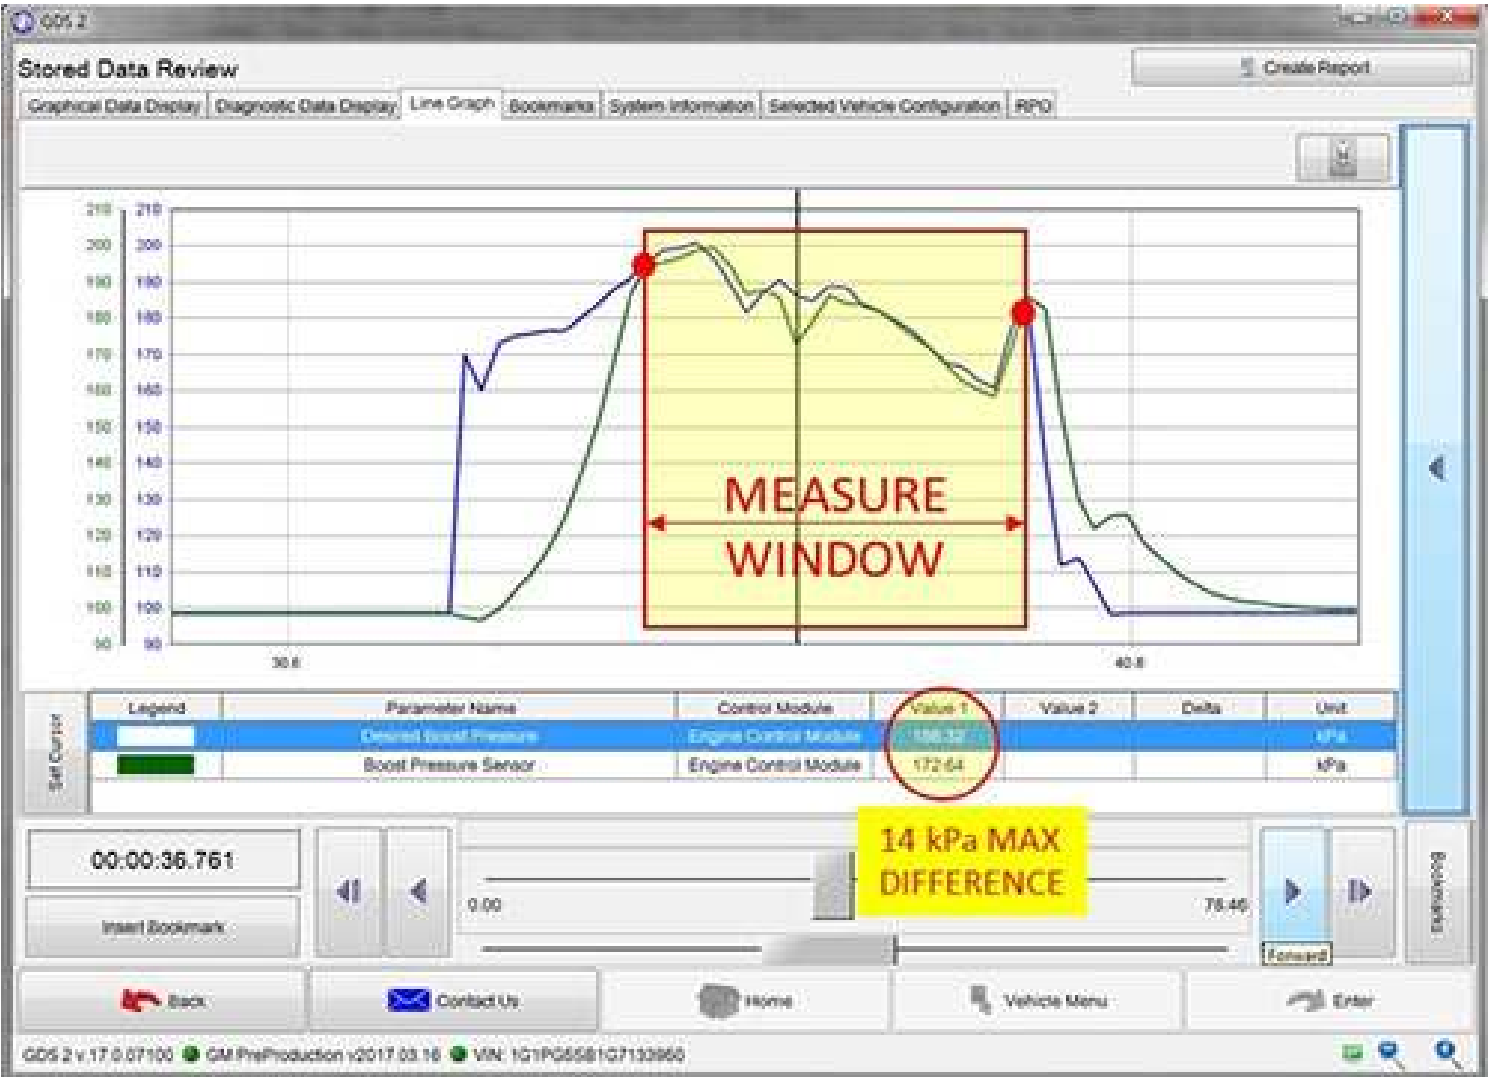
Example of normal turbocharger wastegate operation:  
In this example, notice that the measure window begins once the Boost Pressure Sensor reading (Green) meets the Desired Boost Pressure reading (Blue) and ends when the APP is released per the testing instructions.  
The Boost Pressure Sensor reading (Green) closely tracks the Desired Boost Pressure reading (Blue) indicating normal Turbocharger

operation.

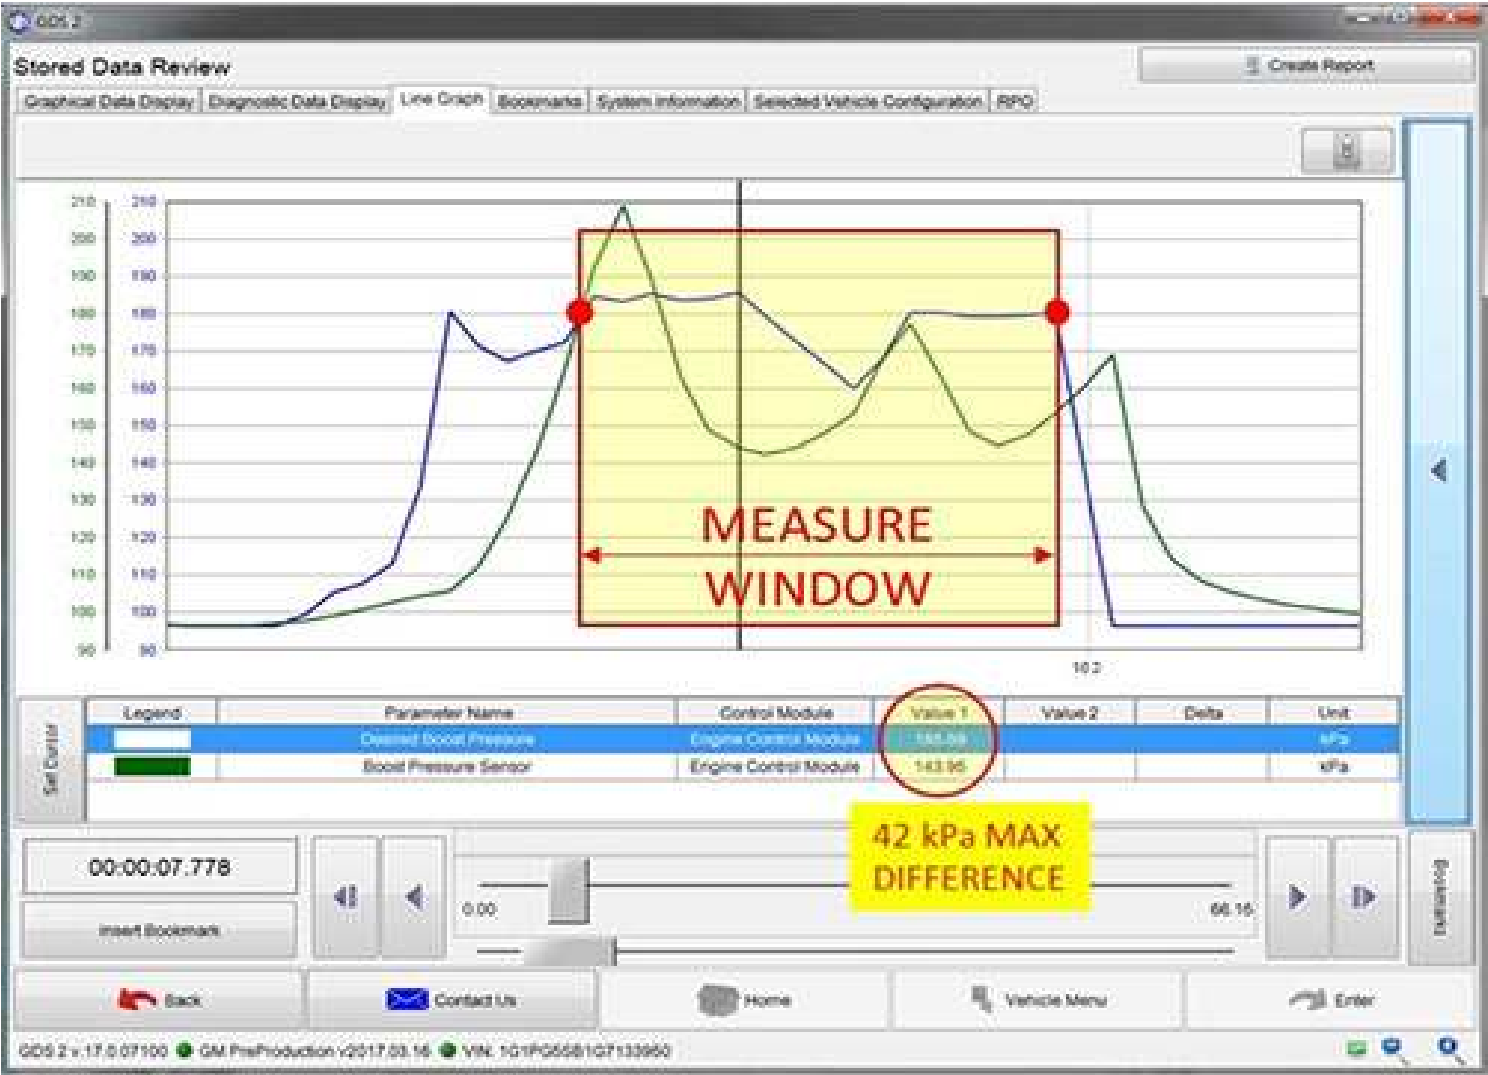
Example of a malfunctioning turbocharger wastegate:  
In this example, notice that the Boost Pressure Sensor reading (Green) moves thru and well above the Desired Boost Pressure reading (Blue).  
As the abnormally high pressure is corrected by the management system, the Boost Pressure Sensor reading (Green) over reacts and dips well below Desired Boost Pressure reading (Blue).  
A difference of 14 KPA (2 PSI) between the Boost Pressure reading (Green) and the Desired Boost Pressure Sensor reading (Blue) Indicates a Malfunctioning Turbocharger.

9. Utilize the Print Screen Function to take a screen shot of GDS2 showing the line graph.
10. Replace the turbocharger if the difference within the Measured Window is more than 14 KPA (2.0 PSI) as shown in the examples.
