# Technical Service Bulletin

| <b>Subject:</b><br><br>CHECK ENGINE LIGHT ON WITH DTC P0172:00 | <b>Bulletin No.:</b> 01-019/18 |
| | <b>Last Issued:</b> 10/10/2018 |

2013 CX-5 2.0L (M/T) with VINs lower than JM3KE\*\*\*\*\*168326 (produced before November 15, 2012)  
2013 CX-5 2.0L (A/T) without kickdown switch with VINs lower than JM3KE\*\*\*\*\*148075 (produced before September 6, 2012)

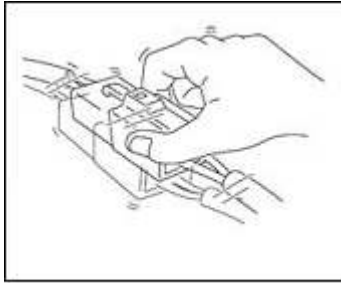
SI118152b

5. Verify the MAF voltage is approx. 0.72V and stable.

**NOTE:** While monitoring the MAF voltage, shake and twist the harness and connector for the mass air flow (MAF) sensor / intake air temperature (IAT) sensor No.1.

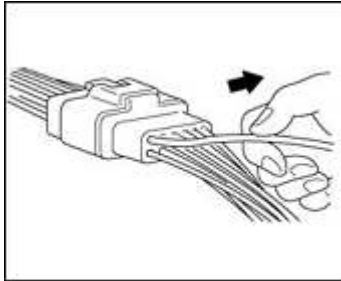
SI118152c

- If the MAF voltage changes as shown when shaking or twisting, the wiring is suspect and should be inspected/repaired before continuing with TSB.

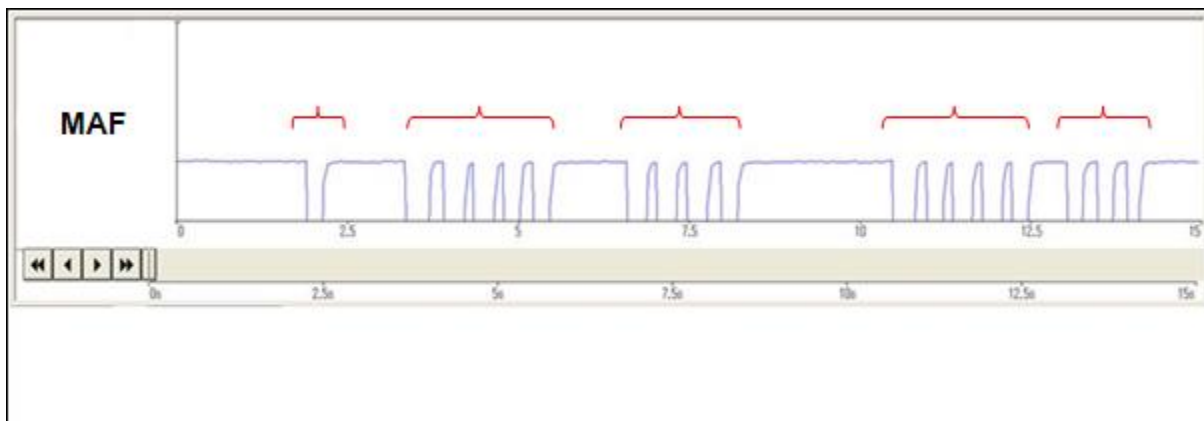
SI118152d

- Is the MAF value normal even when shaking and twisting the harness and connector?
- Yes: Proceed to the next step.
- No: This Service Information does not apply. Diagnose according to the instructions on MGSS online.
