**NUMBER:** 08-059-15 REV. B

RA4 Radio Enhancements

This bulletin involves upgrading the software on the RA4 Radio.

2016 (FB) Fiat 500X

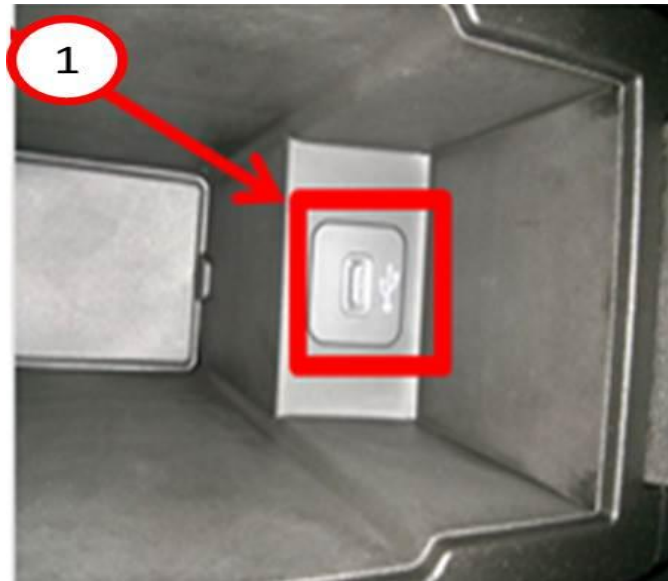
***Fig. 1 Location Of USB Port***

1 - USB port in center console compartment.

7. Remove any customer USB flash drive from both USB ports.
8. With the engine running and radio powered on, insert the **correct** USB flash drive into USB port in the **center armrest compartment**, see ([Fig. 1](#)).
