**NUMBER:** 08-084-15

Electronic Power Steering System (EPS) Instrument Cluster Lamp ON

2015 (BU) Jeep Renegade

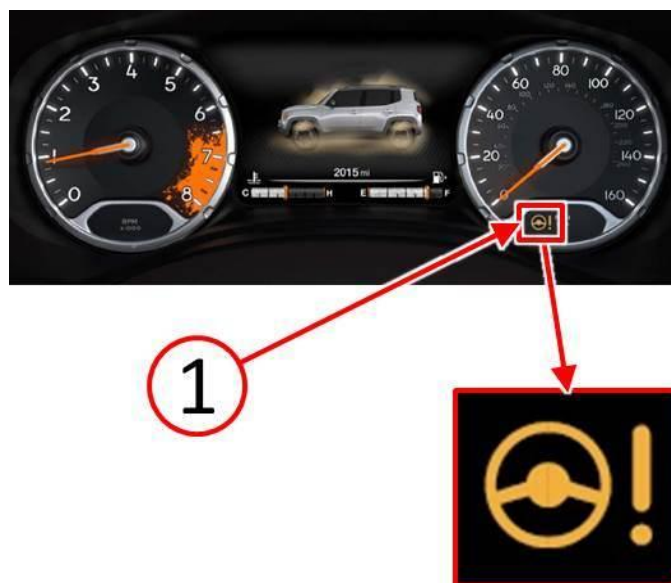
**Fig. 1 Instrument Cluster**

The customer may describe the Power Steering System Warning lamp (1) is illuminated on the instrument cluster ([Fig. 1](#)). Upon further inspection, the technician may find the following Diagnostic Trouble Code (DTC): C1214-87 Conf Data Code Request Message - Missing Message error set in the EPS control unit.

1 - Power Steering System Warning lamp

1. Reprogram the EPS with the latest available software. Detailed instructions for flashing control modules using the wiTECH Diagnostic Application are available by selecting the "HELP" tab on the upper portion of the wiTECH window, then "HELP CONTENTS." This will open the Welcome to wiTECH Help screen where help topics can be selected.
2. Clear all DTCs that may have been set in any module due to reprogramming. The wiTECH application will automatically present all DTCs after the flash and allow them to be cleared.
