**NUMBER:** 18-054-15

Mil Illumination: P2453,P2454,P2455 or P2463 Active or Stored

This bulletin involves determining if the Differential Pressure Sensor and its Connector require repair.

2010-2015 (RT)

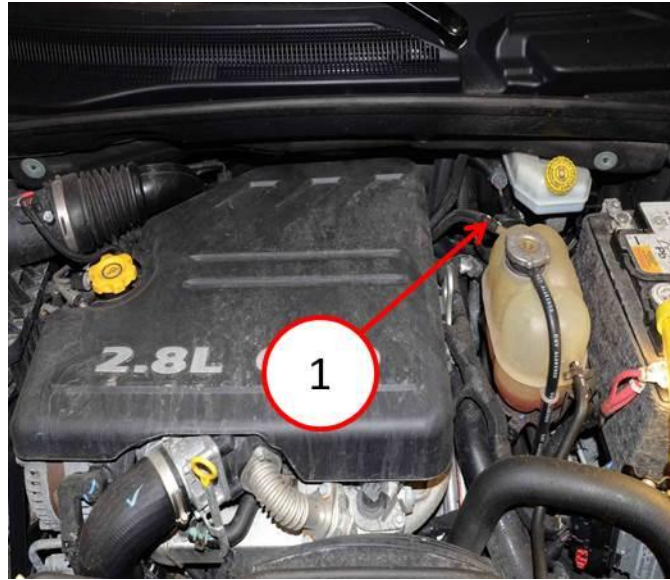
***Fig. 1 Differential Pressure Sensor Location - Engine Compartment Location***

1 -Differential Pressure Sensor Location

1. Disconnect the negative battery terminal.
2. Disconnect the Coolant Bottle and reposition it to reach the Differential Pressure Sensor (DPS) ([Fig. 1](#)).

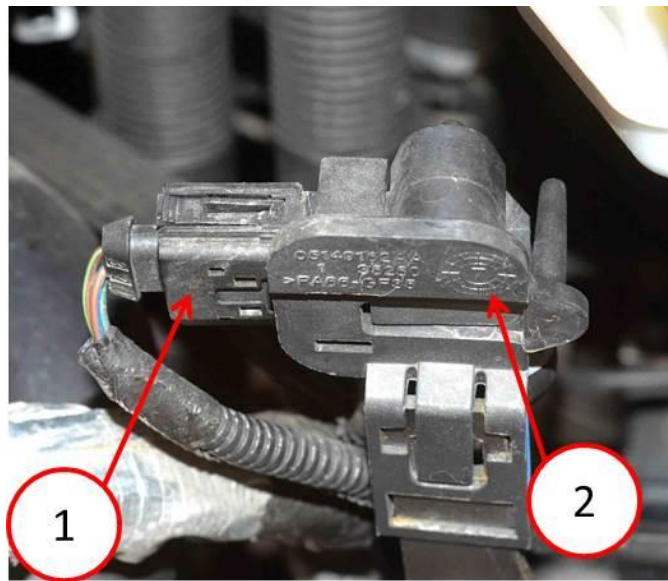
**Fig. 2 Differential Pressure Sensor**

- 1 - Differential Pressure Sensor Harness Connector
- 2 - Differential Pressure Sensor

- 
4. Are the terminals oxidized/ corroded ?
- a. Yes. >>> Proceed with [Step #5](#).
  - b. No. >>> This bulletin does not apply. Normal Diagnostics should be performed.

**NOTE: Normal inspection methods may not uncover the type of corrosion present (fretting).**

- 
3. Disconnect the differential pressure sensor harness connector and check for oxidation ([Fig. 2](#)).

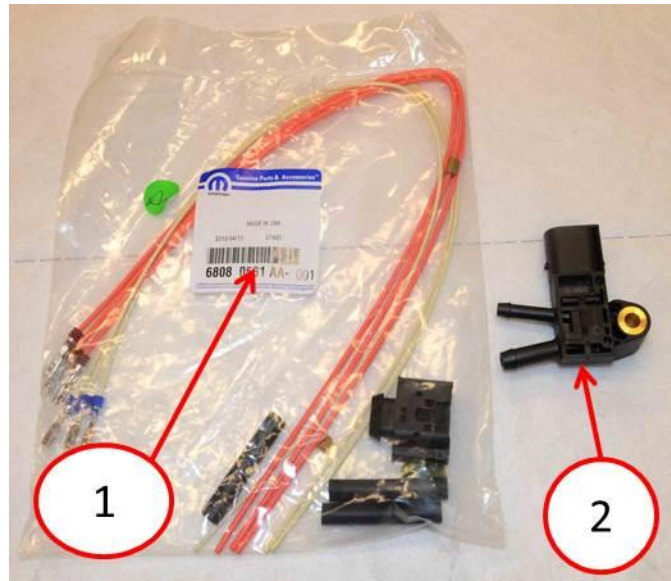
**Fig. 3 Parts Required**

- 1 - P/N 68080561AA - Wiring Kit
- 2 - P/N 56044587AB - Sensor

- 5. Disconnect the differential pressure sensor hoses.
- 6. Release the clips and remove the differential pressure sensor.
- 7. Using the Wiring Kit, P/N 68080561AA ([Fig. 3](#)), replace the existing 3 way connector and terminals with the new components from the kit which will be complete with silver plated terminals. To complete the Service Procedure only the white wires are necessary. Refer to the detailed service procedures available in DealerCONNECT> TechCONNECT under: Service Info>29- Non DTC- Diagnostic>Circuit Testing Procedures>Standard Procedure>Wire Splicing.
