## SERVICE BULLETIN

**APPLICABILITY:** 2017-19MY Impreza

**NUMBER:** 07-140-18

**SUBJECT:** DTC U0284, Additional Diagnostics Added

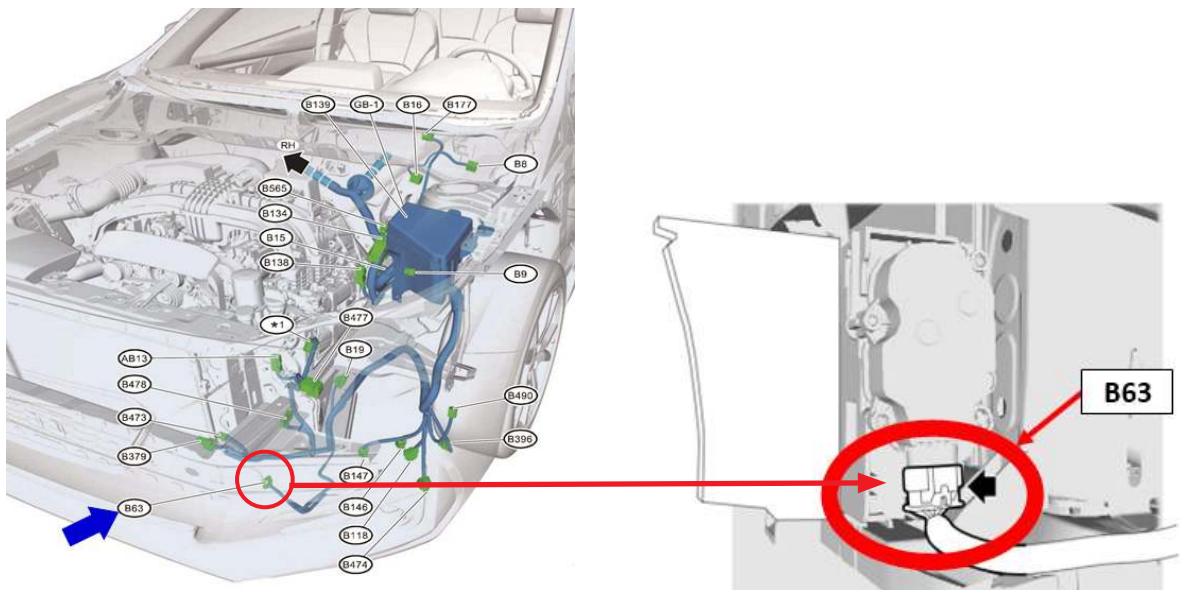
The AGS harness connector **B63** is located at the end of the AGS assembly in the l/front as shown below.

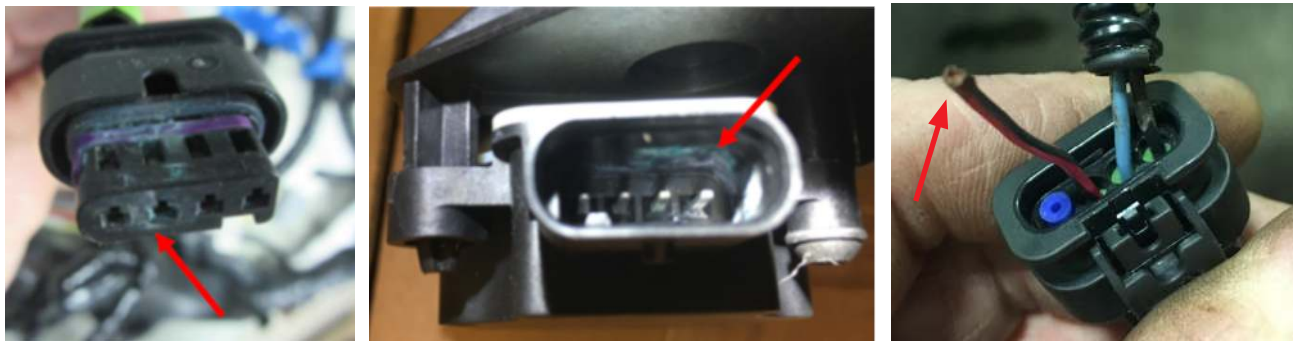
**IMPORTANT:** Before proceeding with any other electrical testing as directed by the current Service Manual diagnostics, access and disconnect the AGS harness connector. The photos below show both sides of the harness connection with corrosion present. If corrosion or an open circuit in the wiring is identified, replace both the bulkhead wiring harness and AGS assembly following the procedure outlined in the applicable Service Manual.

**NOTE:** Do not attempt to repair the wiring or clean the connector terminals. If there is no corrosion in either connector, check the wiring to the harness connector and confirm there is not an open circuit, broken wire as shown below or unexpected high resistance to indicate corrosion in the wiring. If no wiring or connector damage is identified, proceed with electrical testing Steps 3 to 6 as outlined in the applicable Service Manual for DTC U0284.
