## SERVICE INFORMATION BULLETIN

**APPLICABILITY:** 2013-2014MY Legacy and Outback with EyeSight  
2015-2016MY Impreza with EyeSight  
2015-2017MY Crosstrek with EyeSight  
**NUMBER:** 06-67-18  
**DATE:** 10/19/18  
**SUBJECT:** DTC C0075- Additional Diagnostic Procedures

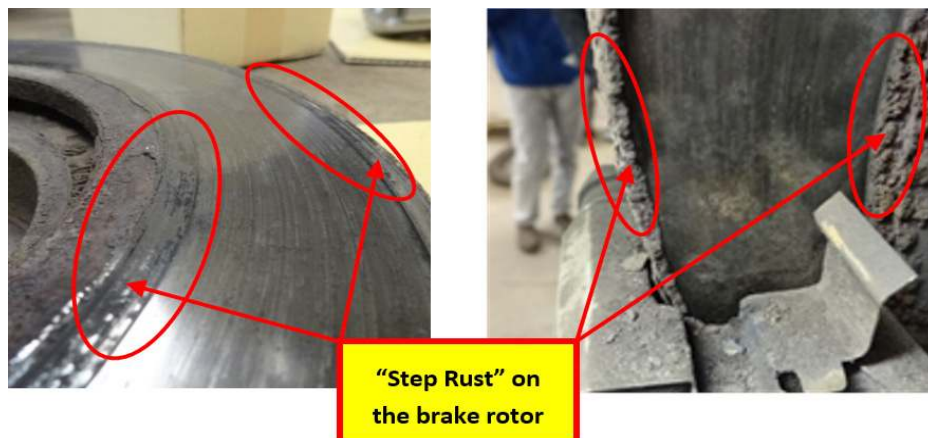
- When the rotor is rusted as shown in the photos below, replace it with a new rotor and brake pad set even if the rotor thickness has not reached minimum thickness.

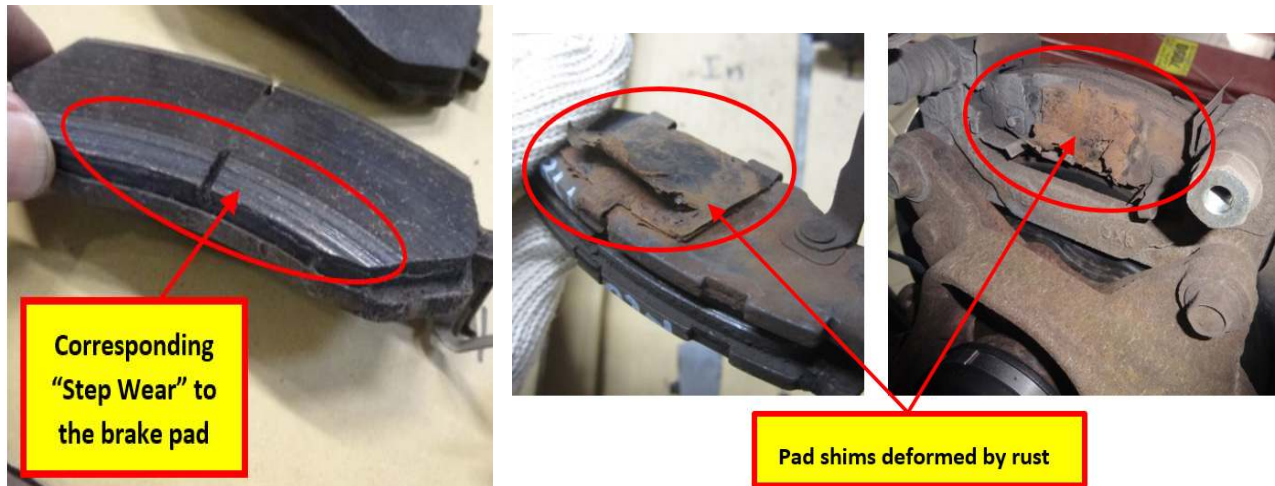
- When the pad shims are rusted or deformed as shown below, replace with new shims.
