## SERVICE BULLETIN

**APPLICABILITY:** 2014-15MY XV Crosstrek Hybrid Electric Vehicle (HEV) **NUMBER:** 16-94-15R

**SUBJECT:** Diagnosis and Repair of DTCs P172A and P0B0B

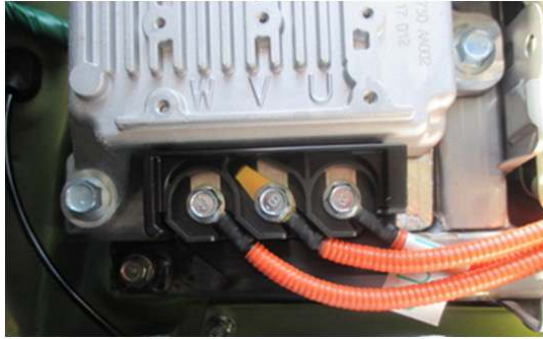
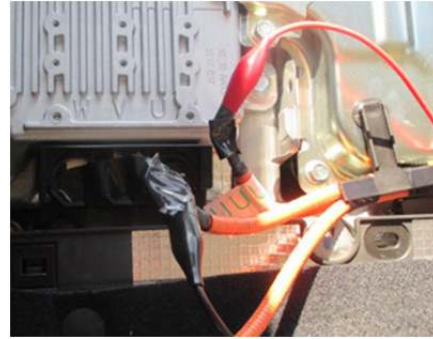
- Remove the rear cargo area floor mat and the sub-trunk (storage tray).
- Remove the orange HEV Service Disconnect plug and put it in your pocket.
- Remove the TORX screws and necessary trim clips securing the aluminum battery cover.
- **ONE AT A TIME**, remove the 3 bolts securing the orange “W”, “V”, and “U” cables to the electric oil pump inverter. As each cable is removed, cover each terminal end with one piece of electrical tape to insulate it. Connect the RED (+) test lead from the DVOM to the “U” cable end and BLACK (-) lead to the “V” cable end as shown. Confirm the “W” cable end is wrapped with insulating tape.

**IF THE DVOM SHOWS 0.5V OR MORE (DVOM will usually display 10V):** the o-ring and possibly the drive motor are damaged. If damaged, the drive motor / case assembly must be replaced. Remove the CVT assembly following the procedure in the applicable Service Manual.

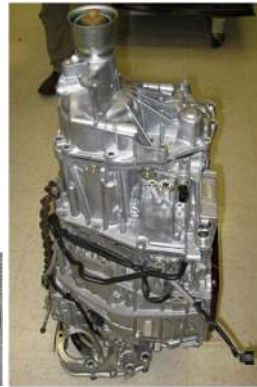
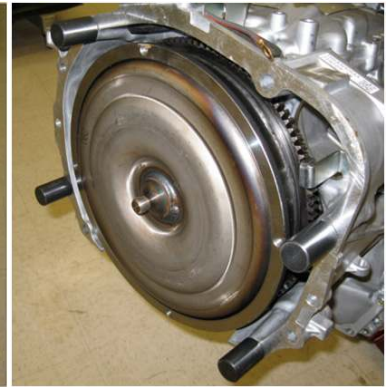
The bulk of this procedure is best performed with the transmission assembly standing vertically. Use the 4- 6M/T stands (S/T# 18632AA000) pictured to the right for support.

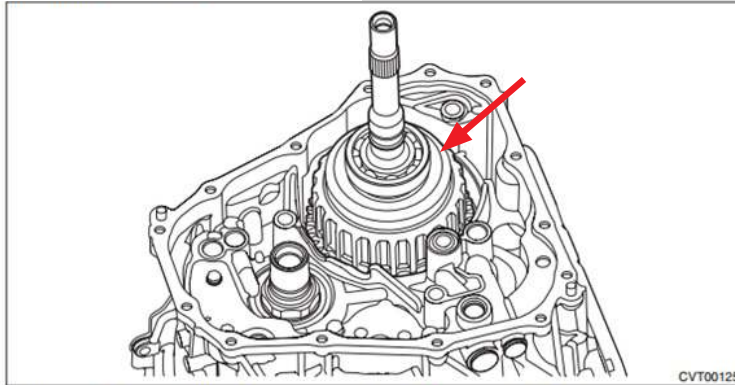
1) **Remove** the output clutch assembly

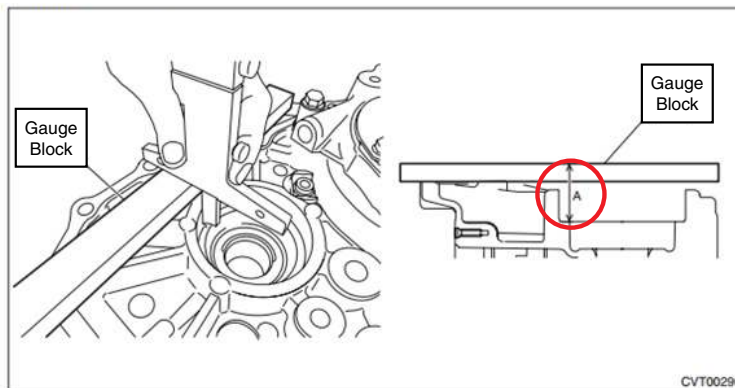
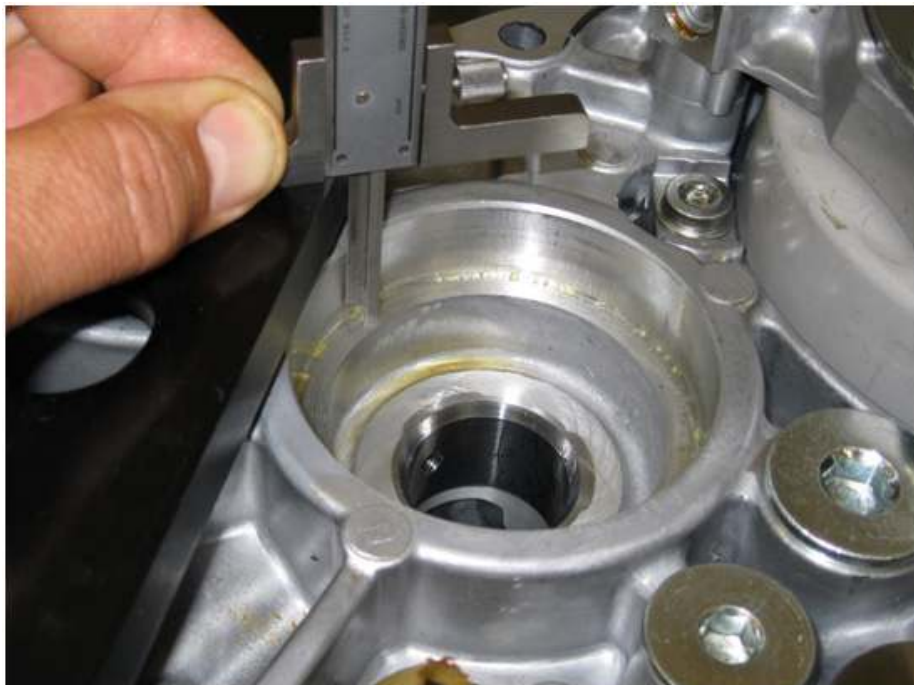
2) Measure the height "A" from the Gauge Block upper face to the ball bearing catch surface.

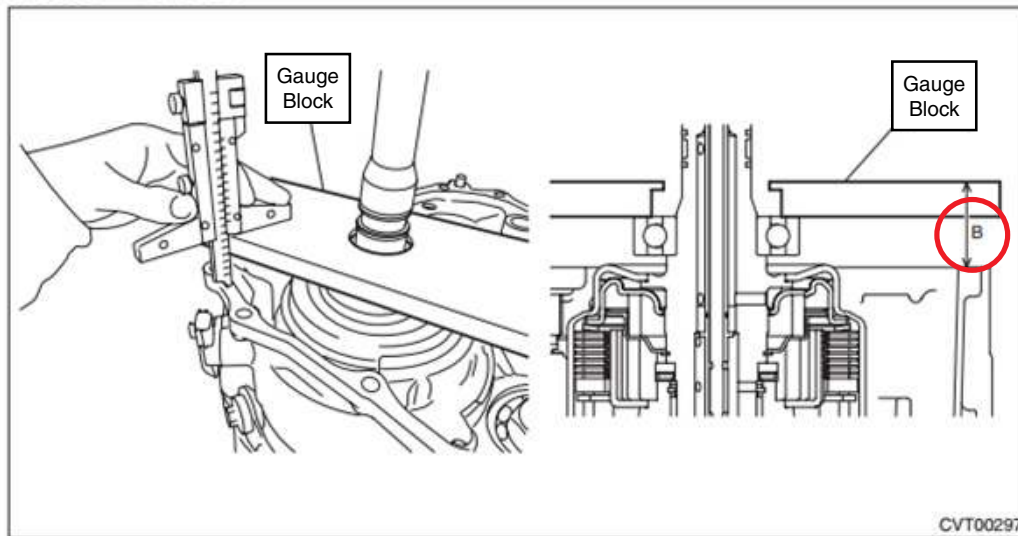
- 3) Reinstall the output clutch assembly then measure the height "B" from the Gauge Block to the mating surface of the transmission case.

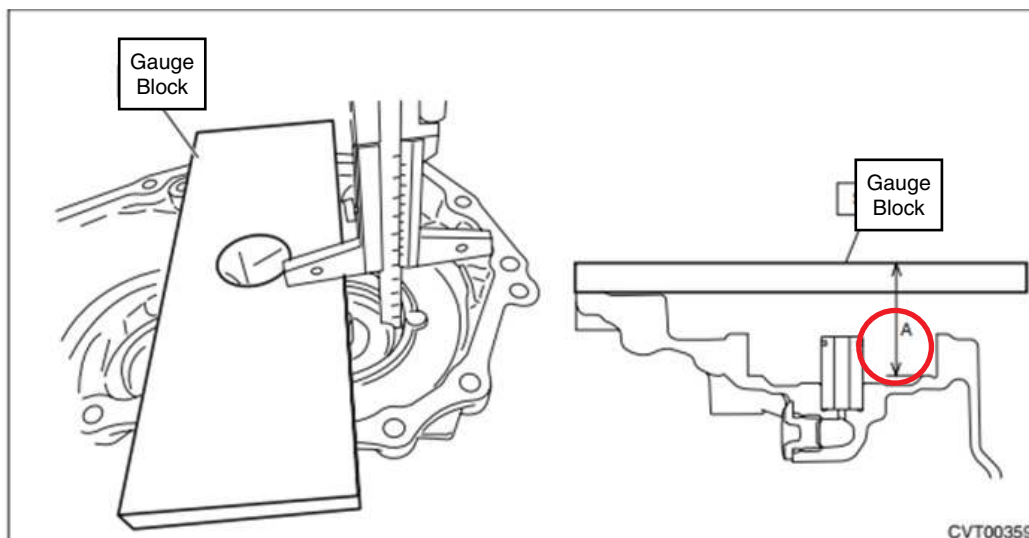
- 1) Measure the height "A" from the Gauge Block upper face to the ball bearing catch surface.

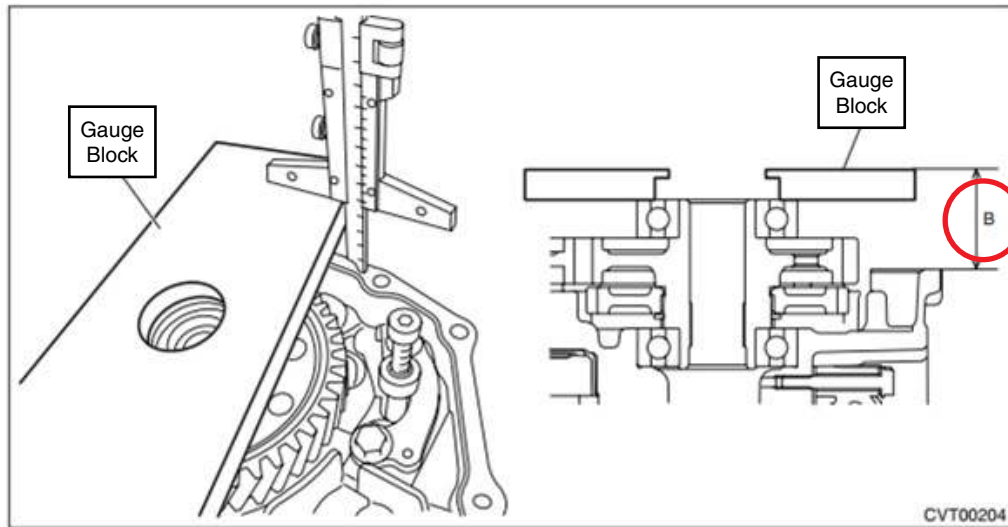
2) Measure the height "B" from the Gauge Block to the mating surface of the transmission case.

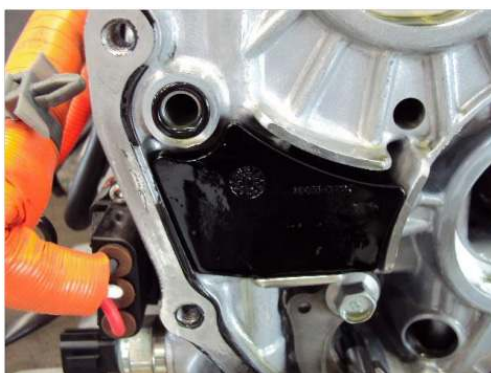
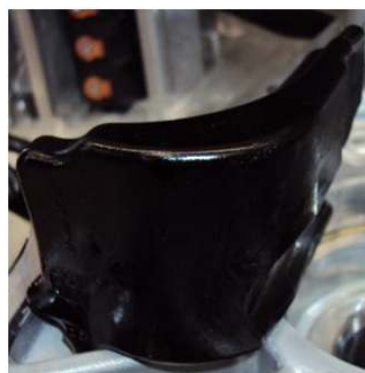
- When installing the secondary pressure sensor and inspection plugs, **ALWAYS** install a new o-ring (with some CVT fluid applied to it) and follow the proper torque specifications as they do vary.
- Remember to transfer both of the oil baffles shown below over to the new assembly.

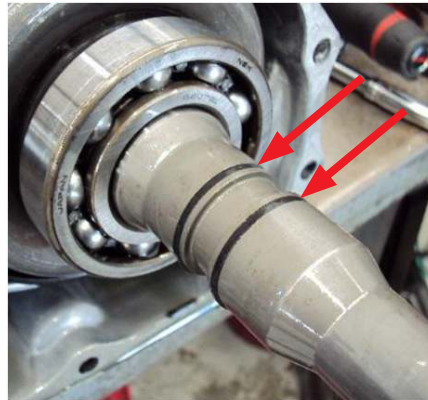
- Never expand the output clutch output shaft interlocked split sealing rings any more than necessary to get them onto the shaft. Use caution and patience as they can be tricky to install. **NOTE:** If these sealing rings become deformed during installation, they **MUST** be replaced.

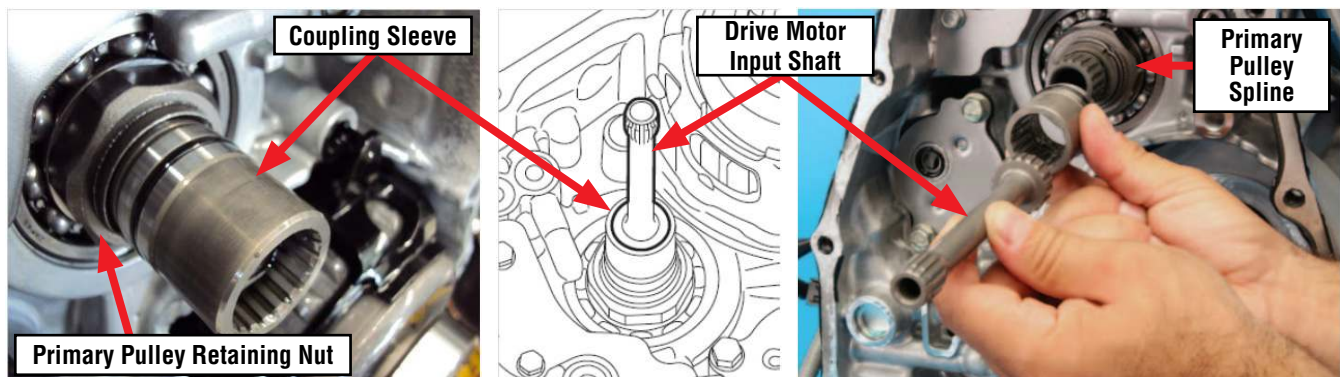
**IMPORTANT: BEFORE applying any sealer to the cases**, always trial fit them together to confirm proper spline alignment between the coupling sleeve, the drive motor input shaft and the primary pulley. The cases are too close together to facilitate turning the primary pulley retaining nut to get the splines aligned properly, especially when there is fresh sealer applied.
