**NUMBER:** 18-023-15 REV.C

Flash: 3.0 L MIL Illumination Diagnostic and System Improvements

2014 (WK) Jeep Grand Cherokee

**NOTE: This bulletin applies to vehicles equipped with a 3.0L diesel engine (sales code EXF).**

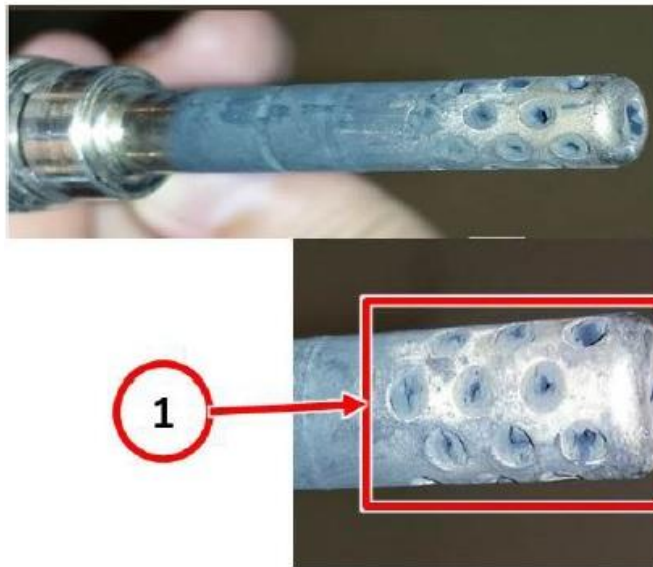
**Fig. 1 EGT Sensor Bank 1 Sensor 1**

11. Inspect the sensor body and probe for any signs of damage or excessive soot. See (Fig. 1).

1 - Excessive soot blocking sensor ports

- 
12. Was excessive soot found on the sensor?
- Yes>>> Proceed to [Step #13](#).
  - No>>> Proceed to [Step #14](#).
13. Using shop air set to a maximum of 80 psi, clean all excessive soot from the sensor probe.

14. Using a suitable multi-meter with appropriate test probes, test the resistance between the sensor connector terminals 1 and 2. With the sensor at room temperature, 65-75 °F (18-25 °C), the resistance should measure between 200 and 240 ohms.
