**NUMBER:** 08-098-15

Hands Free Feature Inoperative

**\*\*2013 - 2016\*\*** (PF)

**\*\*Dodge\*\*** Dart

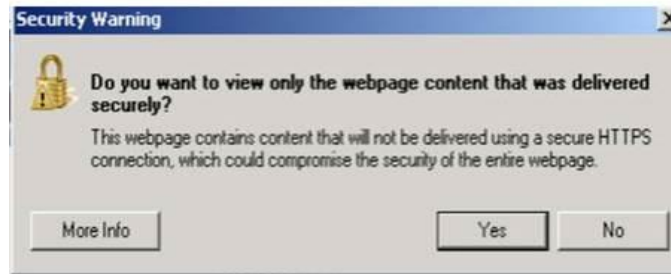
***Fig. 1 Pop-up Security Message***

16. If a security message appears "Do you want to view only the webpage content that was delivered securely?" See ([Fig. 1](#)). Press **No** to continue.

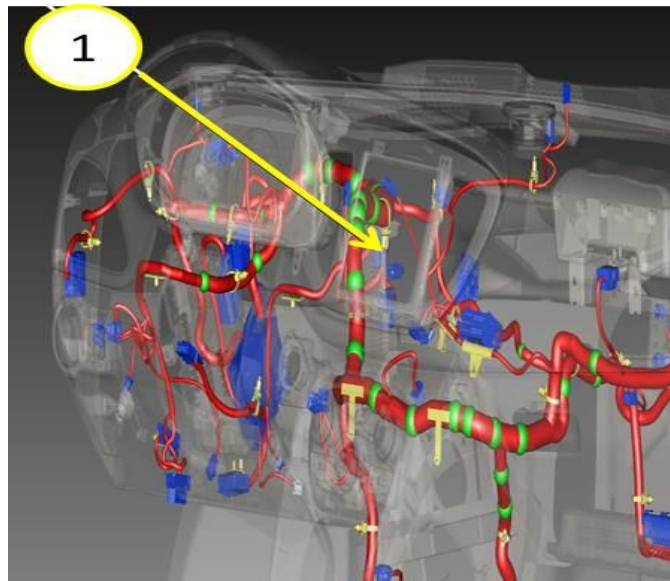
**Fig. 2 CTM Location Under The Dash**

1 - CTM location

18. **\*\*Does this vehicle have a remote USB port (sales code RSX)?**
  - a. Yes >>> Proceed to [Step #21](#).
  - b. No >>> Proceed to [Step #19](#).
19. Gain access to the CTM, refer to TechConnect > Electrical/8E - Electronic Control Modules/MODULE, Convergence Telematics/Removal, CTM location see ([Fig. 2](#)).

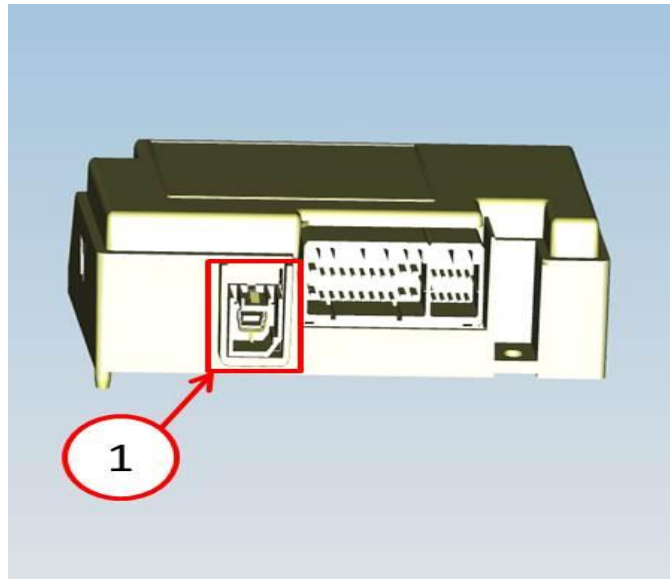
**Fig. 3 Location Of USB Update Cable Port On CTM**

1 - Plug USB cable (68086985AB) in this open port.

20. Plug in USB cable (68086985AB) into the open port of the CTM. (Fig. 3).
