Preliminary Information

PIC6288A Unable to charge the High voltage battery, DTC P1FFE  
Models

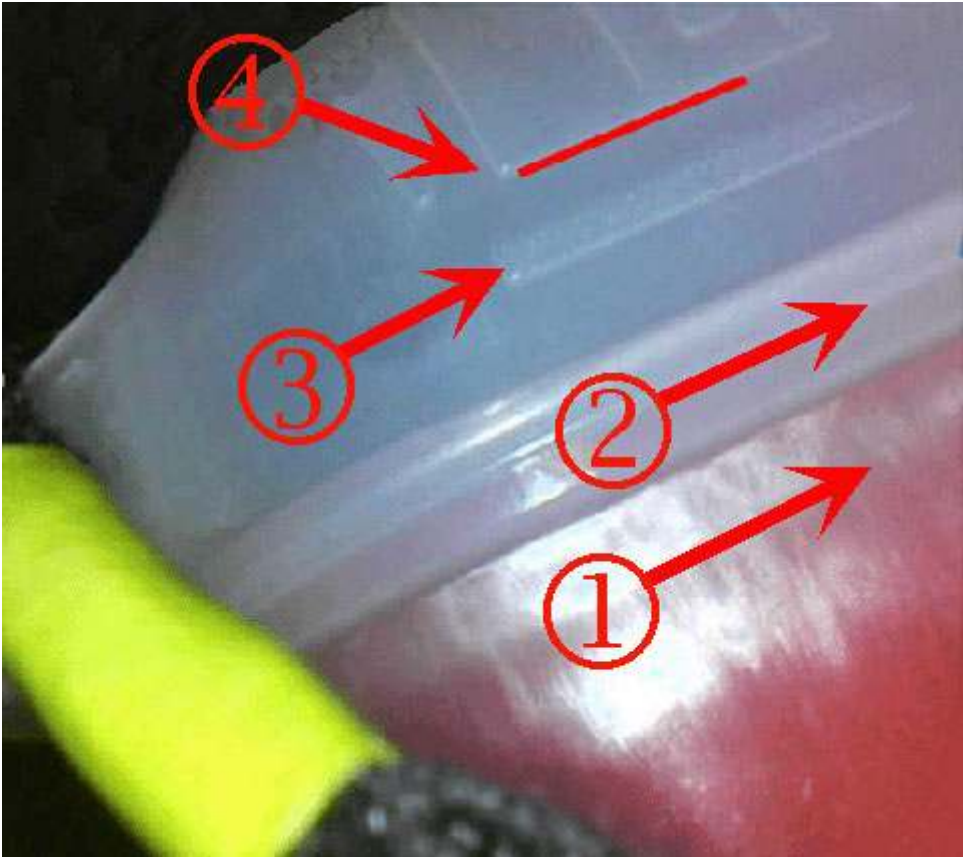
| Condition | Customer is unable to charge the HV battery.<br>DTC P1FFE is set when coolant level is at the full indicator line after Hybrid battery pack service or hybrid battery pack cooling system service. |
| Cause | The coolant level sensor may be stuck, indicating low coolant after Hybrid battery pack service or Hybrid battery pack coolant system service. |

- Verify coolant level in tank, Please follow SI for the right steps to check the Level.
  1. Is where it is possible to false low Coolant DTC (Seen in Development)
  2. Low Fill Level
  3. This is the Fill Level Line
  4. Fill to this Level.

- Run Pump using GDS2 and monitor coolant sensor signal
- Run a magnet across sensor on the outside of float to see if signal changes
- If signal changes no further action required, clear codes and test drive the vehicle
- If unable to get signal to change while using a magnet across sensor float replace sensor and do Evac n Fill.

- **Although Evac n Fill is not required for level sensor replacement, potential air pockets from previous repairs could be root cause of stuck sensor float.**
