# Preliminary Information

## PIP5495H Check Engine Light On With P0299 Or P0234

| Cause: | Misdiagnosis Leading to Returned Turbochargers with NTF |

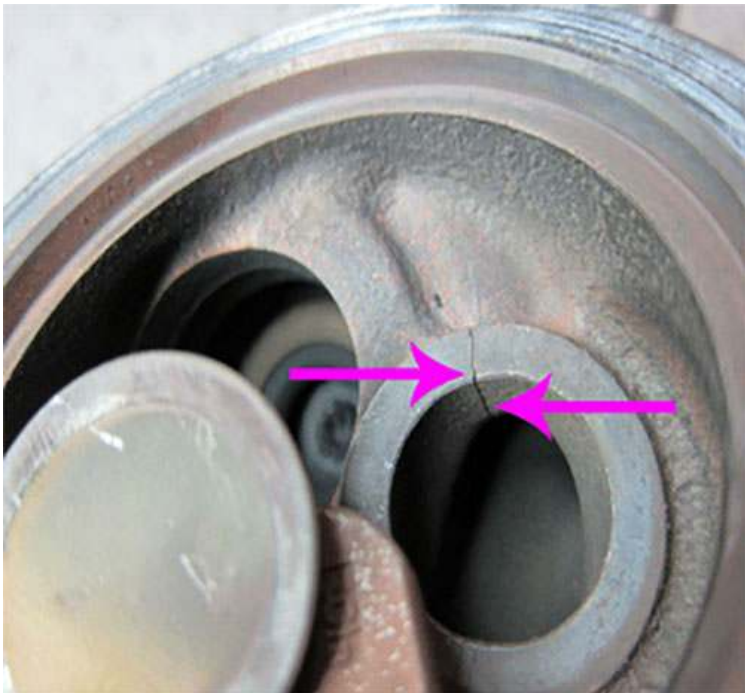
Crack(s) at the wastegate valve port (this is normal and does not affect performance)

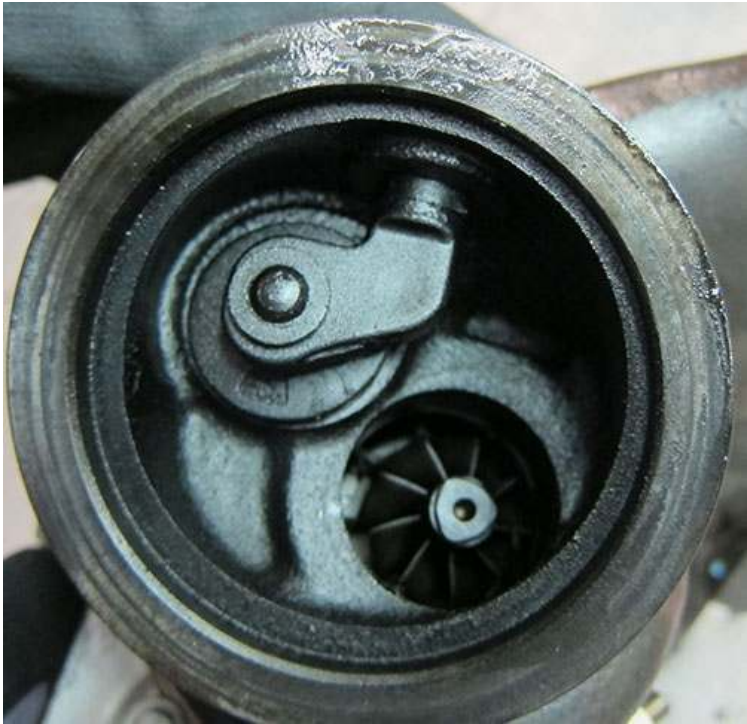
Inspect for the presence of oil in the exhaust system.

If oil is present in the exhaust system, then inspect the turbocharger turbine and compressor wheels to be sure that they are not broken off.

It is very unlikely that the turbocharger will leak oil internally if the turbine and compressor wheel shaft is not broken.
