Preliminary Information

PIT5427B Service Messages on DIC and/or SES MIL

| Brand: | Model: | Model Years: | VIN: | | Engine: | Transmissions: |
|---|---|---|---|---|---|---|
| Chevrolet | Equinox | 2010 - 2017 | All | All | All | All |
| GMC | Terrain | 2010 - 2017 | All | All | All | All |

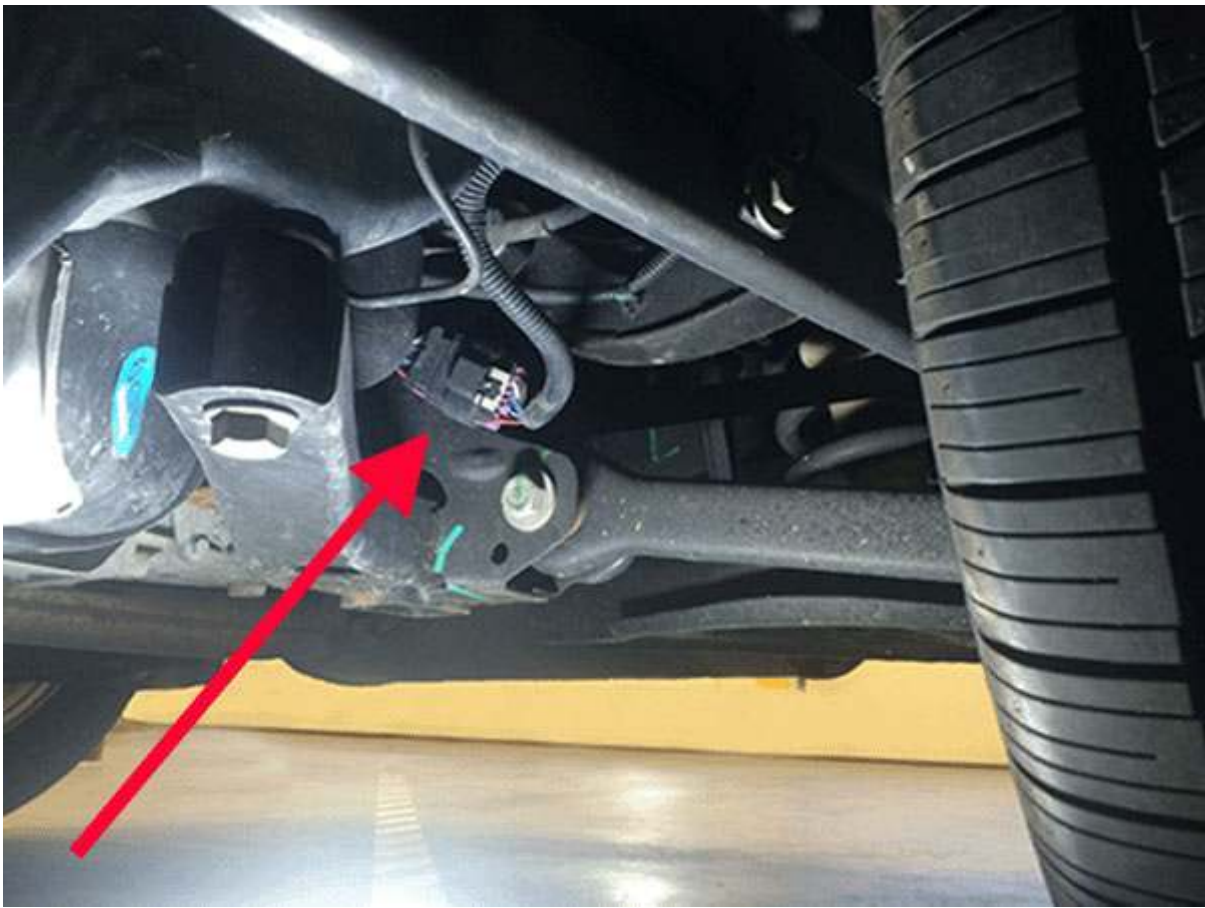
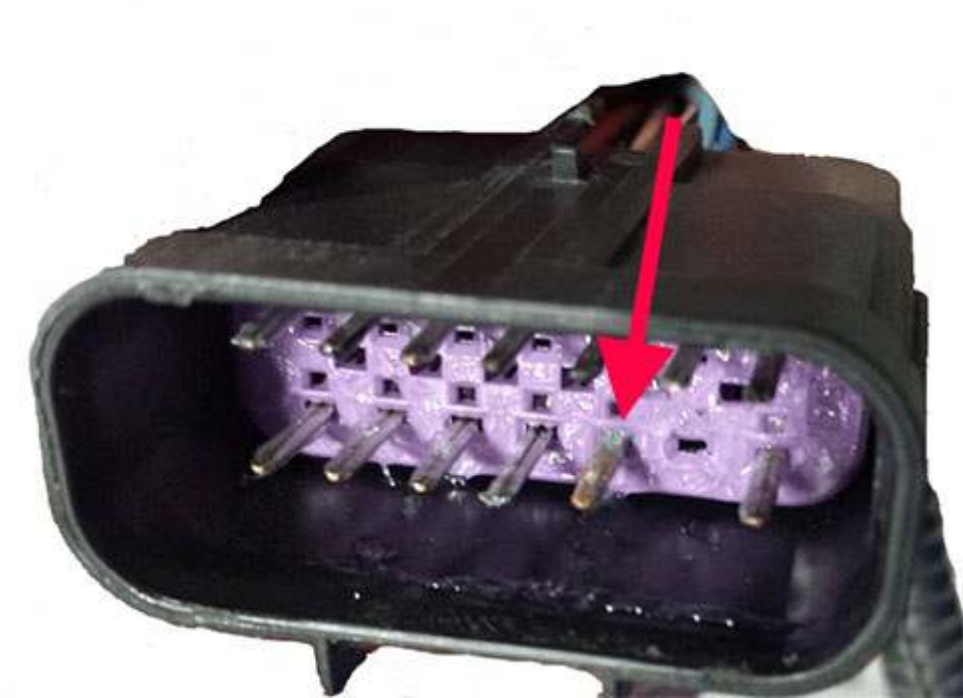
These concerns may be caused by corrosion in the X411 connector located under the rear of the vehicle, behind and to the left of the fuel tank.

**To correct concern, please replace the appropriate terminals / connector at X411 as needed.**
