Preliminary Information

PIP5298A SES Traction Control lamp on and Engine Runs Rough with DTC P0300

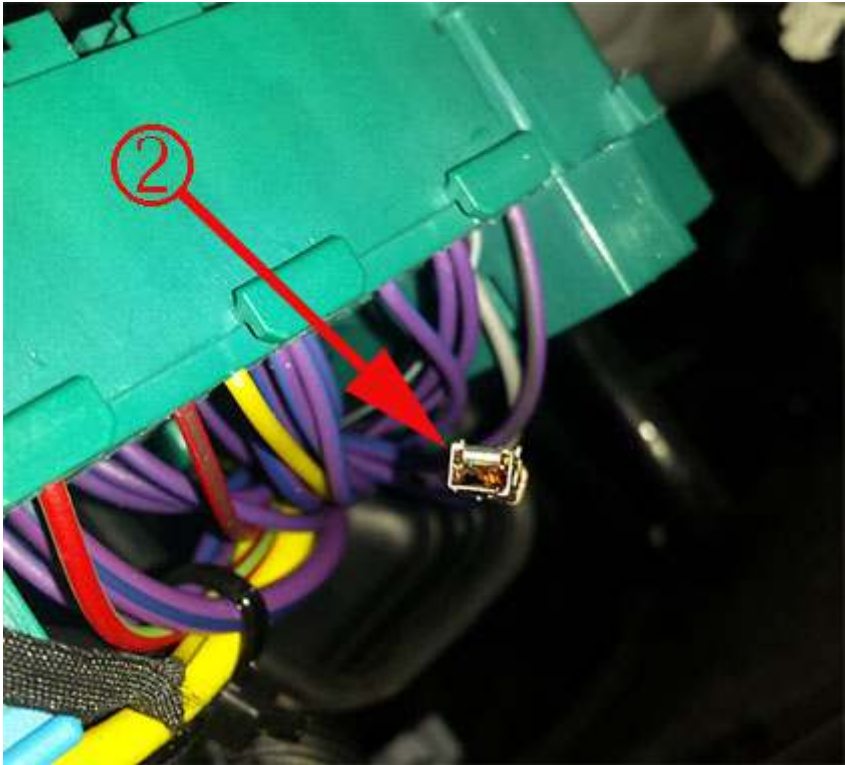
**Notice terminal “spread” NO tension**

If SI diagnostics have been completed with no trouble found inspect for a possible terminal tension concern on both the ignition coil power feed for a possible cause of the DTC P0300 set and/or a rough running engine, and the X2 connector of the UBEC (Under hood Fuse Block) for an intermittent SES Traction control lamp concern and repair as necessary.

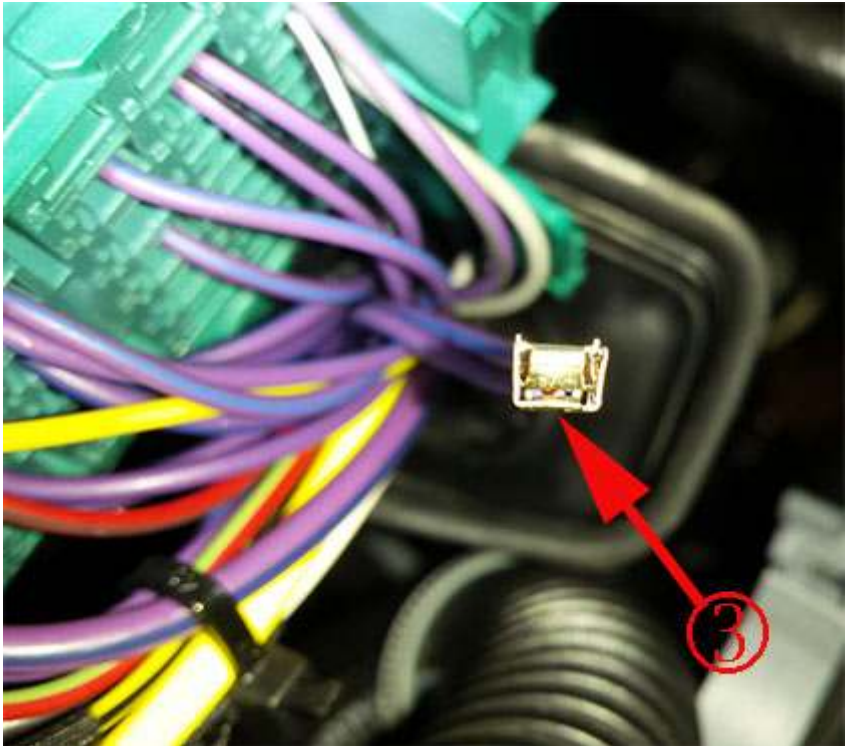
**Notice Tighter tension of terminal after repair**
