Preliminary Information

PIT5643 Intermittent Reduced Engine Power or Stall with P0689 and/or P1682

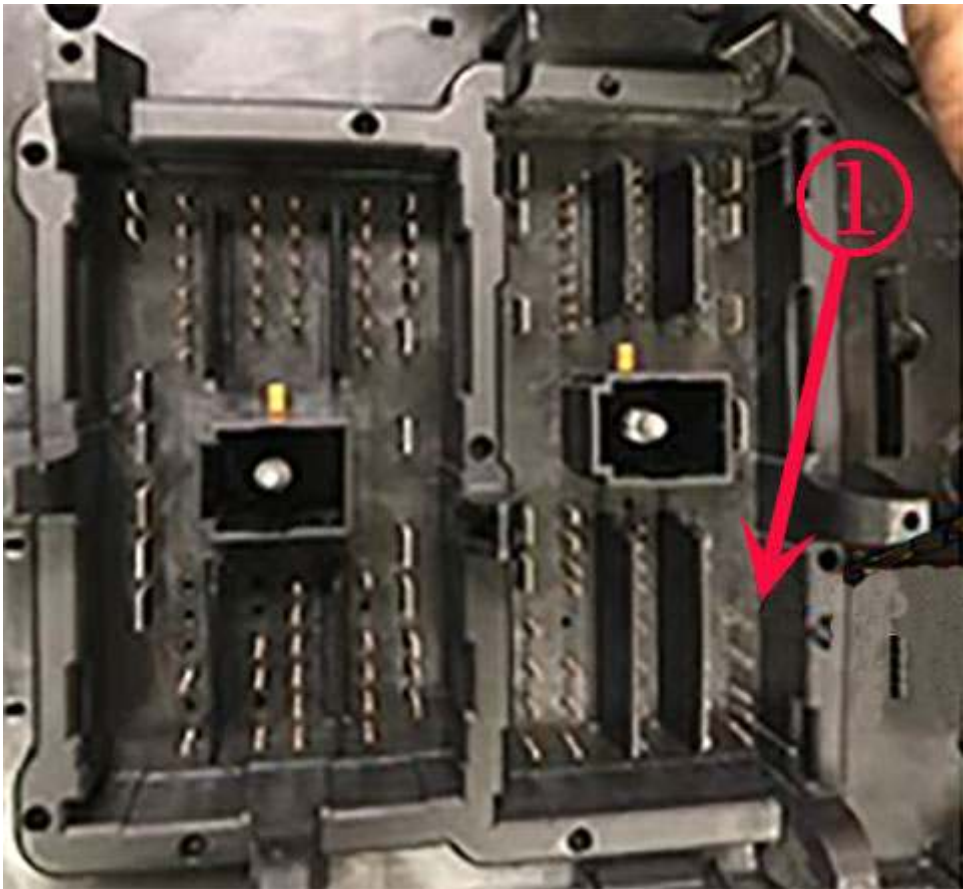
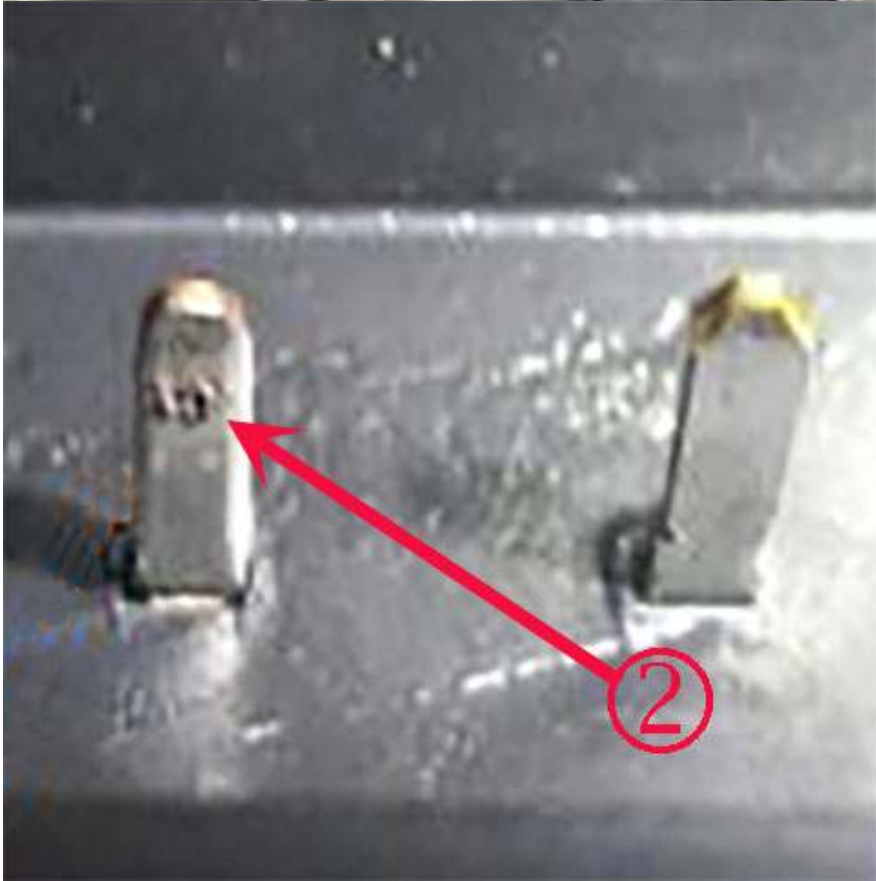
| Cause | Terminal #51 at X3 Connector of Under Hood Fuse Block loose terminal tension with arcing corrosion on terminal #51 on fuse block.<br><b>Note: Engineering is still investigating the root cause. The PI will be updated to a bulletin once the final root is understood.</b> |

1. Follow SI diagnostics for P0689/P1682. If no problem found proceed to 2.
2. Check for water intrusion on IP fuseblock. If water leak and corrosion is found, repair following normal SI procedures. If no indication of water or corrosion proceed to step 3.
3. Remove under hood fuse block and inspect for any arcing corrosion on terminal 51 of the X3 connector. It is helpful to use a cell phone camera to zoom in on the terminal to see the arc spot. If arc spot is found, replace under hood fuse panel and terminal 51 in the harness using a terminated lead.
