# MIL "ON" P023400 - Turbocharger/Supercharger "A" Overboost Condition

**Service Category** Engine/Hybrid System

## Applicability

| YEAR(S) | MODEL(S) | ADDITIONAL INFORMATION |
|---|---|---|
| 2015 - 2017 | NX200T | |

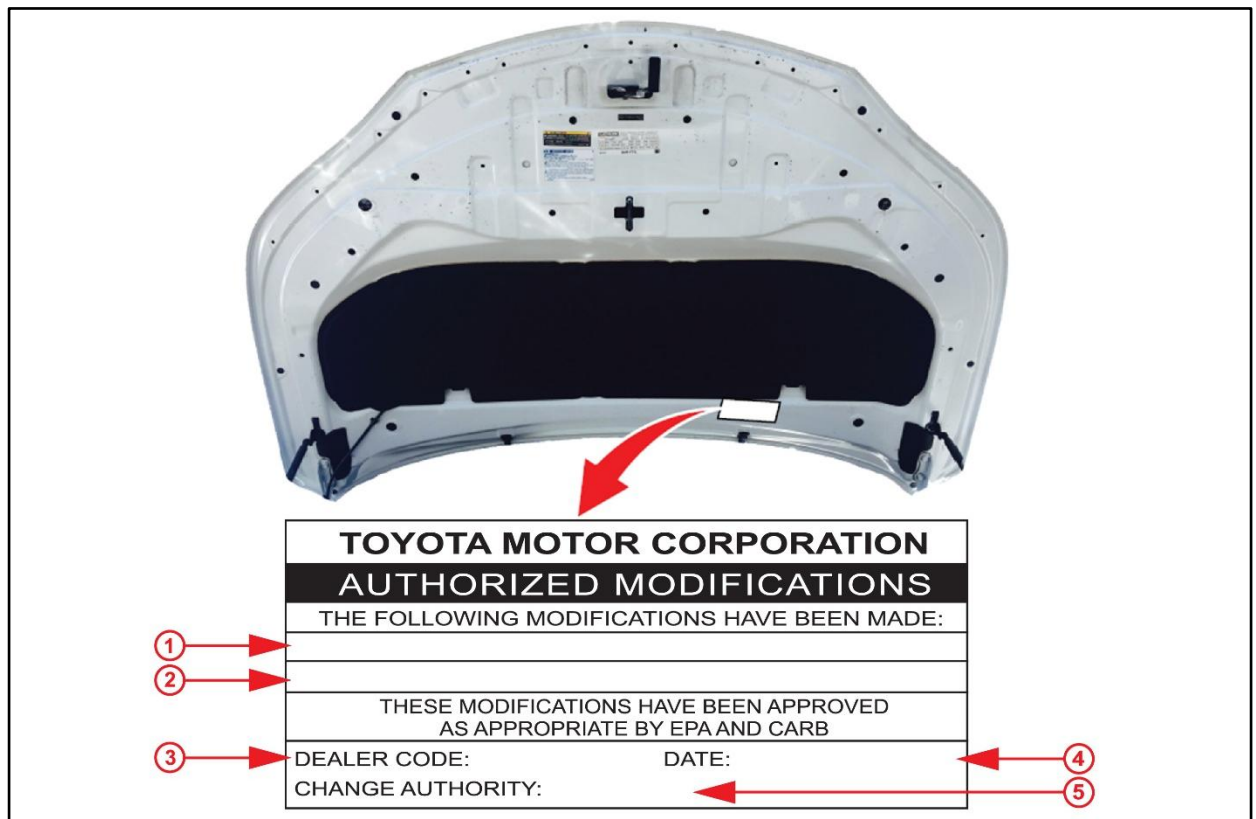
**Figure 1. Location of Authorized Modifications Label on 2015 – 2017 NX 200t**

2. Check for the Authorized Modifications Label affixed to the vehicle in the location shown below. Confirm if the ECM (PCM) calibration has been updated.

4. Install the Authorized Modifications Label.
  - A. Using a permanent marker, enter the following information on the label:
    - ECM part number [Refer to the **Parts Information** section for the **NEW PART NUMBER**]
    - Calibration ID(s) [Refer to the **Calibration Information** section for the **NEW CALIBRATION ID**]
    - Dealer Code
    - Repair Date
    - Change Authority [**This bulletin number**]
  - B. Affix the Authorized Modifications Label to the vehicle at the location shown in Figure 1.  
The Authorized Modifications Label is available through the MDC, P/N 00451-00001-LBL.
5. Test drive the vehicle to confirm the DTC does NOT reset.
