## Technical Service Bulletin

19-BE-001-G

G80 (DH)

HAPTIC STEERING CONTROLLER REPLACEMENT  
DTC CODE B247100

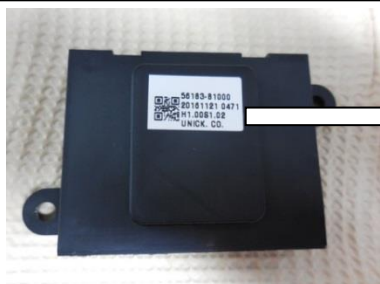
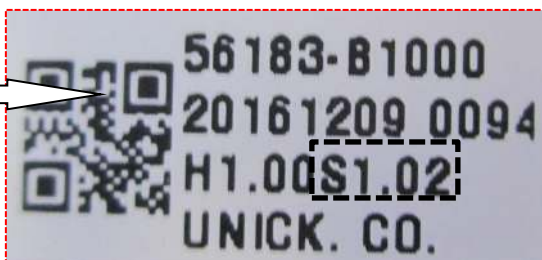
**Description:** Some Genesis G80 vehicles may experience a haptic steering warning light with DTC Code B247100 – Vibration Motor Fault code set. This bulletin provides service information and the procedure to replace the haptic controller.

Ensure replacement haptic controller has S1.02 software level.
