# HYUNDAI

## Technical Service Bulletin

| GROUP<br><b>BODY ELECTRICAL</b> | NUMBER<br><b>19-BE-001</b> |

**SUBJECT:** HAPTIC STEERING CONTROLLER REPLACEMENT  
DTC CODE B247100

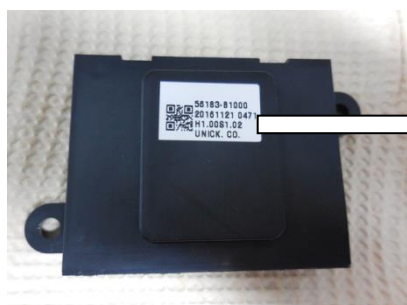
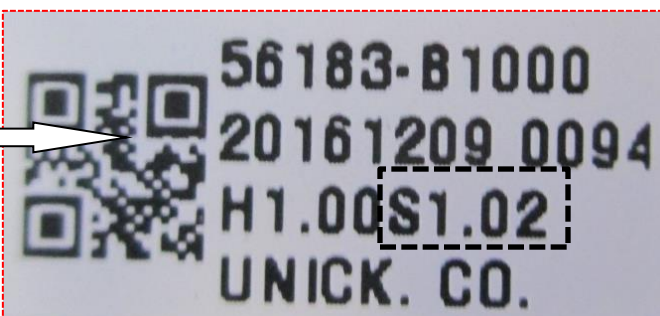
Ensure replacement haptic controller has S1.02 software level.

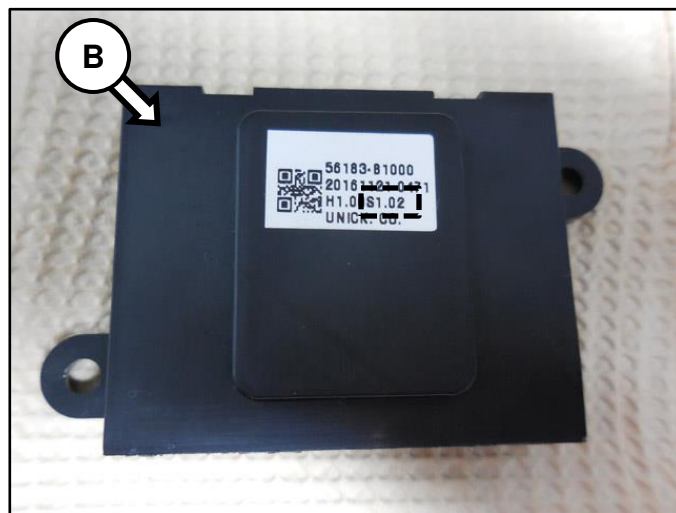
Ensure replacement haptic controller has S1.02 software level.

6. Install the new haptic controller (B).
