| | GROUP<br><b>ELE</b> | MODEL<br><b>2019MY<br/>Sorento (UMa)</b> |
| | NUMBER<br><b>154</b> | DATE<br><b>December 2018</b> |
| <b>TECHNICAL SERVICE BULLETIN</b> | | |
| <b>SUBJECT:      BCW LOGIC IMPROVEMENT FOR DTC C270254</b> | | |

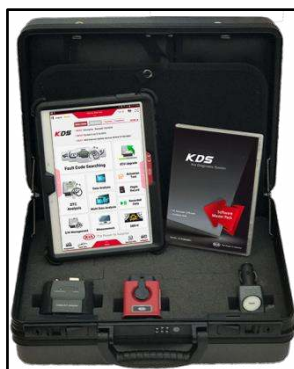
This bulletin provides the procedure to improve the logic of the Blind Spot Collision Warning (BCW) system on some 2019MY Sorento (UMa) vehicles, produced from January 22, 2018 through September 22, 2018, which may experience a Malfunction Indicator Lamp (MIL) illumination with DTC C270254, even though there is no issue or defective part. To correct this concern, apply the improved logic to the BCW using the KDS ECU Upgrade function as described in this bulletin. For confirmation that the latest reflash has been applied to a vehicle you are working on, verify the ROM ID using the table on page 2 of this bulletin.

#### **DTC C270254: Control Module Master Missing Calibration**

To correct this condition, the ECU should be reprogrammed using the KDS download, as described in this bulletin.
