| | GROUP<br><b>ELE</b> | MODEL<br><b>2018-2019MY<br/>Niro (DE PHEV)</b> |
| | NUMBER<br><b>161</b> | DATE<br><b>December 2018</b> |
| <b>TECHNICAL SERVICE BULLETIN</b> | | |
| <b>SUBJECT: COMBINATION TSB / SERVICE ACTION: COOLANT<br/>LEAK – OBC INLET HOSE DETACHING (SA365)</b> | | |

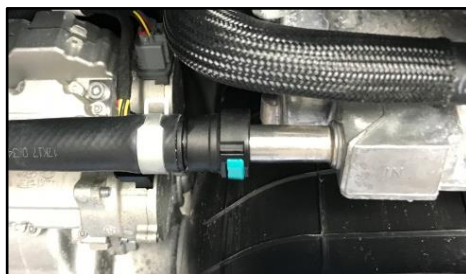
This bulletin provides the procedure to install an onboard charger (OBC) quick disconnect spacer on some 2018-2019MY Niro (DE PHEV) vehicles, produced from March 21, 2018 through August 22, 2018, which may experience the OBC coolant inlet hose detaching. If detached, the following Hybrid System/Refill Inverter Coolant Warning(s) and/or HV DTCs may set: P0A93, P0A3C, and/or P0A3E. Follow the procedure in this bulletin to install a spacer at the OBC coolant inlet hose. Before conducting the procedure, verify that the vehicle is included in the list of affected VINs.
