# Technical Service Bulletin

## 19 Heating output insufficient (DTC B10D004 and/or B11D501)

19 17 90 2047114/4 September 12, 2017. Supersedes Technical Service Bulletin Group 19 number 17-85 dated April 4, 2017 for reasons listed below.

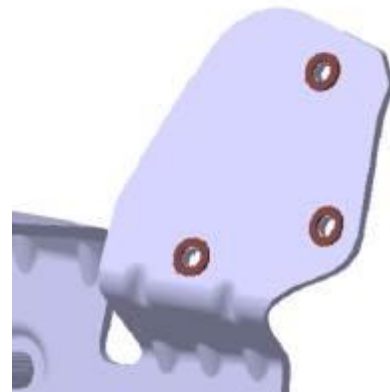
**Figure 1.** Washers installed.

Replace the V50 coolant recirculation pump, use the washers if pump is mounted with screws to the bracket as shown (some models have rubber covered metal band instead):

- N 011 523 21 (3x)

To ensure about 1mm distance between the V50 coolant recirculation pump and its bracket (Figure 1 and 2):

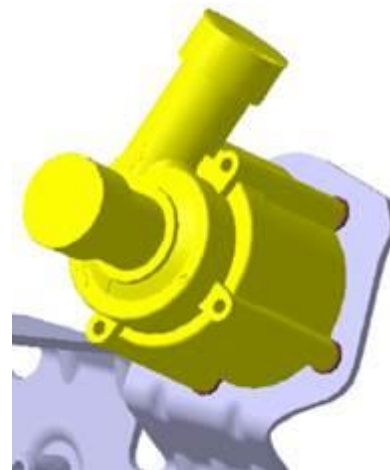
**Figure 2.** Pump mounted.
