## SERVICE INFORMATION BULLETIN

**APPLICABILITY:** 2012-2017MY Legacy and Outback  
 2012-2016MY Impreza  
 2013-2017 Crosstrek  
 2011-2017MY Forester NA and DIT  
 2015-2017MY WRX  
 2013-2017MY BRZ  
 2012-2014MY Tribeca

**NUMBER:** 07-133-18R

**SUBJECT:** Knock Sensor Design Change, DTCs P0327,  
 P0328, P0332 and P0333

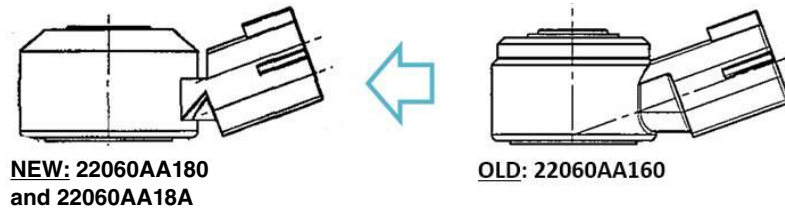
This Service Information Bulletin announces design changes to the engine's knock sensor which will help improve vehicle assembly line efficiency and increase durability. In some cases, the Check Engine light may illuminate and a knock sensor-related DTC set in the ECM memory: P0327, P0328, P0332 and P0333. The knock sensor for DIT engines is now utilized for NA engines to improve durability and resistance to heat.

The reference illustrations below show the difference between the new and the old part.

- The part number for the new knock sensor to be used on Japan-built vehicles is: **22060AA180**.
- The part number for the new knock sensor to be used on SIA / US-built vehicles is: **22060AA18A**.

Follow the procedure in the applicable Service Manual when replacing the knock sensor. The torque specification for the retaining bolt (24 Nm / 17.7 ft. lbs.) is unchanged.

**REMINDER:** Do NOT use anti-seize compound on the sensor retaining bolt threads.
