# Technical Service Bulletin

**SCBS / SBS, LAS / LDWS, MASTER AND/OR HBC WARNING LIGHTS  
ON WITH DTC U3000:98 STORED DURING HOT WEATHER**

**Bulletin No.:** 15-002/18

**Last Issued:** 12/05/2018

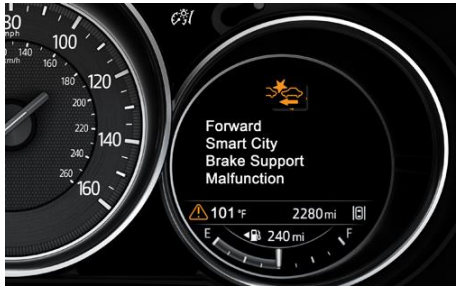
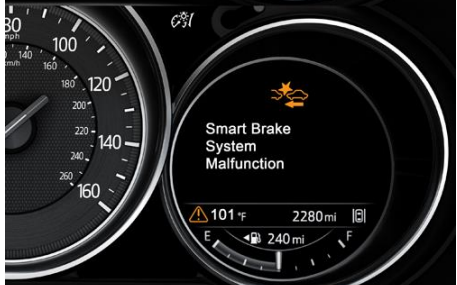
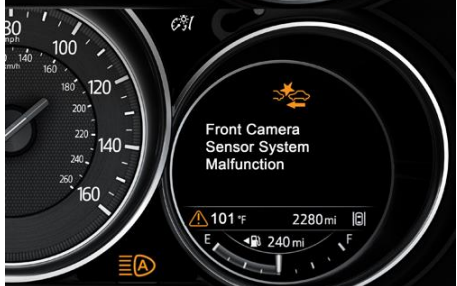
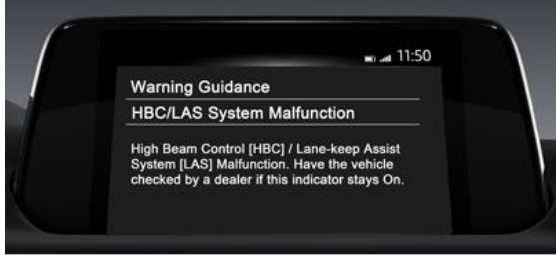
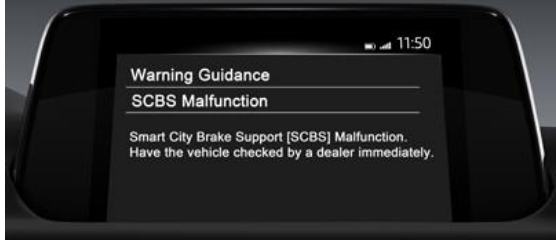
This condition may be caused by FSC control logic that is too sensitive. When the FSC detects DTC U3000:98 during high temperature, it stops the internal communication and stores DTC U3000:04. DTC U3000:04 will not clear and SCBS/SBS, LAS/LDWS, and/or HBC functions will not resume until the ignition switch has been turned OFF even if the temperature of the FSC cools.

The warning lights/messages will be displayed until the FSC cools and the ignition is turned OFF, then back ON.

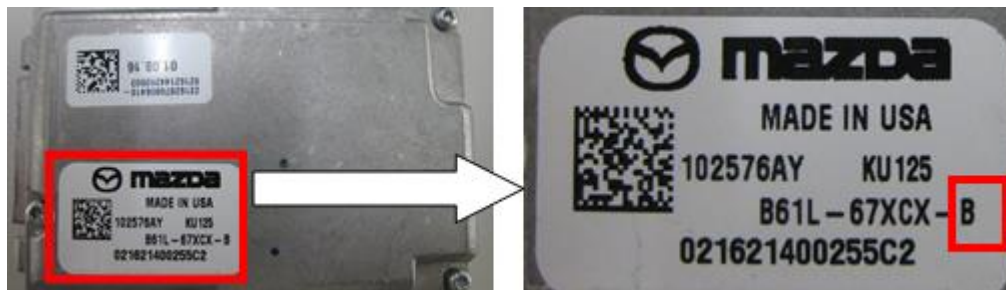
3. Remove the FSC according to the instructions on MGSS (FORWARD SENSING CAMERA (FSC) REMOVAL/INSTALLATION) and check the part number suffix on the label (sample shows suffix "B").

- If the part number suffix is "T" or later, this is the modified part that should NOT be replaced. Go to step 6.
- If the part number suffix is "S" or before, go to next step.

4. Replace the FSC with a modified one according to the instructions on MGSS (FORWARD SENSING CAMERA (FSC) REMOVAL/INSTALLATION).

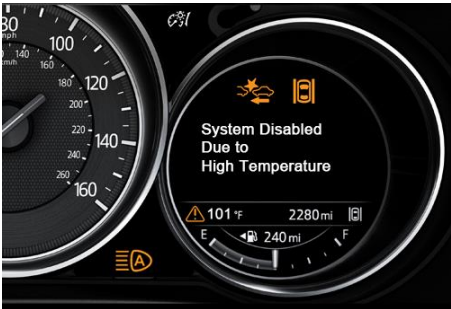
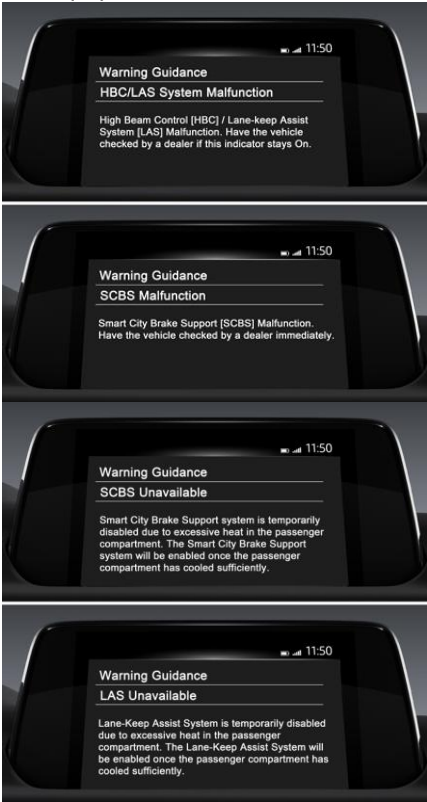
**NOTE:** Even with the modified part, U3000:98 may still be stored depending on how hot the environment is. This is not a FSC failure, but rather a thermal protector function to avoid damage to the FSC hardware.

The warning lights/messages will be displayed until the FSC cools (No need to turn the ignition OFF).
