# Service Alert

| <b>Subject:</b><br><br><b>ENGINE RUNS ROUGH AND/OR LACK OF POWER WITH DTCs<br/>P0340:00, P0304:00, P3400:00, P349B:00, P3498:00</b> | <b>Service Alert No.:</b> SA-041/18 |
| | <b>Last Issued:</b> 12/06/2018 |

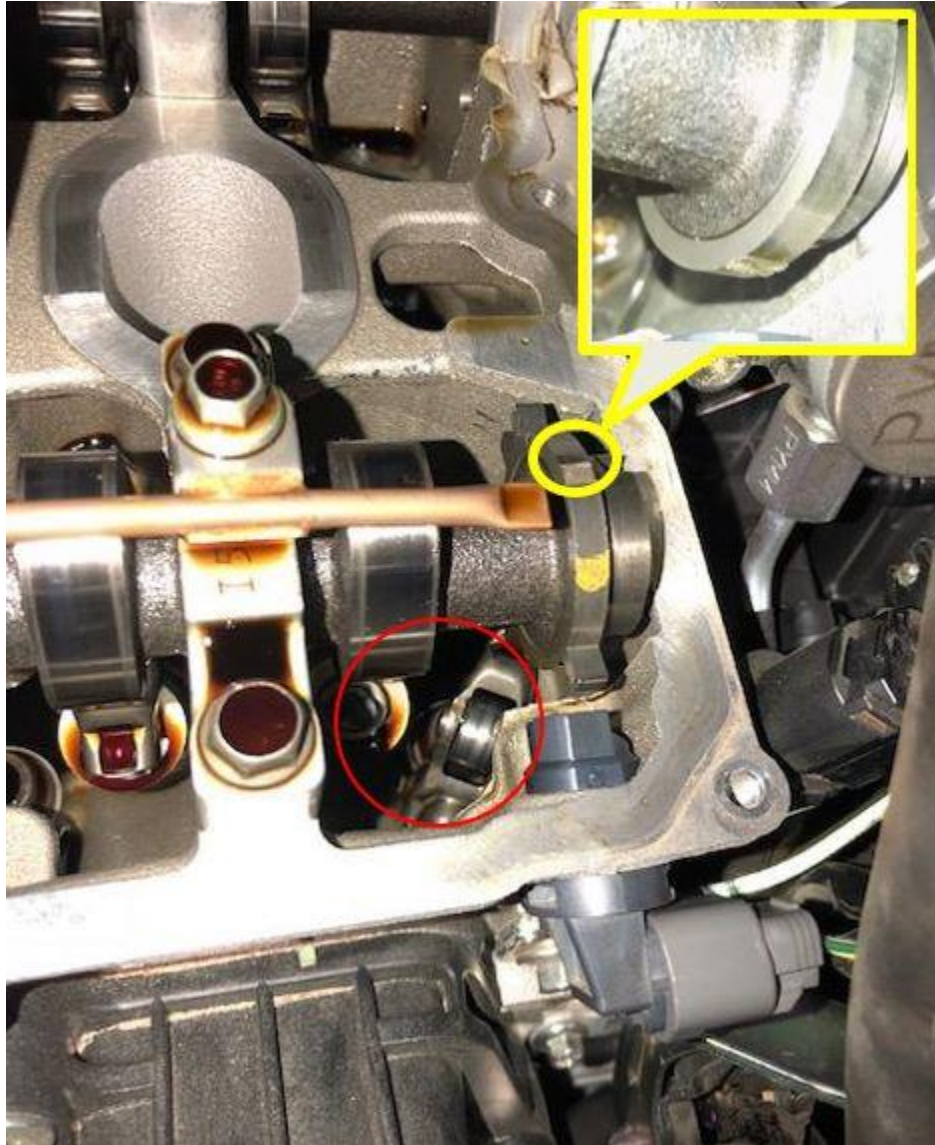
1. Remove cylinder head cover and inspect valvetrain area.
2. Inspect for fallen or broken rocker arm, especially in cylinder deactivation area (cylinders 1 and 4).
3. Verify engine oil change records.
4. Submit pictures of fallen rocker arm, camshaft trigger wheel and engine oil filter cartridge to Siebel.

1. Collect ODR.
2. Contact Technical Assistance Hotline for engine replacement authorization via MASH.
3. Collect and secure all broken pieces into a bag when shipping.
