## Technical product information

| <b>Topic</b> | Emission control system lamp illuminated - DTC P044100 evident |
| <b>Brand</b> | Bentley |

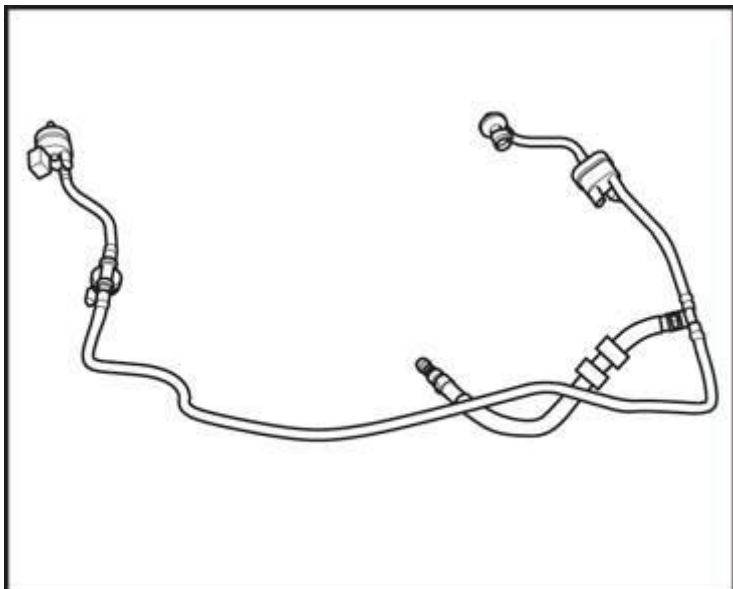
Figure 1

NOTE: The evaporative emission purge valves and supply lines are connected to both banks of the engine

NOTE: The solenoid valves are connected together with a hose, and have to be replaced as a unit as these solenoid valves and hoses are not supplied separately

- 5) Replace the evaporative emission purge valve assembly (Figure 1) - Refer to repair manual Rep.Gr 20 - Evaporative emission purge valve - To remove and fit - pay attention to any debris/contamination falling from the ends of the line during disconnection, If contamination is found in the ends of the line or the engine ports please raise a DISS query

**IMPORTANT:** Please ensure the openings of the purge line assembly are fully sealed prior to returning back to Bentley Motors (Use the bungs which were fitted to new assembly for this purpose)
