## TECHNICAL SERVICE BULLETIN

### Inoperative Park Aid Camera, Luggage Compartment Lamp, Luggage Compartment Lid Release And/Or Poor Satellite Radio Reception

**18-2362**

Ford  
2015-2017 Mustang

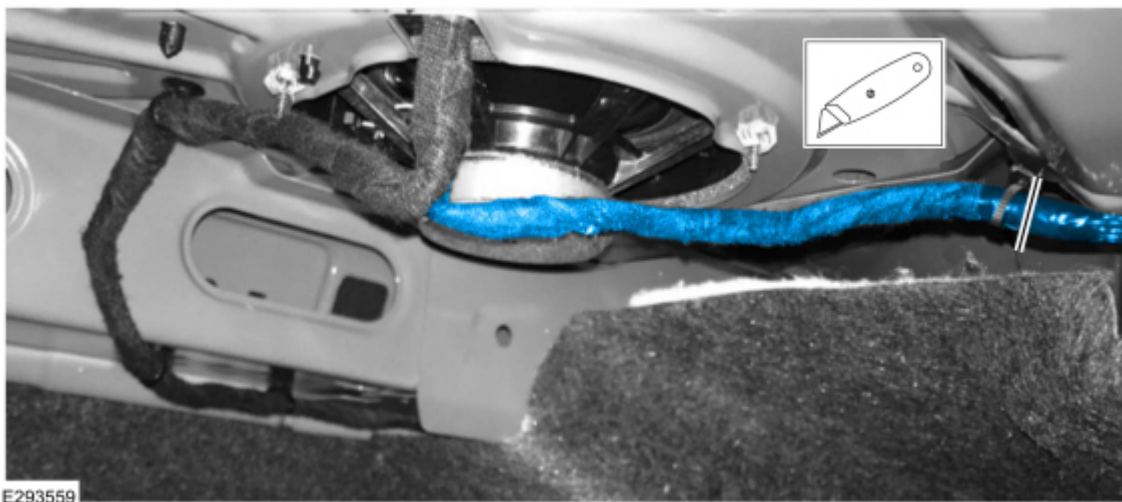
Figure 1

**Issue:** Some 2015-2017 Mustang vehicles may experience an inoperative rear parking aid camera, luggage compartment lamp, luggage compartment lid release and/or poor satellite radio reception. This may be due to damage to the 14A005 harness in the area of the right side luggage compartment lid hinge. This concern may be accompanied by diagnostic trouble codes (DTCs) B115E, C1001, and B1A89.

- Cut out the damaged section of the harness. Make the cut at the location of the harness noted. (Figure 1)

- Splice in the new section of harness, matching wire colors on the existing vehicle harness and the replacement section of harness as necessary. Follow the recommended wiring splice procedures in Section 5 of the Wiring Diagram. Stagger the location of each of the wire splices along the harness to minimize the overall size of the repair.

3. Wrap the spliced area in Coroplast Electrical Wire Harness Tape or equivalent.
4. Secure the replacement section of harness into the same body holes as the original section of harness was using the clips attached to the replacement section of harness.
5. If DTCs were previously present, connect the appropriate Ford scan tool or equivalent to the DLC and clear all DTCs.
