## SERVICE BULLETIN

| Reference number: | SB-03-0450V2 | Issued: 10 January, 2019 |
| Subject: | V12 Secondary Air Injection System Codes P0492 P0491 | |
| Model(s): | DB11 V12, DBS Superleggera | |

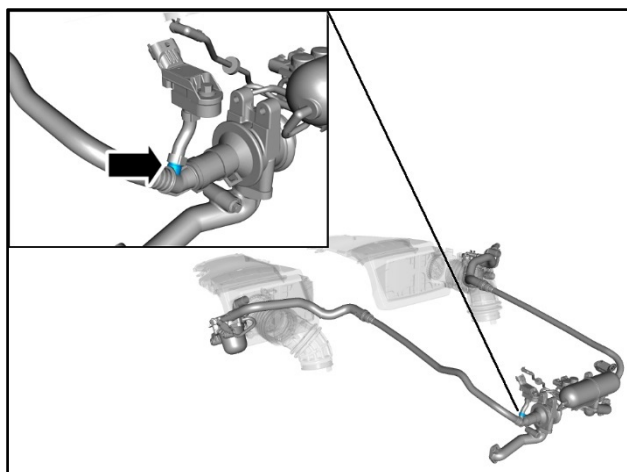
Figure 1

We have found a problem with the SAI pump to SAI control valve pipe. In some incidents, the pipe has split at the elbow for the sensor. (Refer to Figure 1). To do a check for leaks, attach a smoke leak tester to the pipe on the SAI pump side.

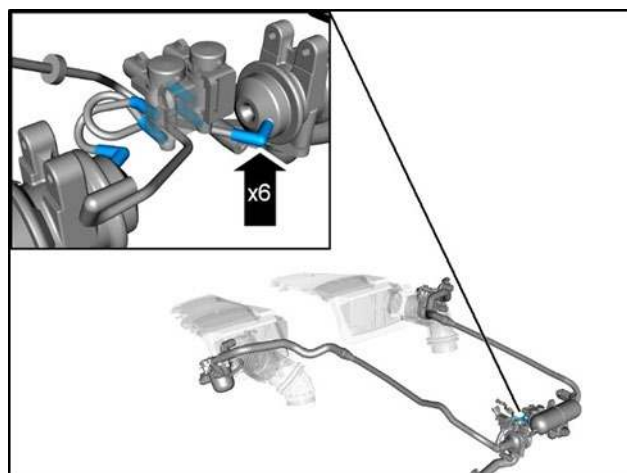
**Figure 2**

It is possible that the vacuum pipes for the SAI control valve are not correctly attached. This can cause failure of the SAI control valve operation. In these incidents, make sure that all of the vacuum connections shown in Figure 2 are correctly attached.
