# Preliminary Information

## PIC5903B Spark EV Chevrolet Volt Opel Ampera Models With Or Without Service Vehicle Soon Lamp - SVS - or Check Engine Lamp On With DTC P0534 Set Current Or History

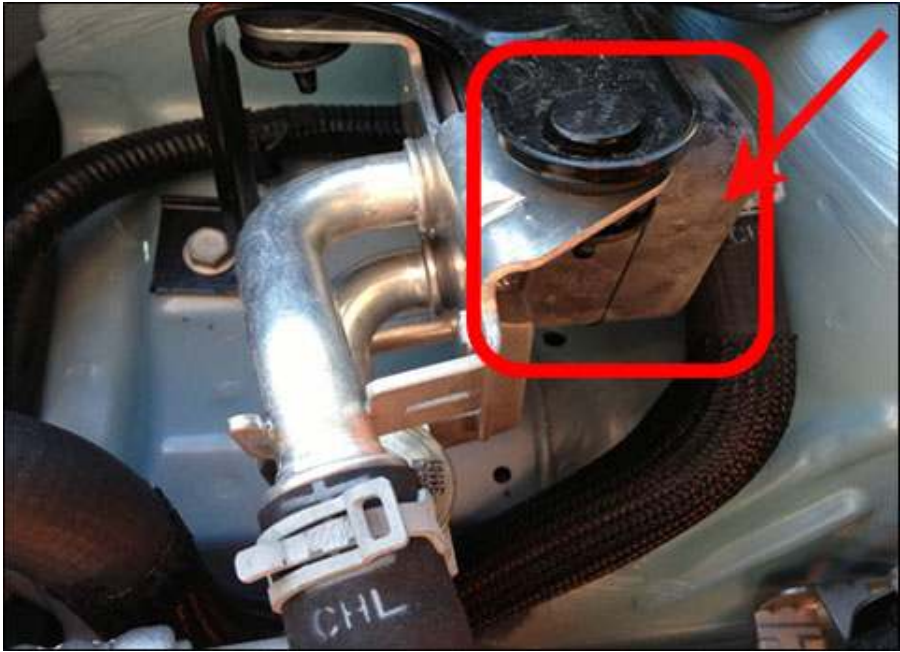
- A. Shown below is a picture of the RESS Cooler from the Spark EV. The black insulator cover can be easily pulled back to inspect the Cooler Plate notches without removal.

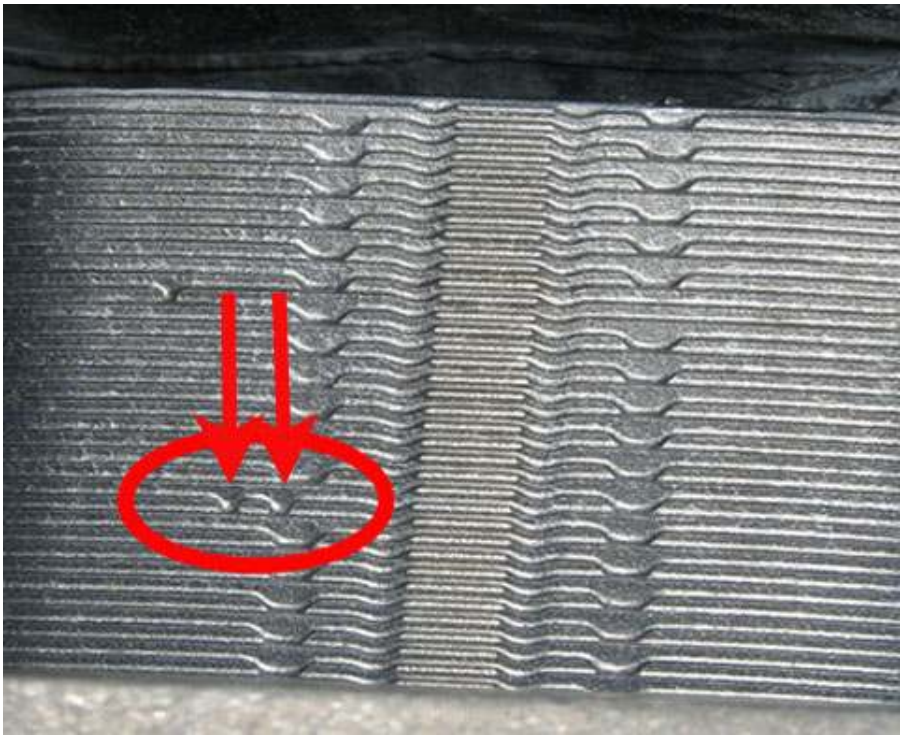
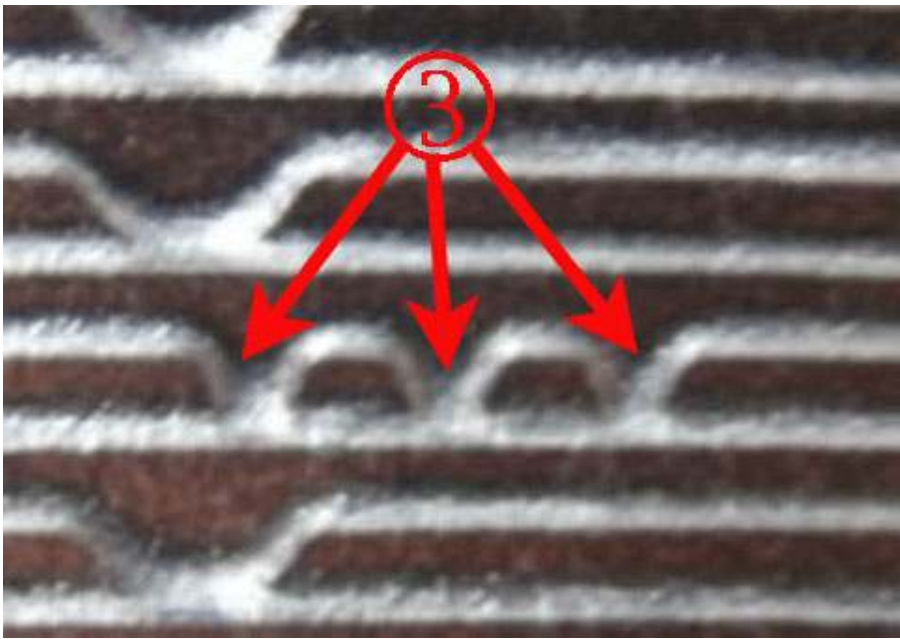
2. The RESS Cooler passes inspection if the RESS Cooler has two notches. If there are three notches, replace the RESS Cooler. (see photos below).
  3. If the vehicle build does not fall within the suspect date range, continue to operate the vehicle with GDS2 connected.

3 Notches equals replace cooler.

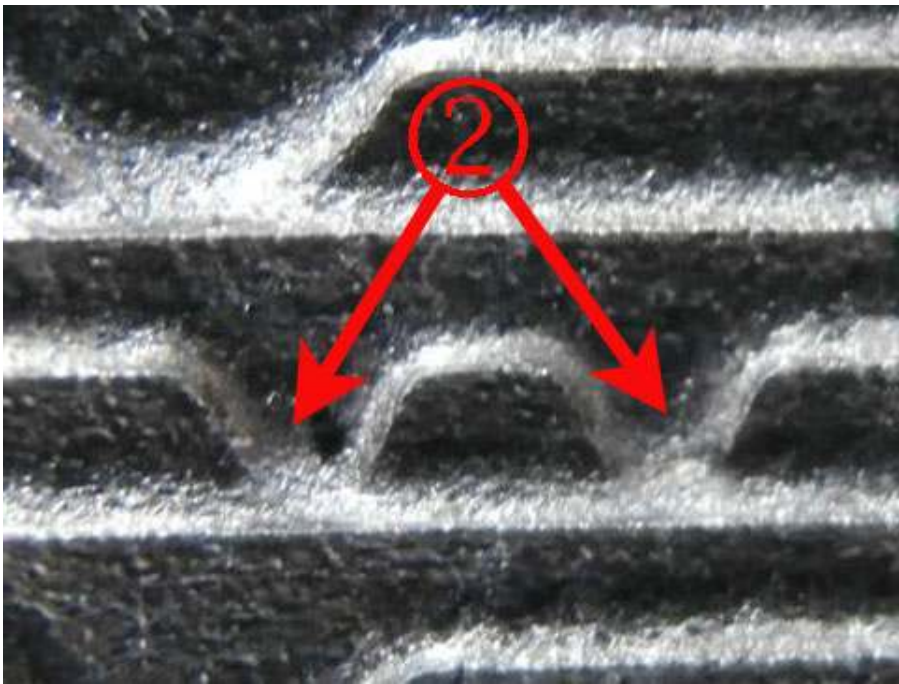
2 Notches equals DO NOT replace cooler.
