Preliminary Information

PIT5391E No Crank / Start then Immediate Stall / SES MIL / Service 4WD / Relay Clicking / Rearview Camera Inop / DTC (Inspect Ignition 1 voltage)

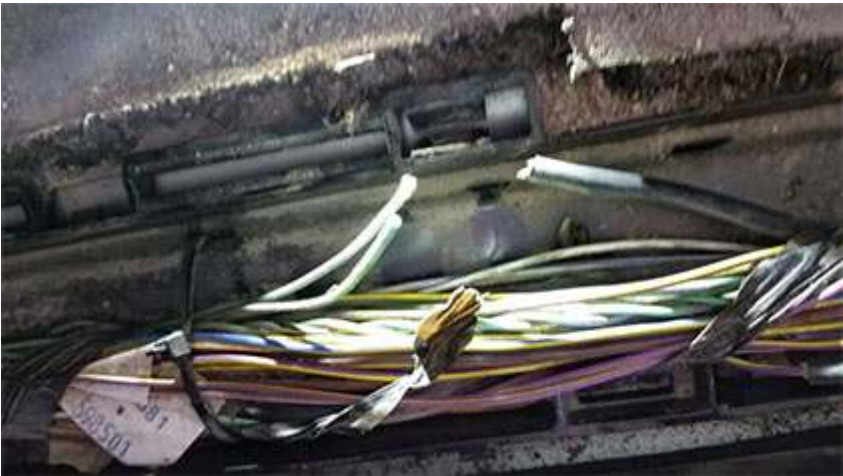
- 3. Circuit 5199 under the driver's sill plate for being damaged/corroded, as shown below.**

**Repair any wiring / terminal issues using the appropriate SI wiring repair documentation.**
