# Preliminary Information

## PIP4005A Intermittent No Crank, Battery Light, and/or SES Light - Inspect Hybrid Battery

### Models

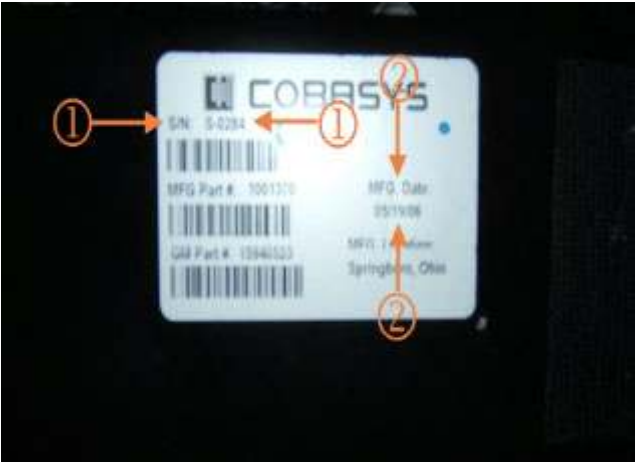
- 1) Serial Number
- 2) Manufacturing Date

If the SI diagnostics do not isolate a cause for this concern, follow all safety precautions and SI procedures to check for a loose negative hybrid battery cable at the hybrid battery. This is the cable on the driver's side of the hybrid battery. If the cable is loose, follow SI procedures to remove the negative hybrid battery cable from the hybrid battery and note the break-away torque of the composite nut on the repair order. Once the cable is removed, remove the fuse the fuse that is behind the negative hybrid battery cable terminal and inspect the negative hybrid battery stud, fuse, and negative cable terminal for signs of arching. If there is any sign of arching, replace the damaged component (s) as necessary. If the negative hybrid battery stud shows signs of arching, it will be necessary to replace the complete hybrid battery assembly. If the negative cable was loose but there was no sign of arching on any of these components, reassemble the negative hybrid battery connection by following all safety precautions and SI procedures. The composite nut for the negative hybrid battery cable should be torqued to 95 lb in (10.7 Nm). Once the composite nut is torqued to specification, confirm that the negative cable is tight. If so, note the serial number and manufacturing date (shown in the photo below) on the repair order.

**Important: As requested above, please document the battery serial number, battery manufacturing date, and composite nut break-away torque on the repair order. If there is a TAC case on this concern, please contact TAC and ask the TAC consultant to document this information in your TAC case.**
