Preliminary Information

PIC6285C Diagnostic Aid for DTCs P1AEE and P1AEF, Control Module Hybrid/EV Battery System Voltage High Voltage (Over-Voltage)

| Brand: | Model: | Model Years: | VIN: | | Engine: | Transmissions: |
|---|---|---|---|---|---|---|
| Chevrolet | Volt | 2016 - 2019 | All | All | All | All |

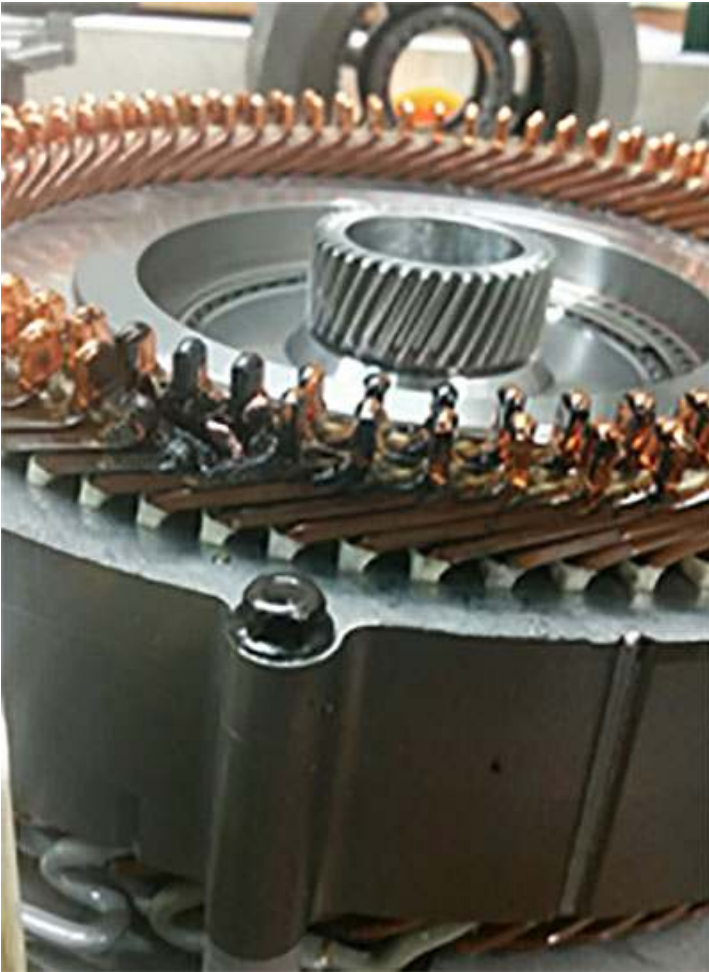
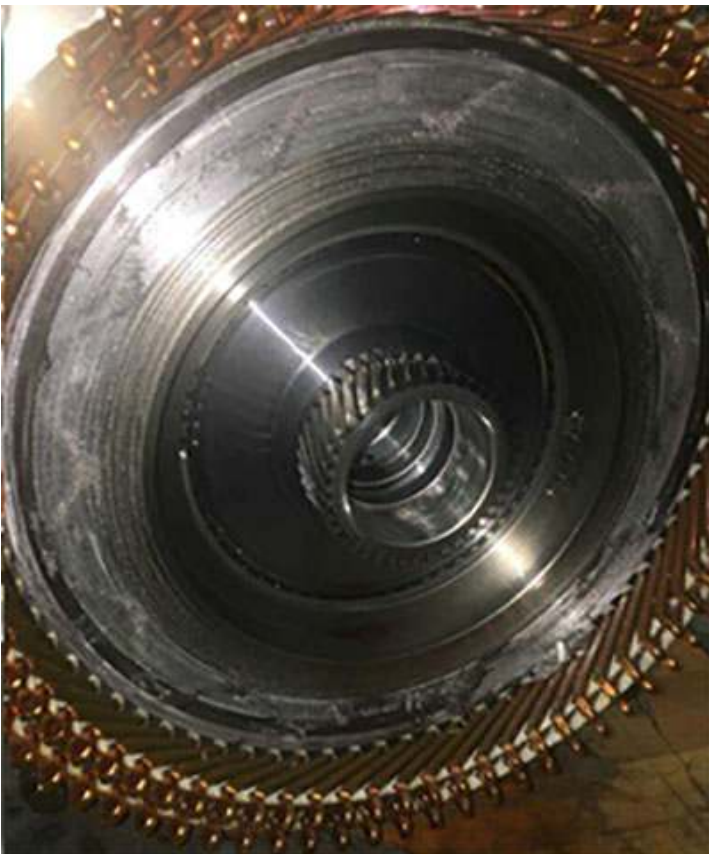
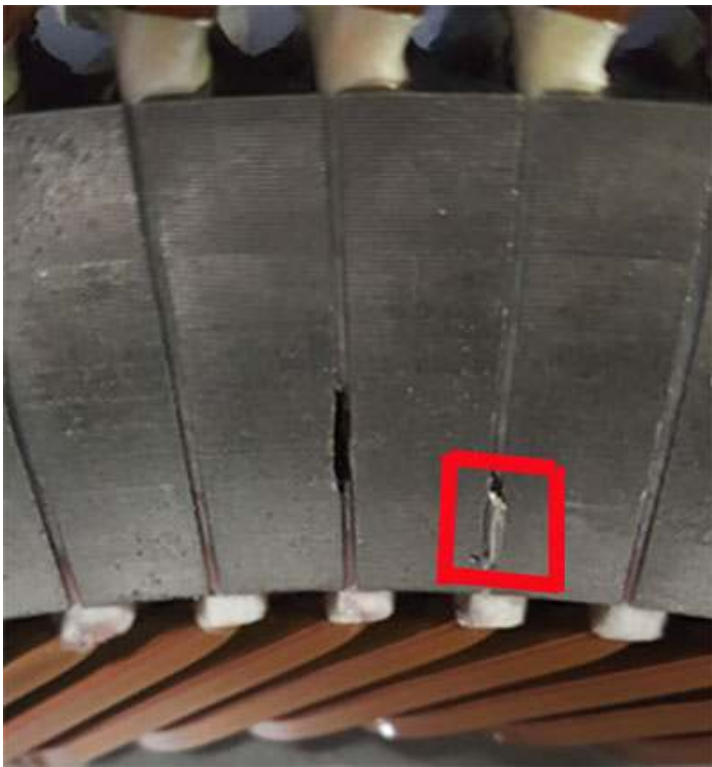
If accompanied by DTCs P1AF0/P1AF2/P1E22 or P0C01/P0C04, then the loss of isolation will be located within the transmission, usually due to debris in the motor stators from a failed internal component.

Examples of debris causing stator problems:

Use the *Loss of Isolation on the High Voltage Main Bus* procedure in SI to help pinpoint which subsystem is causing the loss of isolation.

**Note: Any loss of isolation will not self-heal and needs to be repaired for vehicle safety. Clearing codes without repair is not an acceptable remedy of this category due to the vehicle hazards created by P1AEE and P1AEF.**

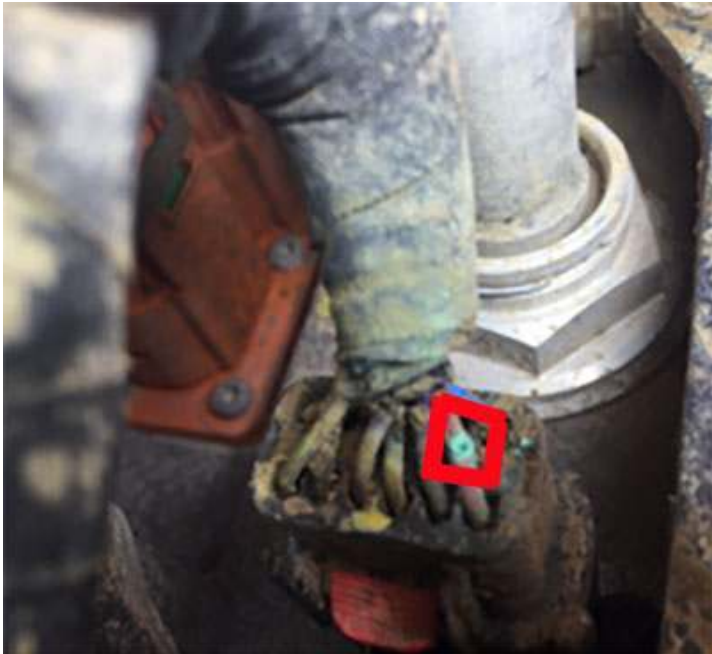
**Any compromise in these circuits may cause the contactors to open unexpectedly.**

**Example of connector X357 with stone impingement and corrosion on wiring:**

**Inspect circuits 3961 and 3959 for contactor control as well as B+ 5240 and ground circuit 2050 (G302).**

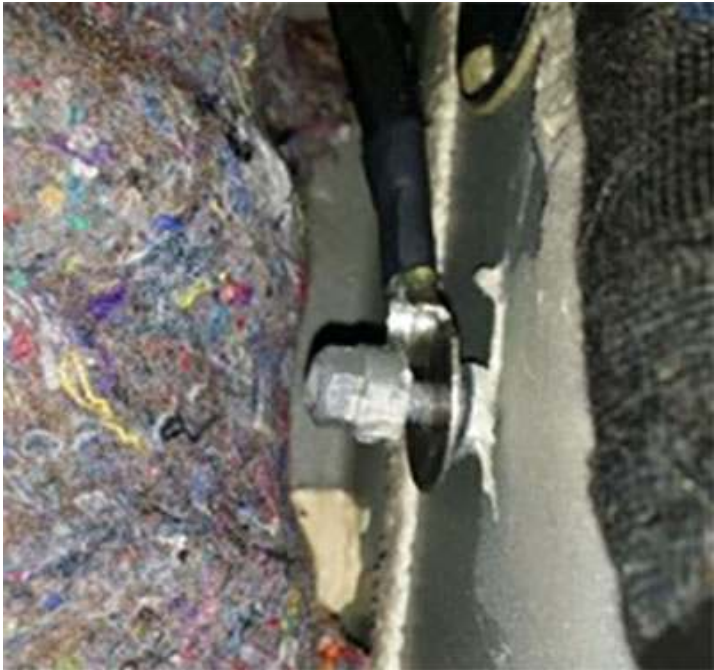
**Example of loose ground G302:**

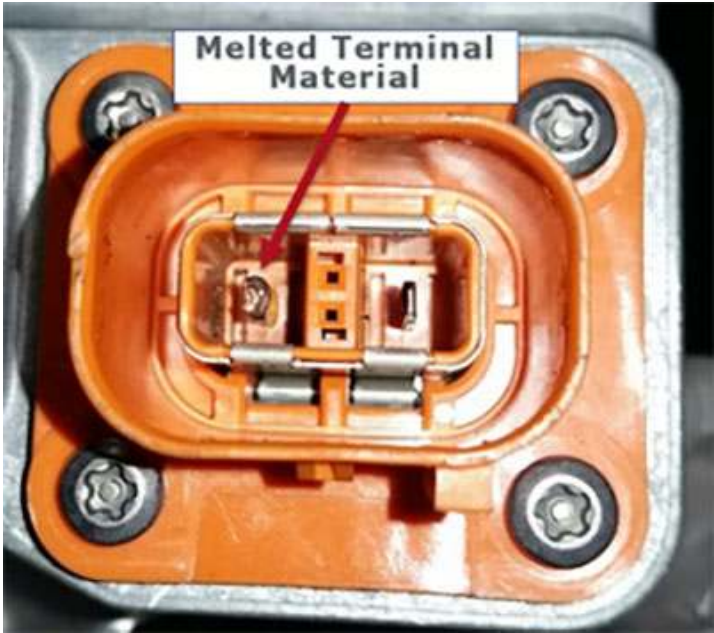
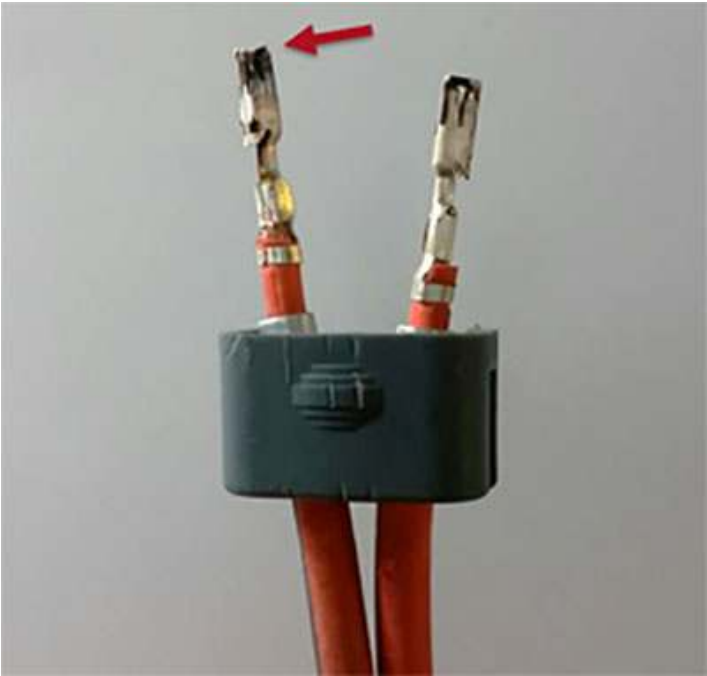
**Example of a loose connector X2 at the K10 Coolant Heater Control Module:**

**This is expected to be a less common category for P1AEE and P1AEF. If one of the parameters is near but not equal to zero, properly inspect each of the orange high voltage connectors on the vehicle for a loose connection on the high voltage bus.**
