# Service Alert

| <b>Subject:</b><br><b>CHECK ENGINE LIGHT ON WITH DTCs P2A04:00, P2272:00 AND/OR OTHER DTCs</b> | <b>Service Alert No.:</b> SA-004/19 |

2007-2015 CX-9

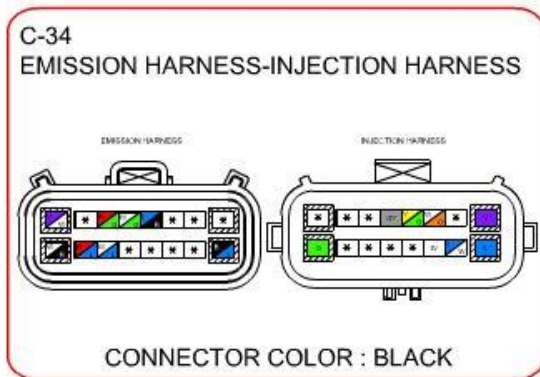
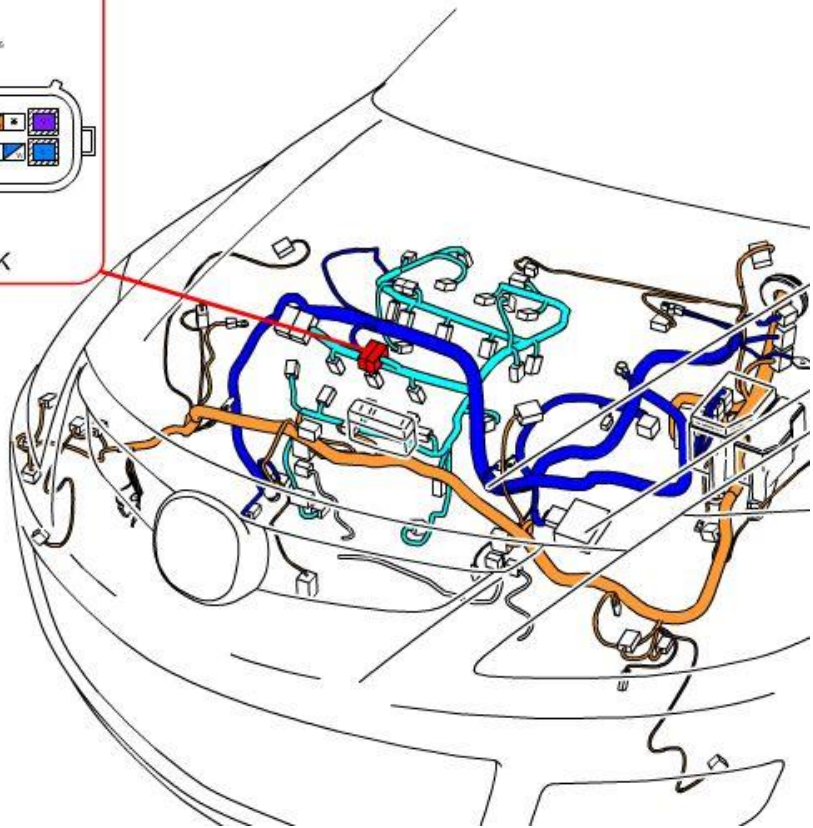
1. Verify the customer concern.
2. Inspect the C-34 connector (shown below) for engine oil contamination.

- If oil contamination is not present, this repair is not applicable. Diagnose DTCs according to the instructions on MGSS online.
  - If oil contamination is present in the C-34 connector, perform the following steps:
    - a. Inspect the engine oil pressure switch for external leaks.
    - b. If external leak is found, replace the engine oil pressure switch.
    - c. Clean the C-34 connector and harness of oil contamination, then go to step 3.
3. Inspect the related O2 sensors according to the instructions on MGSS online.
- If the related O2 sensors are operating correctly, go to step 4.
  - If the related O2 sensors are not operating correctly, replace the affected O2 sensor(s) according to the instructions on MGSS online, then go to next step.
4. Clear DTC(s) and test drive to confirm repair.
