**March 5, 2019**

Version 7

**Product Update: 2017-18 CR-V: Software and A/C Control Unit Update, DTC P0300, P0301, P0302, P0303, P0304, or P0172****Supersedes 18-114, dated February 1, 2019, to revise the information highlighted in yellow****REVISION SUMMARY**

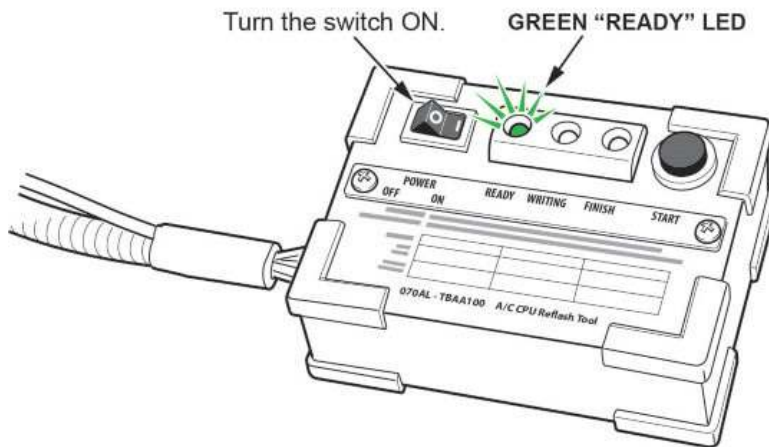
If the green LED starts flashing, there might be an issue with the tool. Use a different or known good cable or tool as needed and try again.

- 5.6. Turn the power switch to **ON**. A solid green LED should come on.

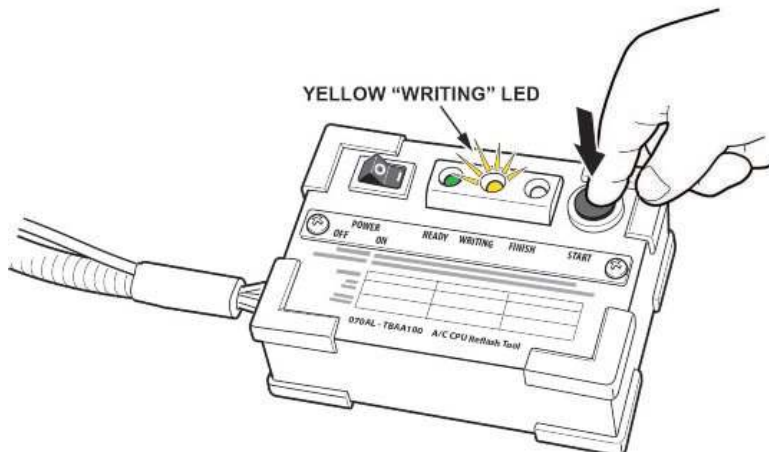
If the yellow LED is flashing, the vehicle may have been updated previously or is ineligible for the update, or the sub cable is worn out. If the sub cable is worn out, replace it and try again. The 32 pin connector on the sub cable is expected to last about 50 connections. **If the yellow LED is still flashing after replacement of the sub cable, refer to S/B 19-026, 2017-18 CR-V: Software Update with A/C Control Unit Replacement; DTC P0300, P0301, P0302, P0303, P0304, or P0172 for further instructions.**

- 5.7. Once the solid green LED is on, press the black "start" button on the right-hand side to start the rewriting process.
- 5.8. A solid yellow LED should appear, which means that the tool is rewriting the A/C control unit.

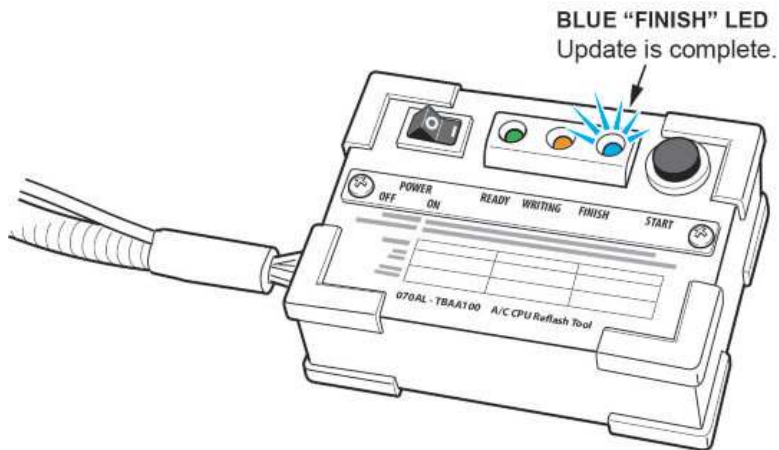
If the blue LED is flashing, the update has failed. Power off the tool and repeat the procedure again. If the error is consistent, replace the sub cable and try again. The 32 pin connector on the sub cable is expected to last about 50 connections.

5.9. Once complete, a solid blue LED should come on, which means the procedure is complete.
