Preliminary Information

PIP4751G Hybrid Drivability Concerns Jerk Bump Or Surge At Low Speeds

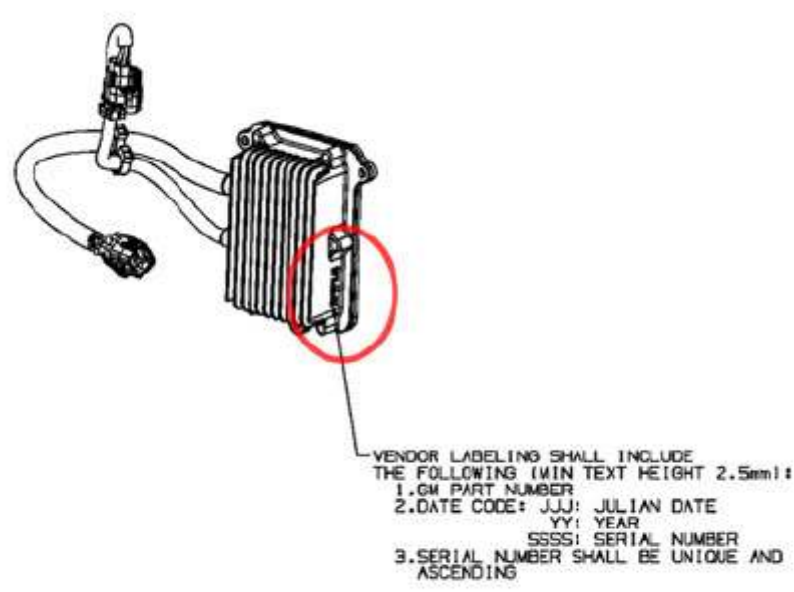
- 1) Check all vehicle modules and address any DTCs that may be present except for P2797 or P0C2B.
- 2) Once other DTCs have been addressed obtain the date code off of the auxiliary transmission fluid pump control module as indicated in the figure below.

- 4) If the P2797 and/or P0C2B procedures do not identify either the auxiliary transmission fluid pump control module or auxiliary transmission fluid pump fault and the complaint is re-produced during those test procedures, inspect the “Hybrid Low, 1-2 clutch” assembly. (concerns relating to the “Hybrid Low, 1-2 clutch” assembly, typically manifest as a P079A DTC, but may not set the DTC).
- 5) If the customer concern does not re-produce, the “Hybrid Low, 1-2 clutch” assembly is operating normally and the control module has a Date Code of 089-11-XXXX or older, replace the auxiliary transmission fluid pump control module.
