# Preliminary Information

PIT4614C Hybrid No Crank With DTC B009F or Service Hybrid message with no codes.

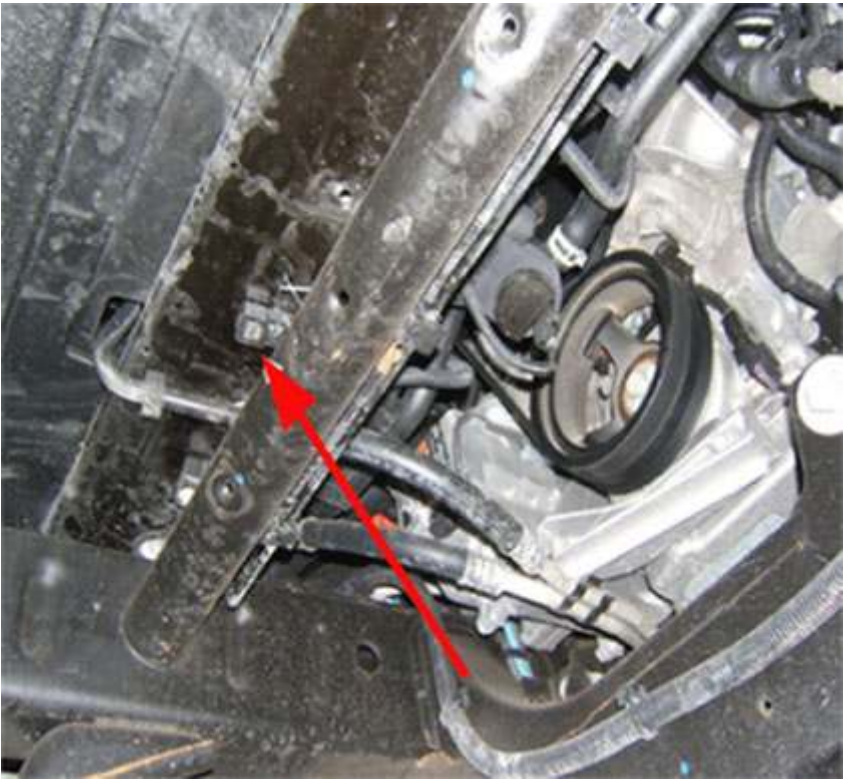
**This concern may be caused by water intrusion past the weatherpack seal on the High Voltage Circuit Impact Detection (HVCID) sensor. The sensor is located in the center of the lower radiator support. (See Photo below)**

1. Inspect the HVCID sensor for cracks and the terminals for corrosion. Replace sensor and/or terminals and weather-pack seals if any signs of corrosion or damage is found.
2. If no damage or corrosion was found and there were no codes, Leave the connector unplugged to induce a code.
3. Cycle the ignition off unplug the tech2 power down for 2 minutes
4. Then clear code.
5. Recheck for message and codes.
6. If code resets then will need to replace the sensor and terminated leads then repeat steps 2-5
