| | GROUP<br><b>ENG</b> | MODEL<br><b>2018MY<br/>Stinger (CK) 2.0T</b> |
| | NUMBER<br><b>191 (Rev 2, 02/20/2019)</b> | DATE<br><b>November 2018</b> |
| <b>TECHNICAL SERVICE BULLETIN</b> | | |
| <b>SUBJECT: SERVICE ACTION: 2.0T ECU REPLACEMENT FOR<br/>DTC P053F AND/OR P0087 (SA352)</b> | | |

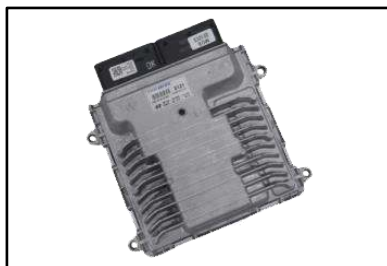
This bulletin provides the procedure to replace the Electronic Control Unit (ECU) on ALL 2018MY Stinger (CK) 2.0T vehicles, produced from September 29, 2017 through March 27, 2018, which may exhibit engine hesitation and/or a Malfunction Indicator Light (MIL) ON with DTCs P053F and/or P0087 as the engine is warming up to operating temperature. Follow the procedure below to replace the ECU. Before conducting the procedure, verify that the vehicle is included in the list of affected VINs.

**P053F: Cold Start Fuel Pressure Performance  
P0087: Fuel Rail/System Pressure – Too Low**
