# Technical Journal

**Steering Assistance Temporarily Reduced, PSCM U30031C**REF NO:  
**TJ 34142.4.0**ISSUING DEPARTMENT:  
**Technical Service**CAR MARKET:  
**United States and Canada**PARTNER:  
**3 US 7510 Volvo Car USA**ISSUE DATE:  
**2018-12-18**STATUS DATE:  
**2018-12-20**FUNC GROUP:  
**6422**FUNC DESC:  
**Steering gear, servo complete****Page 1 of 3****“Right first time in Time”**

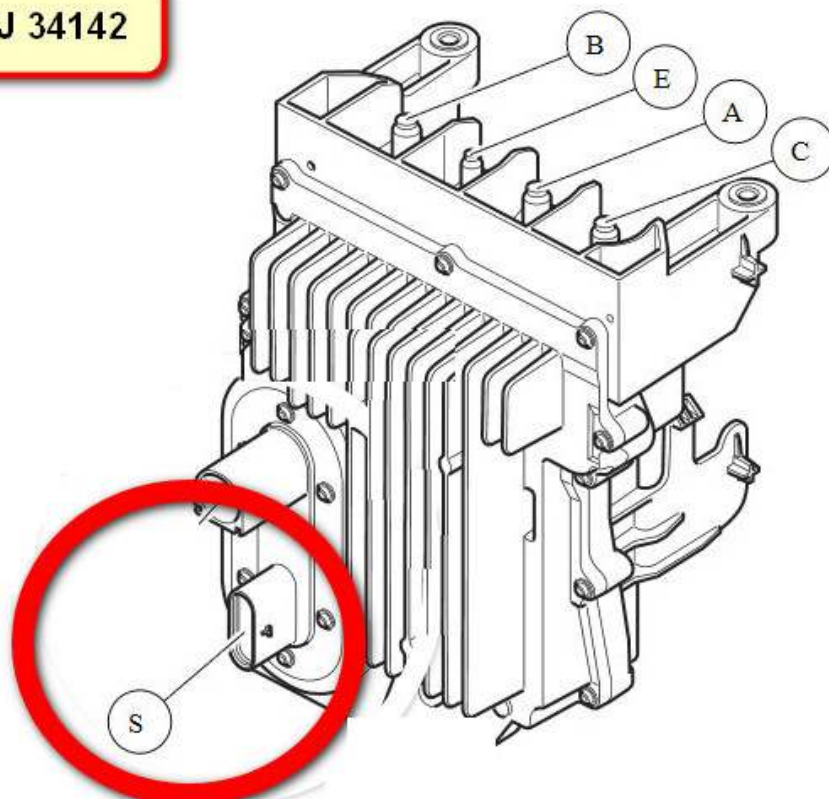
TJ 34142

\* The DTC indicate that one of the internal switches in the BCSM may be in the wrong position when cranking (during start/stop) and it could result in symptom similar to poor main battery state of charge (SOC).

\* Disconnect the S connector on the BCSM (4/153) for 15 minutes and then reconnect it, see picture.
