# Technical Service Bulletin

## 37 Transmission malfunction, DTC P17F600, U008000, and/or U010100 stored in TCM or ECM

37 19 85 2053878/2 March 12, 2019. Supersedes Technical Service Bulletin Group 37 number 19-84 dated February 26, 2019 for reasons listed below.

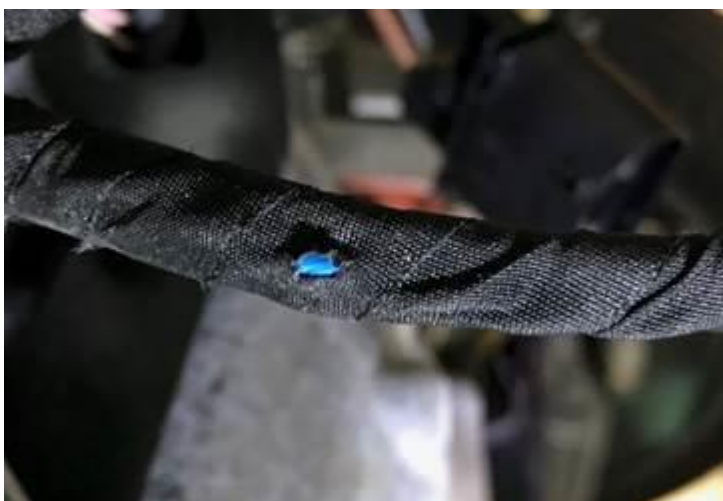
**Figure 2.** Example of a small rip in the protective tape.

2. Replace the transmission harness with a new part and reroute the transmission harness. The transmission harness should not be repaired.

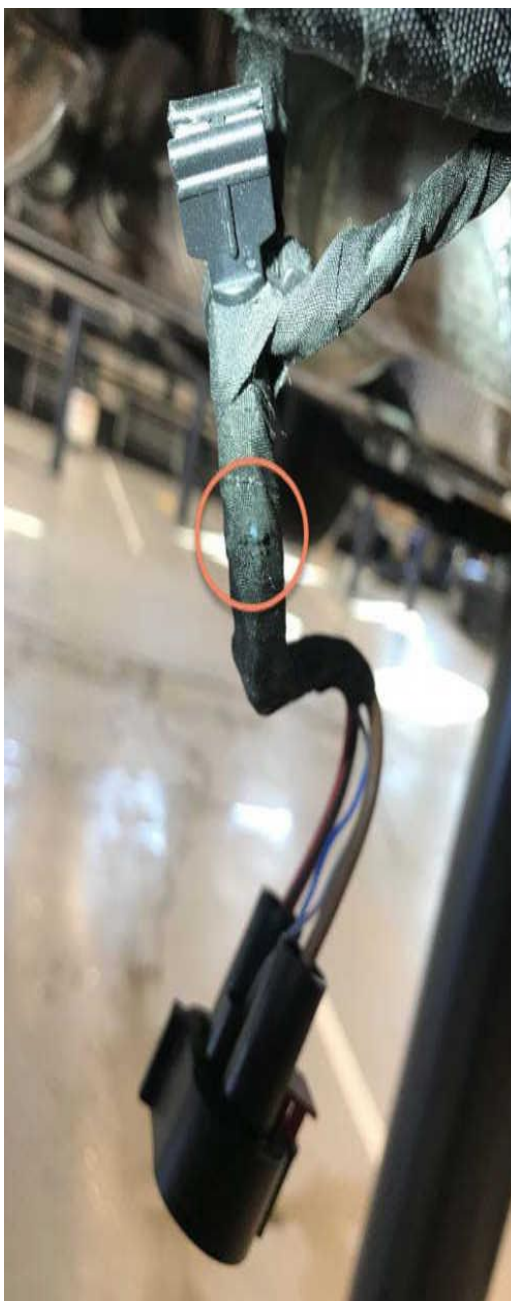
**Figure 3.** The damage on the harness might be difficult to spot.

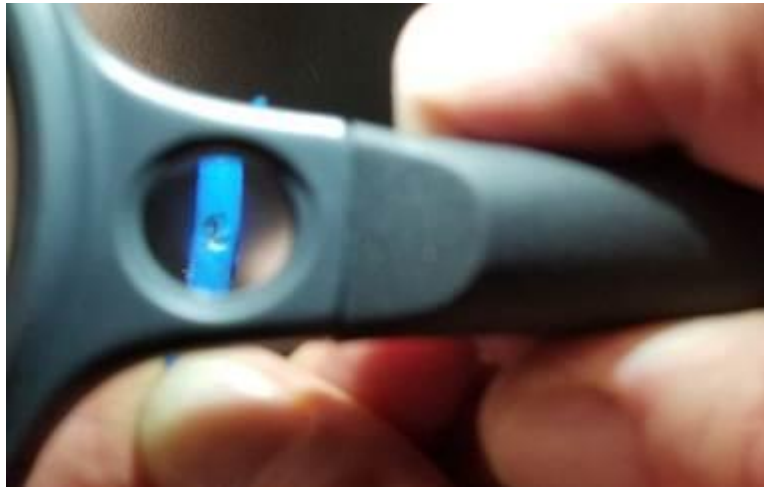
**Figure 4.** The cause of the DTC may be as small as a pinhole.
