# Technical Service Bulletin

## 01 MIL on, DTCs P20E900 or P20FE00 stored in ECM

01 19 12 2034359/8 March 15, 2019. Supersedes Technical Service Bulletin Group 01 number 19-05 dated February 13, 2019 for reasons listed below.

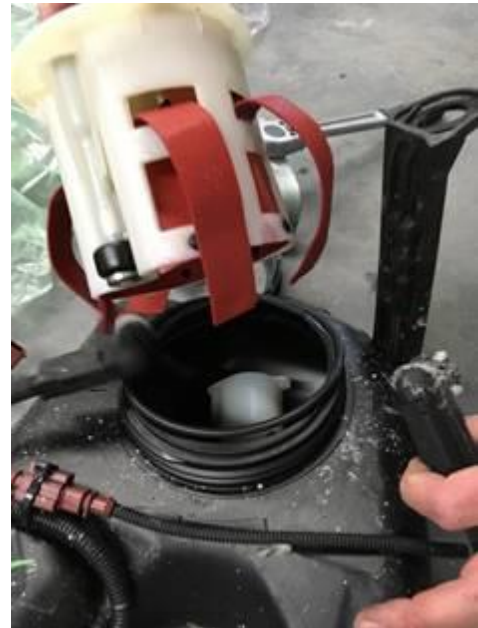
In vehicles produced during a certain period, the AdBlue filter seal within the level sensor module may have been damaged during the assembly process or the AdBlue filter housing may come loose over time. This can allow unfiltered AdBlue to be drawn into the delivery system, subsequently damaging the pressure sensor and reducing agent pump V437.

**Figure 1.** Filter element housing is loose inside the tank.

1. In cases with the above fault codes, remove the active tank according to instructions in the Elsa Repair Manual.
2. Remove the G684 Reducing Agent Tank level sensor.
3. Inspect the reducing agent filter housing which should be clipped to the G684 level sensor module. If the filter housing is loose (see Figure 1 and Figure 2), **then the G684 level sensor AND the V437 reducing agent pump must be replaced.**

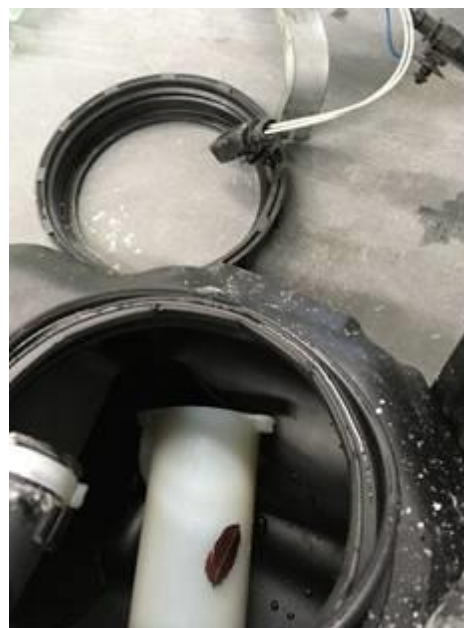
**Figure 2.** Filter element housing is loose inside the tank.
