# Technical Service Bulletin

## 37 Transmission malfunction, DTC P17F600, U008000, and/or U010100 stored in TCM or ECM

37 19 86 2053878/3 March 21, 2019. Supersedes Technical Service Bulletin Group 37 number 19-85 dated March 12, 2019 for reasons listed below.

| Model(s) | Year | VIN Range | Vehicle-Specific Equipment |
|---|---|---|---|
| A6, A7 | 2019 | 000001 - 050600 | 3.0TFSI |

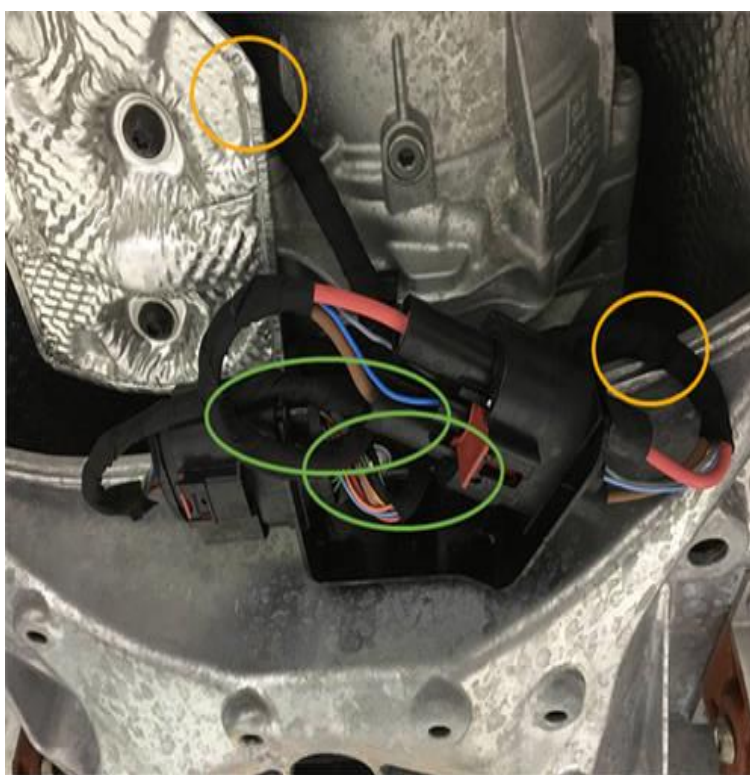
The transmission harness can come in contact with the crossmember and could be damaged.

**Figure 1.** Common areas for harness damage.

2. Replace the transmission harness with a new part and reroute the transmission harness. The transmission harness should not be repaired.
  - Remove the old transmission harness in the vehicle.
  - Wrap the exposed wires on the new transmission harness as shown in Figure 5.
  - Mount and route the new transmission harness as shown in Figure 6.

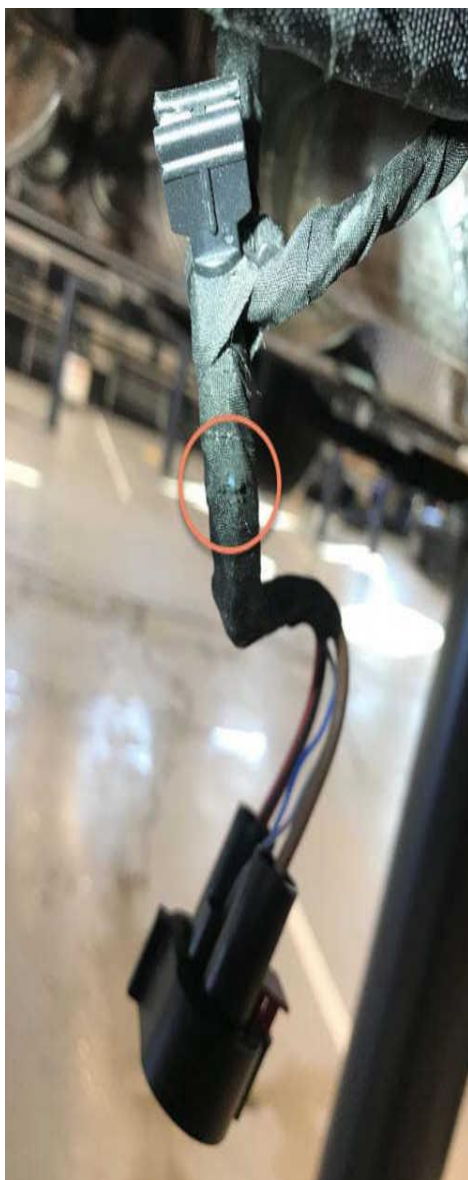
*Figure 3. The damage on the harness might be difficult to spot.*
