# Technical Service Bulletin

## 57 DTC B132E29 and B132F29 stored in the door control modules

57 19 55 2054419/1 March 26, 2019.

| Model(s) | Year | VIN Range | Vehicle-Specific Equipment |
|---|---|---|---|
| A6, A7, A8, and Q8 | 2019 | All | Not Applicable |

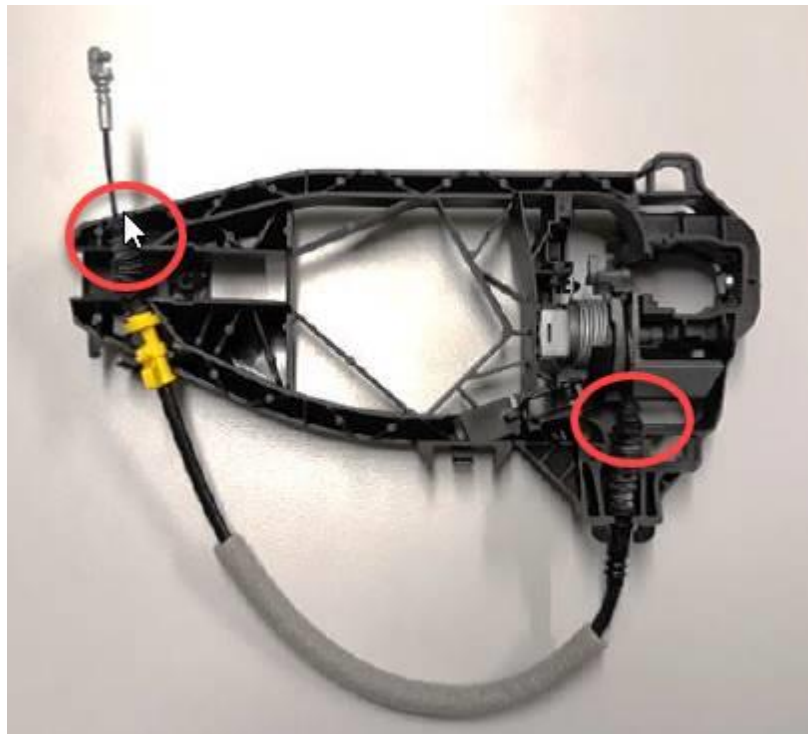
Due to some manufacturing residue left on the cable, water is allowed to enter the Bowden cable attached to the door lock, which can freeze and not allow the door to unlock. Once the vehicle is brought in the shop for a short period of time or left in overnight, you may not be able to reproduce this concern. It happens frequently when it is cold outside and the vehicle has been taken through a carwash. If the faults are stored, you can proceed with this bulletin without reproducing the concern.

**Figure 1.** Remove Bowden cable.

1. Gain access to the Bowden cable for the affected door and remove it. It is possible to have water entry on both ends of the cable as shown in Figure 1.

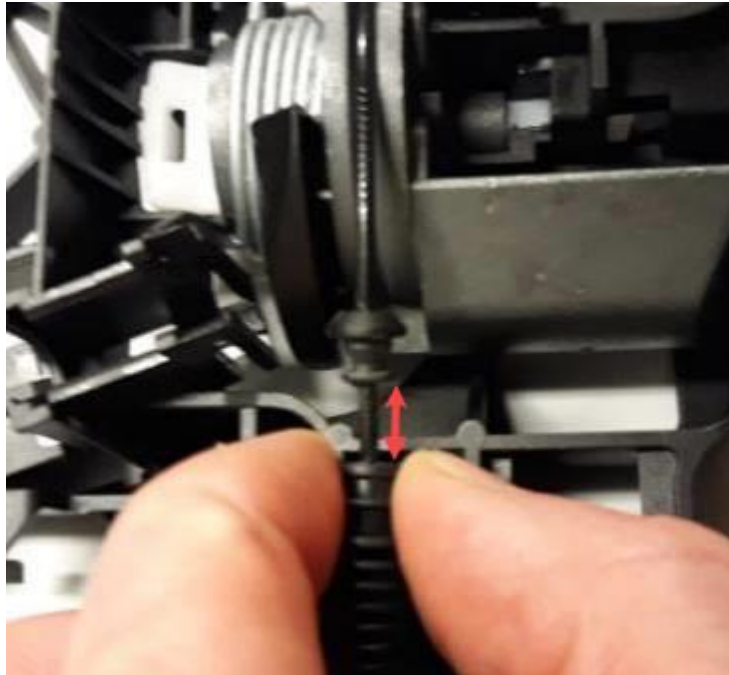
*Figure 2. Separate the boot from the cable retainer.*

2. With the cable removed, you will need to separate the boot from the cable retainer (Figure 2).

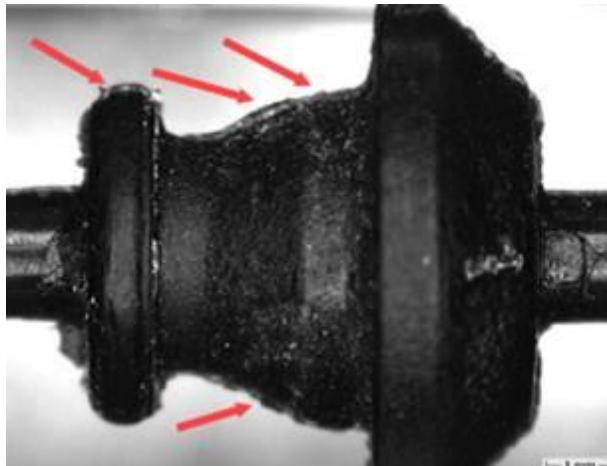
*Figure 3. Burrs that need to be removed.*

3. In Figures 3 and 4, you can see the burrs that need to be removed from the retainer. They can be removed with a razor knife.

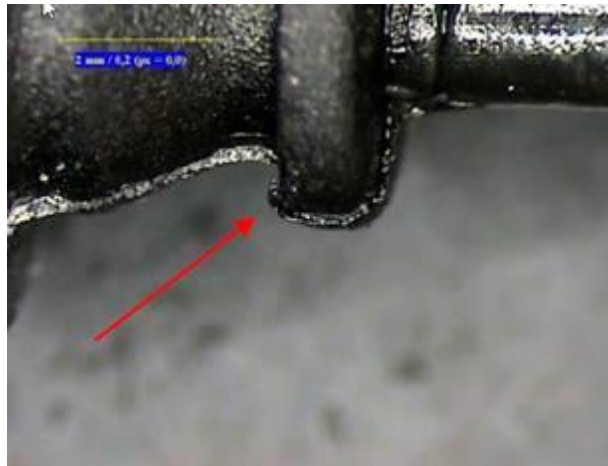
**Figure 4.** Burrs that need to be removed.

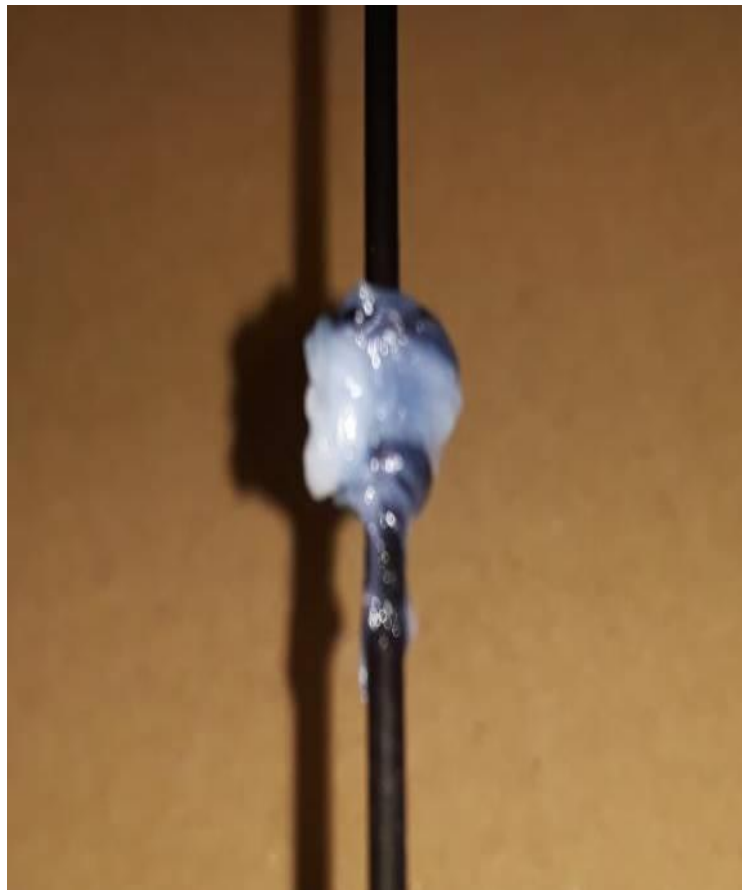
**Figure 5.** Apply the grease.

4. Apply the grease to both retainers on the cable. Only part number G 000 450 02 is to be used for this application (Figure 5).
