## TECHNICAL SERVICE BULLETIN

### 6.7L - Illuminated MIL With DTCs U029D And/Or P2209

**18-2365**  
18 February  
2019

| <b>Ford</b><br>2017-2019 F-Super Duty |

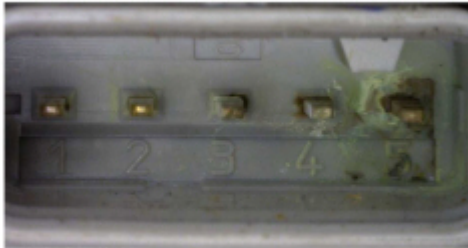
Figure 1

1. Disconnect the nitrogen oxides (NOx) sensor module 11 and inspect for moisture or corrosion on the pins of the sensor or the wiring harness. Are there any signs of moisture or corrosion present? (Figures 1-2)

(1). Yes - replace the NOx sensor module 11. Refer to Workshop Manual (WSM), Section 303-14. Proceed to Step 2.
