# Preliminary Information

## PIT5499A ABS or ESC MIL on Service Trailer Brake Message or Low Brake Fluid Warning

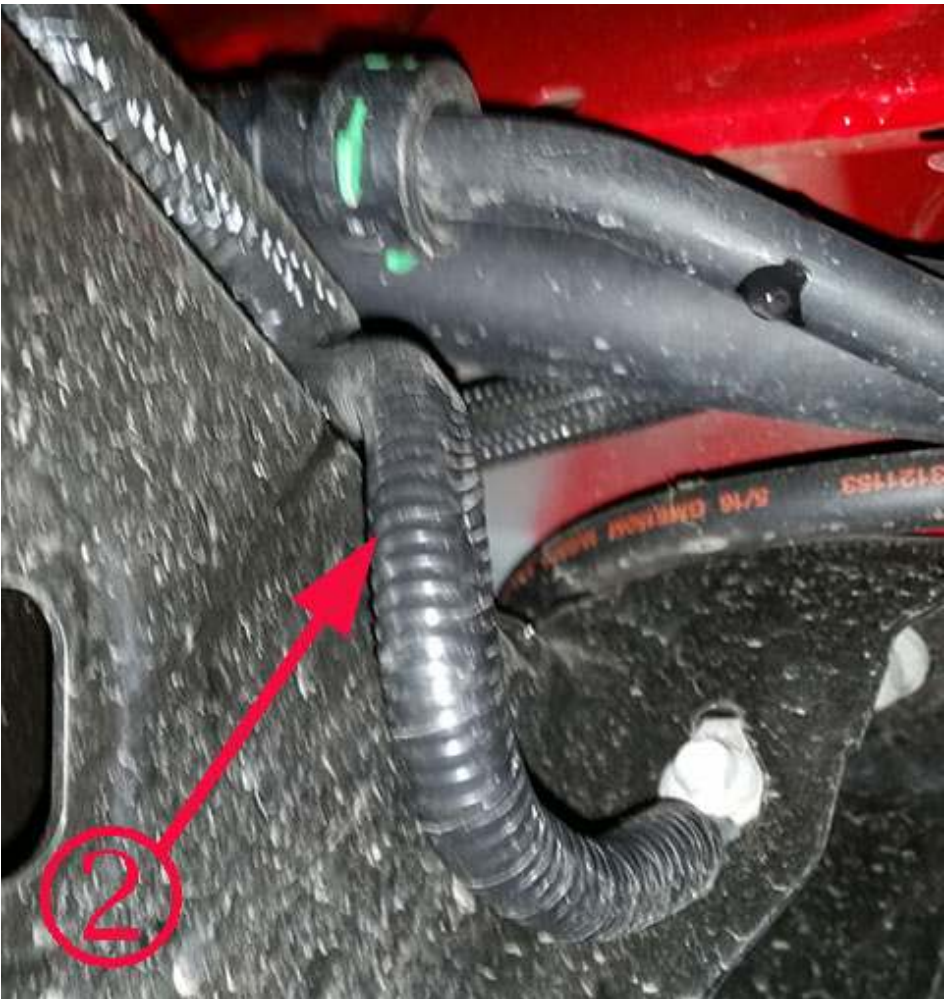
The customer may state the ABS / ESC MIL is on , the Low Brake Fluid lamp on (master cylinder fluid level is full) or a Service Trailer Brake message. The technician may find codes C0035, C0040, C0045,C0050, C0055, C0267, U0121, U0415 or U0420.

Inspect the EBCM connector for water intrusion or terminal corrosion. If either is found, replace the EBCM and replace the effected terminals. Remove the tape from the conduit leading to G400 between the main harness and the ground lug.

If no water intrusion or corrosion is found in the connector, remove the tape from the G400 conduit and continue with published diagnostics. Please note in the repair information if there
