# Preliminary Information

PIP5402B Check Engine Light MIL P015B, P1101 and /or P0101 Reduce Engine Power

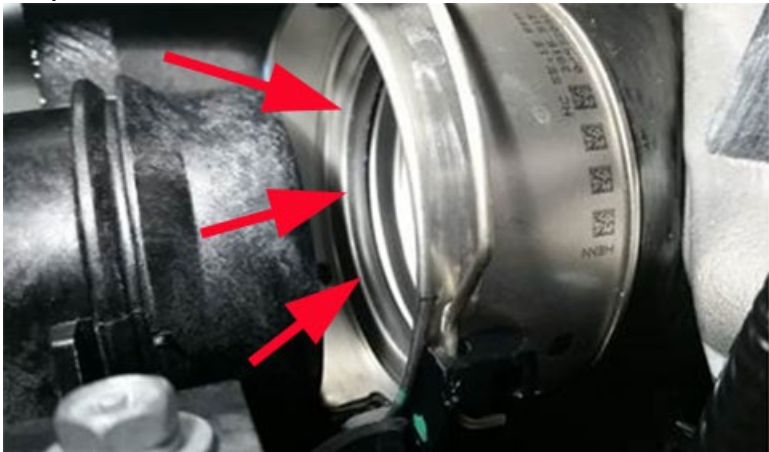
After following normal SI diagnostics, if a solution is not found, inspect for a missing/damaged O-ring seal in the charge air cooler coupler.

This coupler is located on the passenger side of the charge air cooler where the air duct slips into it.

The arrows in the picture below are pointing to the O-ring seal being discussed.

The picture below is from an ATS. Other models are similar.
