# Preliminary Information

PIP5402C Check Engine Light MIL P015B, P1101 and /or P0101 Reduce Engine Power

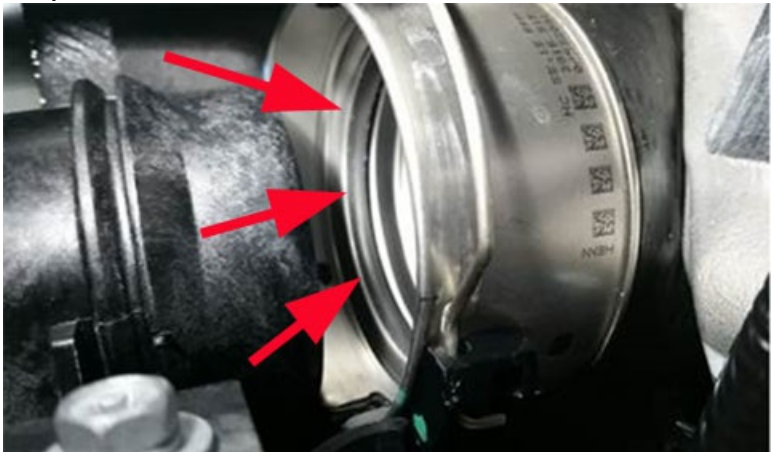
This coupler is located on the passenger side of the charge air cooler where the air duct slips into it. The arrows in the picture below are pointing to the O-ring seal being discussed.

The picture below is from an ATS. Other models are similar.

After following normal SI diagnostics, if a solution is not found, inspect for a missing/damaged O-ring seal in the charge air cooler coupler.
